## **Landslide Mechanism of a Slope in Nanhuan Road, Funxin, Northeast China**

Huiming Liu\*, Changming Wang, Suoyu Zhang, Bing Wang

### **Abstract**

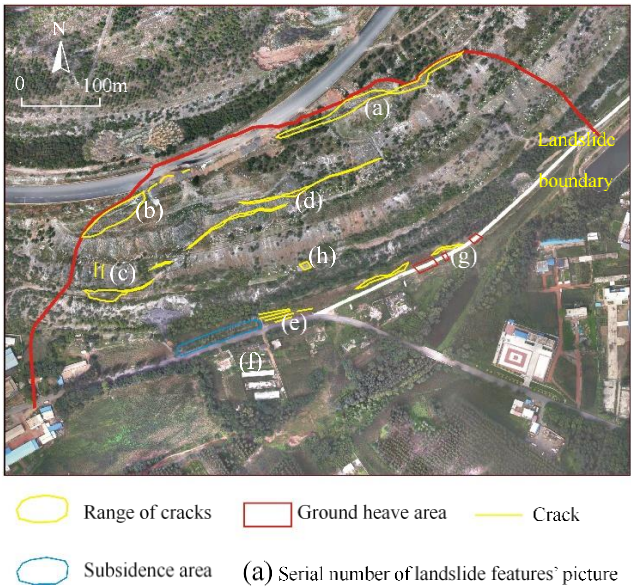
Fig.2. Location of Landslide Features in the Site Survey in September 2015

In August 2013, the first sign of ground heave was recorded at the intersection of Yimin Road and Huancheng Road at the bottom of the slope. Besides, cracks and sliding features were discovered on the slope of Step 1. Two months later, the area of cracked pavement on Nanhuan Road further expanded, leaving three obvious cracks on the pavement. The cracks were up to 340m in length and 1~30cm in width. The height difference between the two sides of crack was 20cm at the most. According to the observation data, the maximum road settlement was 15.1cm, and the maximum crack width was 12cm from August to September in 2013.

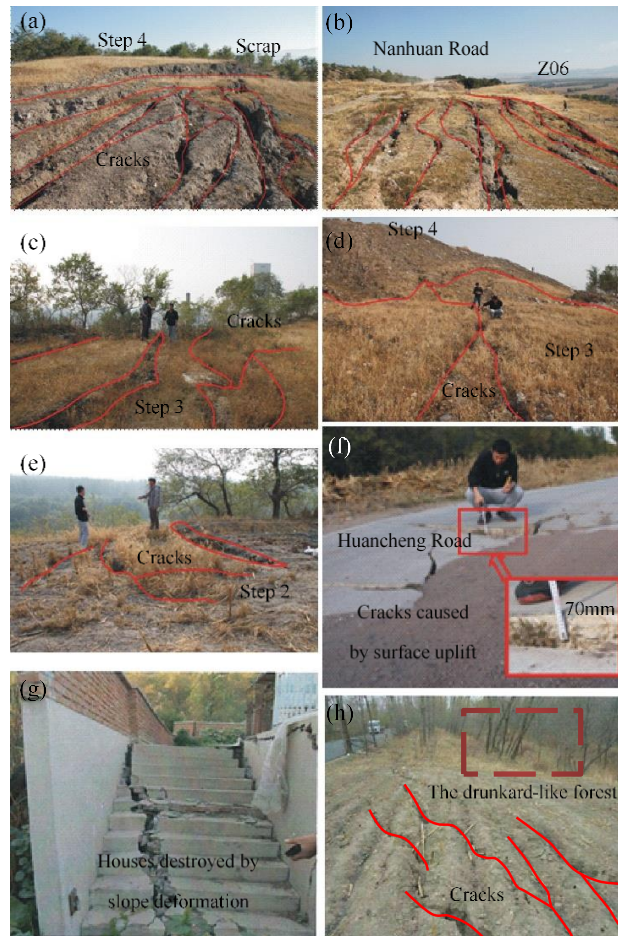
Fig.3. Most Evident Damages of the Nanhuan Road Landslide

As the road continued to settle with the deformation of the slide mass, a number of backfills were performed on the subsidence section by the road maintenance department. The site survey in September 2015 shows that the total pavement settlement had surpassed 5m, clear boundaries had formed around the slide mass, and a number of cracks had formed on the surface of the slide mass (Fig.2.). At the bottom of the slope, the deformation had induced uneven settlement of Yimin Road, ground heave in the surrounding residential areas, and cracking on the walls of residential buildings (Fig.3.).

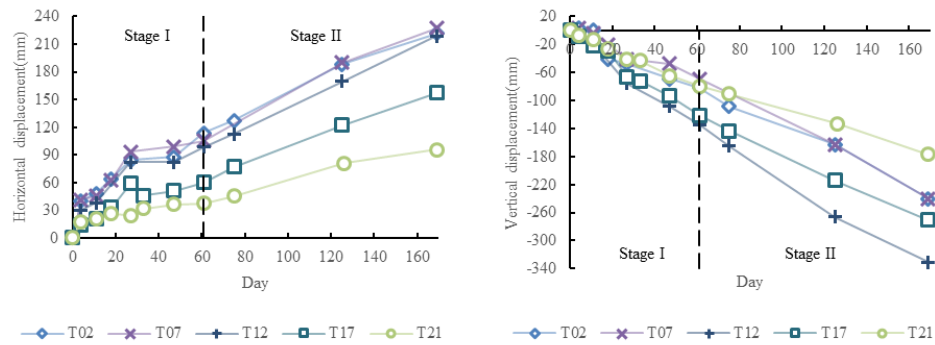
Fig.6. Displacement of Step 4

On the top platform (Step 4) of the slope (Fig.6), all the monitoring points underwent obvious displacement in the horizontal direction. The horizontal displacement increased with the monitoring time. During the monitoring process, the most pronounced displacement increments were measured at T02, T07 and T12, all of which fell in the range of 219mm~227mm at the end of Phase 2. In the vertical direction, all the monitoring points on this platform exhibited apparent settlement. The vertical settlement also increased with the monitoring time. The most prominent vertical settlements were measured at T12 and T17 in Phase 1. The settlement values of T07, T02 and T21 were very close to each other. In Phase 2, the settlement of T21 gradually slowed down. At the end of Phase 2, T12 and T17 had the greatest settlements (331mm vs. 271mm), followed by T02 and T07, both of which shared similar degree of settlement (240mm); the minimum settlement was observed at T21 (177mm).

To sum up, T12 underwent the significant displacement in both directions, T02 and T07 were mainly displaced in the horizontal direction, T17 was mainly displaced in the vertical direction, and T21 had unobvious displacement in either direction.

For the monitoring points on Step 4, the horizontal displacement was consistent with the sliding direction of landslide, and the vertical deformation was displayed as settlement. The settlement of the monitoring points (T02, T07, T12) in backfill area was greater than the one (T21) in the original area.

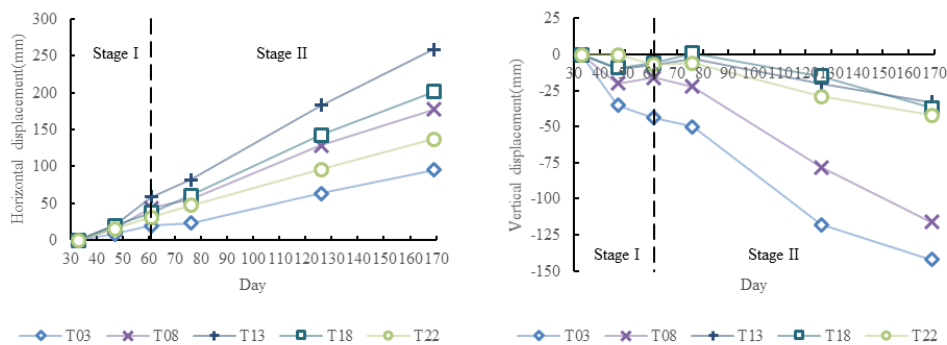
Fig.7. Displacement of Step 3

The monitoring points in Step 3 of the slope exhibited different displacement features (Fig.7). The monitoring points underwent horizontal displacement along the direction of the slope, and the displacement value increased steadily with the growth of the monitoring time. At the end of Phase 2, the monitoring points were ranked as  $T13 > T18 > T08 > T22 > T03$  in descending order of displacement. In the vertical direction, each monitoring point in this platform underwent significant deformation. The settlement also increased steadily with the growth of the monitoring time. At the end of Phase 2, T03 and T08 had the most obvious settlements (142mm vs. 116mm), while the settlements of T13, T18 and T22 fell in the interval of 37mm~42mm.

In short, T08 underwent the significant displacement in both directions, T13, T18 and T22 were mainly displaced in the horizontal direction, and T03 was mainly displaced in the vertical direction.

Step 3 was formed by the accumulation of slags. The shape of the slope had a great impact on the horizontal deformation. Under the impact, the monitoring points on the edge (T03, T22) underwent the smallest horizontal displacements, while the monitoring point in the protruding position (T13) had a much greater horizontal displacement. At the beginning of the monitoring, T03 boasted the greatest vertical displacement under the action of the backfill subgrade on Step 4. The deformation of T03, in turn, affected the surrounding area, such as inducing major growth of the vertical displacement of T08. With less impact of backfill and surrounding settlement, there was no significant increase in the vertical displacements of T13, T18 and T22.

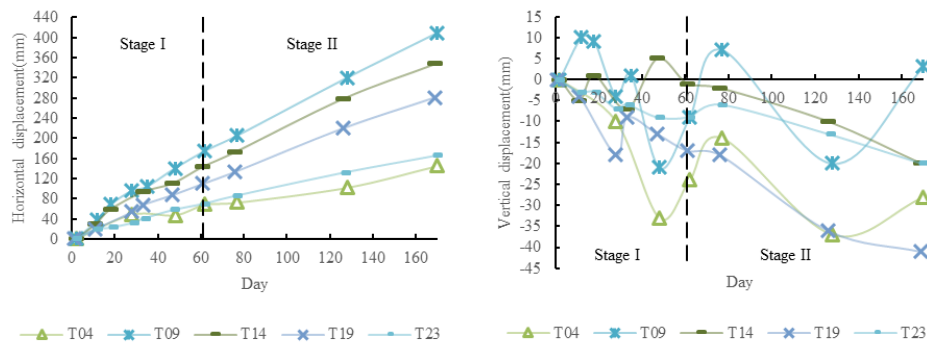
Fig.8. Displacement of Step 2

As shown in Fig.8, all of the monitoring points on Step 2 exhibited obvious displacement in the horizontal direction, which increased with the monitoring time. At the end of Phase 1, the monitoring points were ranked as  $T09 > T14 > T19 > T23 > T04$  in descending order of displacement. In the vertical direction, the monitoring points differed markedly in the deformation trend. As the

monitoring time increased, the vertical settlement of the monitoring points showed great uncertainty. For instance, T04 experienced varied degrees of settlement and uplift during the monitoring: the final trend was settlement (28mm) at the end of Phase 2. For the monitoring point T09, the vertical deformation was an uplift (max: 10mm) at the beginning of Phase 1, the uplift and settlement appeared alternatively during Phase 1, and trend was settlement (9mm) at the end of Phase 1; the uplift and settlement appeared alternatively again during Phase 2, and the final trend was uplift (3mm) at the end of Phase 2. The monitoring point T14 experienced uplift (max: 5mm) and settlement (max: 7mm) alternatively during Phase 1. During the monitoring period, the displacement trend of T19 was mainly manifested as settlement, and the final settlement was 41mm at the end of Phase 2. For the monitoring point T23, settlement was the main displacement trend in Phase 1 and the final settlement reached 20mm at the end of Phase 2; of course, there was a slight uplift trend at the beginning of Phase 2.

Step 2 had a similar horizontal displacement to Step 3. The monitoring points on the edge (T03, T22) underwent the smallest horizontal displacements, while the monitoring point in the protruding position (T09, T14) had the largest horizontal displacements. In the vertical direction, the monitoring points on Step 3 experienced irregular uplift and settlement during the monitoring period. Hence, it is assumed that Step is located on and affected by multiple sliding surfaces.

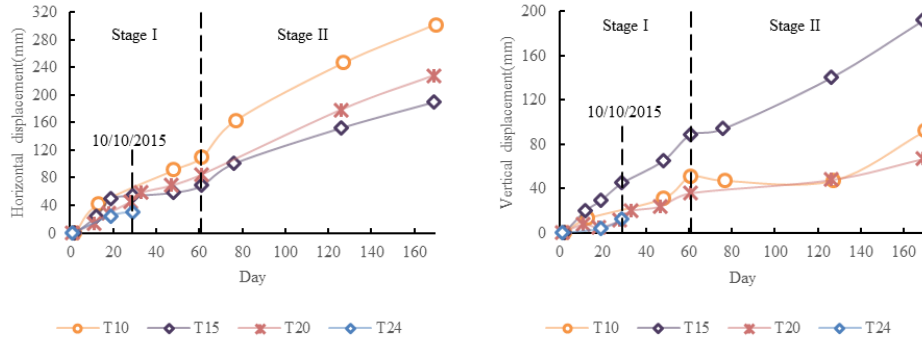
Fig.9. Displacement of Step 1

As shown in Fig.9, all of the monitoring points on Step 1 exhibited obvious displacement in the horizontal direction. At the end of Phase 2, the monitoring points were ranked as T10> T20> T19> T15 in descending order of displacement. There was also significant deformation in the vertical direction at these monitoring points, that is, a steady increase in the uplift with the growth of the monitoring time. At the end of Phase 2, the maximum uplift occurred at T15 (192mm). T10 and T20 had similar uplifts, which varied between 67mm and 92mm.

Situated at the bottom of the slope, Step 1 was severely squeezed by the upper sliding mass. Under the squeezing effect, the monitoring points on the step exhibited a large displacement. The effect of the sliding mass also led to the pronounced uplift at the bottom.

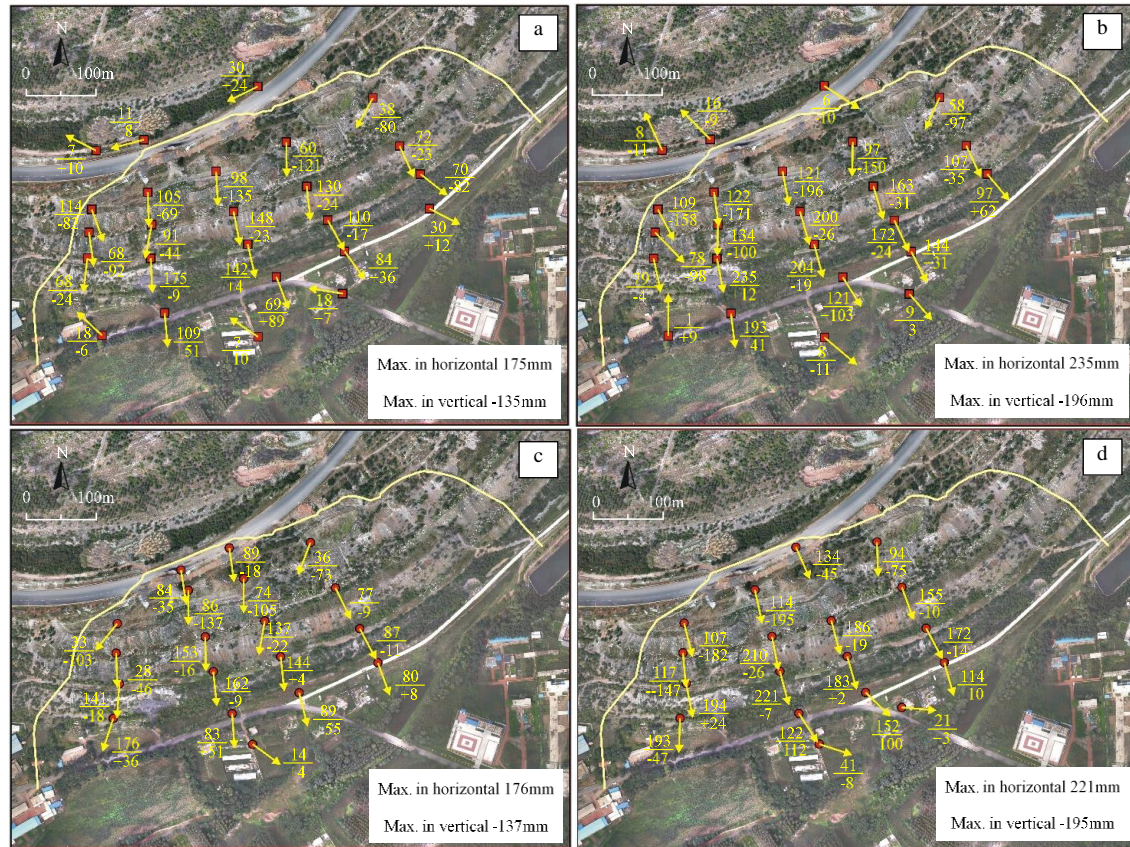
In Phase 1 (Fig.10.a, c), T09 was the most horizontally displaced monitoring point (175mm), T12 was the most vertically displaced monitoring point (135mm), Z03 was the most horizontally displaced borehole (176mm), and Z06 was the most vertically displaced borehole (137mm). The measured results of Phase 2 are independent of those of Phase 1. In Phase 2, the displacement of each monitoring point increased in varied degrees (Fig.10.b, d). The results are as follows: T09 was the most horizontally displaced monitoring point (235mm), T12 was the most vertically displaced monitoring point (196mm), Z08 was the most horizontally displaced borehole (221mm), and Z06 was the most vertically displaced borehole (195mm).

Sorting out the monitoring results, it was concluded that the horizontal displacements of the monitoring points fell in  $150^{\circ}\sim 180^{\circ}$ . According to the direction of displacement, the landslide was determined as south-trending, and the middle part of the sliding mass was the hotbed of landslide.

Fig.10. Displacement of monitoring points and boreholes (a. Displacement of monitoring points during Phase 1. b. Displacement of monitoring points during Phase 2. c. Displacement of boreholes during Phase 1. d. Displacement of boreholes during Phase 2. Note: The horizontal and vertical displacements were measured at the slope from September 2015 to February 2016. As for the fraction  $\frac{A}{\pm B}$  in the figure, A is the horizontal displacement, B is the vertical displacement, + is the uplift, and – is the settlement.)

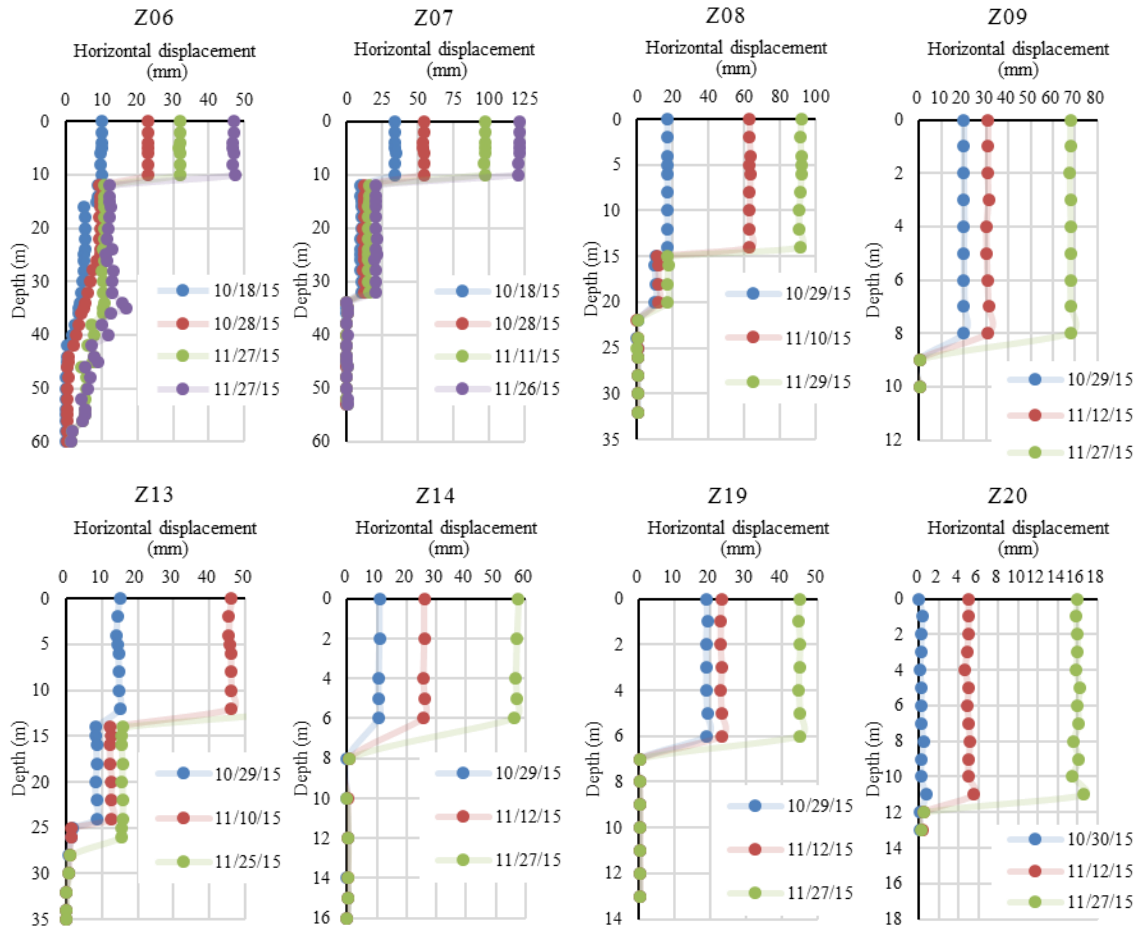
Fig.11. Horizontal Displacement Profiles of the Slope

After the site survey, the inclinometer measurement of the slope was conducted from October 2015 to November 2015. With the boreholes as the monitoring holes, an inclinometer was adopted to measure the horizontal displacement of each borehole at different depths. The selected boreholes include Z06 (depth: 60m), Z07 (depth: 53m), Z08 (depth: 32m), Z09 (depth: 10m), Z13 (depth: 35m), Z14 (depth: 16m), Z19 (depth: 13m) and Z20 (depth: 13m). During the measurement period, Z06 underwent 1 relative displacement at the depth of 15m; Z07 underwent 2 relative displacements at the depths of 10m and 32m; Z08 underwent 2 relative displacements at the depths of 14m and 20m; Z09 underwent 1 relative displacement at the depth of 8m; Z19 underwent 1 relative displacement at the depth of 6m. The measurement results reveal that the slope was still in the process of sliding. The locations of two sliding surfaces can be initially identified based on the site survey and inclinometer measurement.

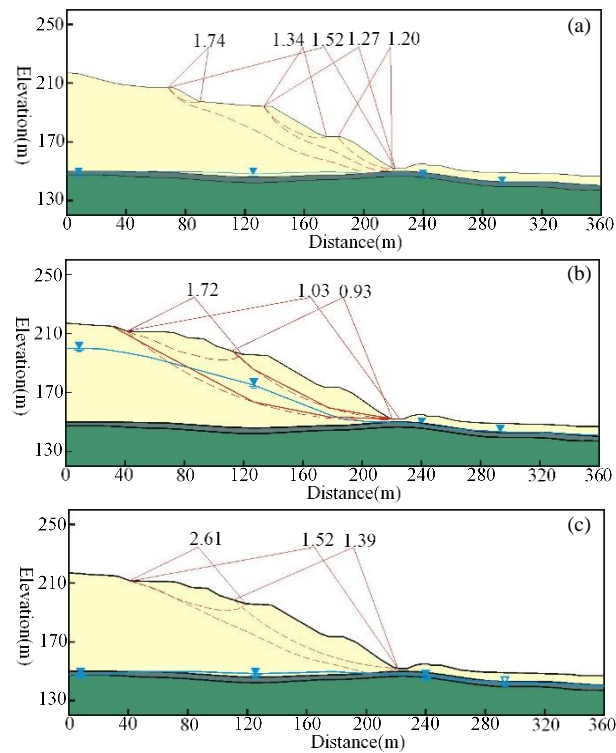
Fig.12. Slope Stability Analyses in Different Conditions (a. Before backfill b. After backfill c. The effect of rainfall infiltration)

In condition 1, the whole slope consisted of 3 steps. The safety factor was 1.52 for the whole slope, 1.27 for Steps 1 & 2, and 1.20, 1.34 and 1.74 for each of the three steps in ascending order. The safety factors demonstrate that the slope was in the stable state in condition 1 (Fig.12. (a)).

In condition 2, two tensile fractures were selected as the trailing edge of the slope according to the landslide features acquired in the site survey. Then, three sliding surfaces were identified

after checking the stability of each step. The safety factor was 1.52 for the whole slope, 2.61 for Steps 3 & 4, and 1.39 for Steps 1, 2 & 3. The safety factors indicate that the slope was still in the stable state in condition 2 (Fig.12. (b)).

In condition 3, the groundwater table rose in the slope under rainfall infiltration. The slope stability was checked in the same way as in condition 2. The safety factor was 1.03 for the whole slope, 1.72 for Steps 3 & 4, and 0.93 for Steps 1, 2 & 3. This means the slope was in the failure state (Fig.12. (c)).

The calculated results are in good agreement with the data measured by the inclinometer. The two slip surfaces are basically reasonable, because the slags were not accumulated evenly year after year.

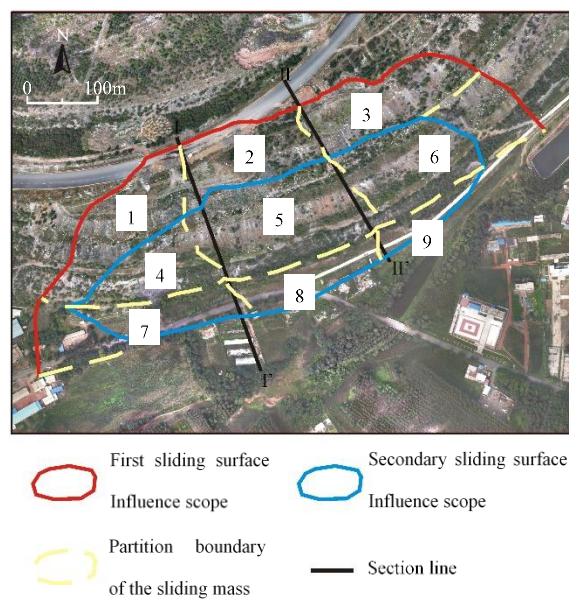
Fig.13. Segmentation of the Slide Mass Based on the Investigation Results

Based on the results of site survey, surface displacement monitoring, inclinometer measurement and limit equilibrium, the slide mass was segmented according to the sliding rate and the deformation features (Fig.13.).

Region 1: According to the results of surface displacement monitoring, this region has the greatest settlement in the sliding area, and a relatively insignificant horizontal displacement. During the construction of Nanhuan Road, the subgrade backfill added to the load on the slope crest, resulting in the settlement of the whole slope. In return, the settlement deformation led to the tensile fracture of the road and shear cracking on the edge of the primary sliding surface.

Region 2: This region is located between the two tensile fractures resulted from the sliding surface. There are two effects of subgrade backfill during the construction of road. On the one hand, the original slope experienced a typical settlement due to subgrade settlement and backfill soil weight; on the other hand, a more pronounced displacement occurred in the main sliding direction under the deformation squeezing of the subgrade backfill. Under the joint effect of horizontal and vertical deformations, Nanhuan Road was displaced by over 5m in this region.

Region 3: Situated on the outside of the subgrade backfill area, this region is still affected by the deformation of the backfill area. The upper part of the region has several tensile fractures, which become narrower as the distance from the backfill area increases. Since the backfill was not conducted in this region, the vertical displacement here is much smaller than that in Regions 1 and 2.

Region 4: This region is located within the secondary sliding surface. The whole slide mass slid down along the slope direction. With the extrusion of deformations in Regions 1 and 2,

however, the stress in the slide mass was distributed abnormally, creating irregular settlement and uplift.

Region 5: Located in the middle of the slide mass, this region shares a similar sliding situation with Region 3. Under the joint action of settlement and sliding in Region 2, the tensile fractures created by the secondary sliding surface tended to expand during the monitoring process.

Region 6: This region partially falls in the secondary sliding surface and partially on the sliding boundary. Hence, it was influenced by the deformation of Region 3 and a part of secondary sliding surface. Of course, the deformation effect from Region 3 was unobvious for the latter stayed beyond the backfill area. Besides, the regional displacement decreased with the increase in the distance from the sliding surface.

Region 7. This region is located in the south of the slope foot. Here, the surface deformation was manifested as uplift. The surrounding buildings were deformed and destroyed, and the pavement of Huancheng Road underwent wavy uplift and tilt.

Region 8: The region is located in the middle of the slope foot. The surface deformation was also manifested as uplift. The walls of the residential buildings were damaged and covered with tensile fissures. The road pavement was hit by severe settlement (max: 5m).

Region 9: The region is located on the north of the slope foot. The surface deformation was exhibited as slight uplift with small regional elevation. The road pavement cracked and slightly uplifted.
