## Assessing and Mitigating Seismic Risk for a Hospital Structure in Zaruma, Ecuador: A Structural and Regulatory Evaluation

This research, conducted in Zaruma, southern Ecuador, seeks to evaluate the seismic vulnerability and performance level of the Humberto Molina Hospital's reinforced concrete buildings. The study employs an examination of national and international seismic codes for rehabilitation, along with the implementation of recommended techniques. Structural characteristics of the buildings were identified through auscultation, surveys of reinforcing steel, and the extraction of concrete cores. The amassed data, coupled with a seismic hazard analysis of the site, facilitated a structural assessment of the blocks, conducted in accordance with national (MIDUVI) and international (ASCE/SEI) codes. The Federal Emergency Management Agency (FEMA) subsequently proposed rehabilitation alternatives for each block. Due to the importance of the hospital's functions, data collection was limited to blocks B3 and B4. The structural system, composed of moment-resisting concrete frames, exhibits potential vulnerabilities due to knocking (collision) and torsion, attributed to its irreg

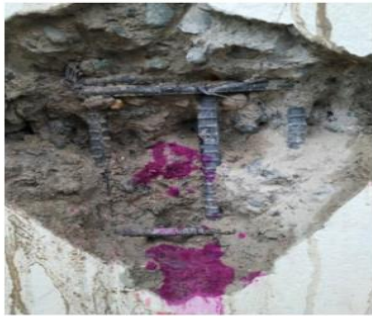
(a) Reinforcing steel

**Figure 5.** Auscultation work in the column of B4

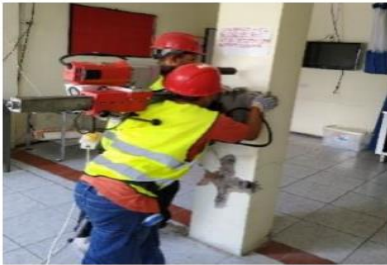
(b) Extraction of concrete cores

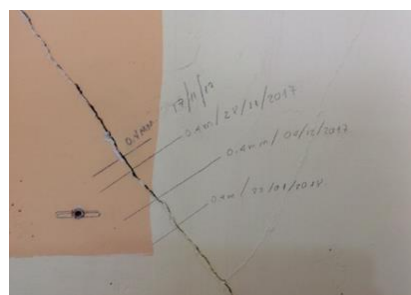
There are configurations within each block that do not comply with the national and international standards used (such as adjacent buildings (seismic joints), the existence of cracks in the masonry walls, masonry wall connection, the presence of a short column, and a high ratio of appearance of walls). Table 10 and Table 11 present solutions for each problem, as suggested by FEMA [37]. Figure 12 shows images of damage found in B3 and B4, respectively.

(a) Measurements in crack in masonry of mezzanine 1 of B3

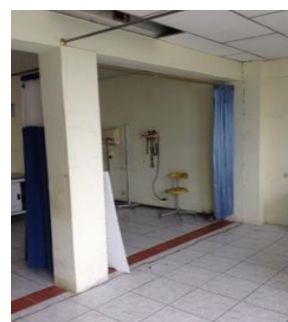
(b) Crack in subfloor in correspondence with joint in B4
