Slope Stabilization Systems for Accident Prevention: A Case Study of the Expansion and Improvement of the Huaruro Countryside, Arequipa

Victor Gabriel Castillo-Rudas¹, Marco Antonio Cotrina-Teatino^{2*}, Jairo Jhonatan Marquina-Araujo³

Department of Mining Engineering, Faculty of Engineering, National University of Trujillo, Trujillo 13001, Peru

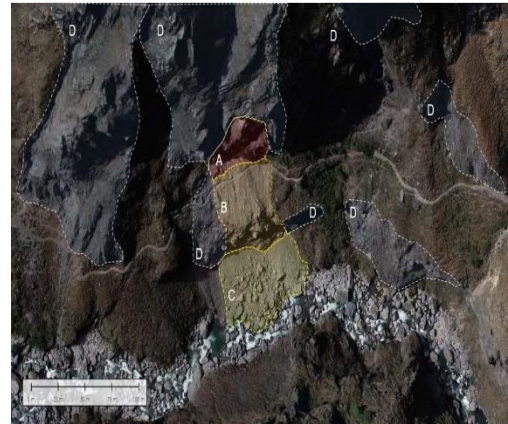
The study began with an exhaustive geotechnical diagnosis of the slopes, focusing on topographic and geomorphological characteristics including slope angle, rock type and material stability. Figure 4 illustrates in detail the zones of detachment (A), transport (B), accumulation (C) and areas where rockfall events were previously initiated (D). Zone A is the elevation of the access road in this sector with an altitude of 2935 msnm, the width of the landslide measured at the road crossing was 50 m, the collapse trajectory initiated from a near vertical (>85°) upper rock massif wall with a steep rock slope (40° slope and 55 m long), the distance measured from the head of the main escarpment to the foot of the accumulation zone is approximately 200 m, with an average slope of 55 degrees. Zone B has a thin layer of coarse colluvial material, the material being extremely loose and erodible, especially when

disturbed. Zone (C) are slope zones that are produced by accumulation of material and zone (D) are source zones where previous rockfall events were initiated.

Figure 4. Orthophoto of the landslide zone (progressive 0+500)

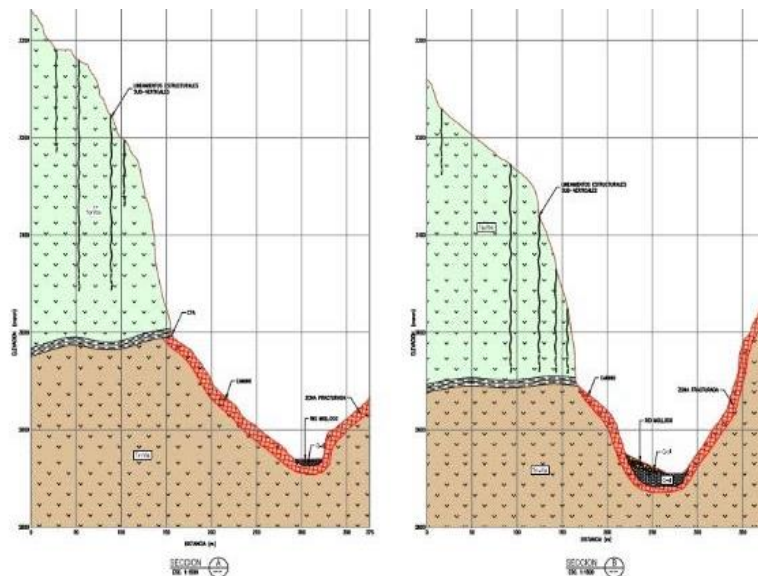
Figure 5. Geological profiles with subvertical geological structures

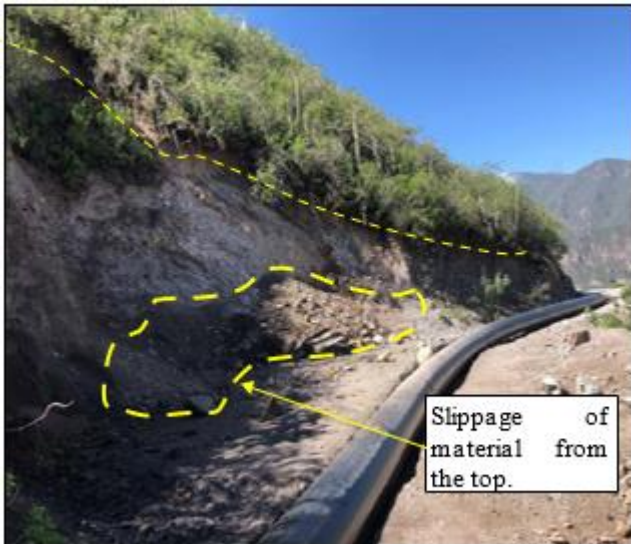
Figure 6. Slope in sector 7+930 - 7+960 in section 2

Figure 6 shows the diagnosis of the slope in sector 7+930 - 7+960 in section 2, where a deep slope cut of the quarry excavation is observed, it presents subvertical cuts and monitoring is recommended, as well as signage to restrict access.

In sector 7+930-7+960, the slope is unstable due to the subvertical cut that was the result of the excavation of the quarry to fill the material. In sector 8+270-8+290, the slope has fallen rock fragments because of the earthquake and in sector 10+210-10+260 the slope is currently being cut and fragmented for the axis of the pipeline.

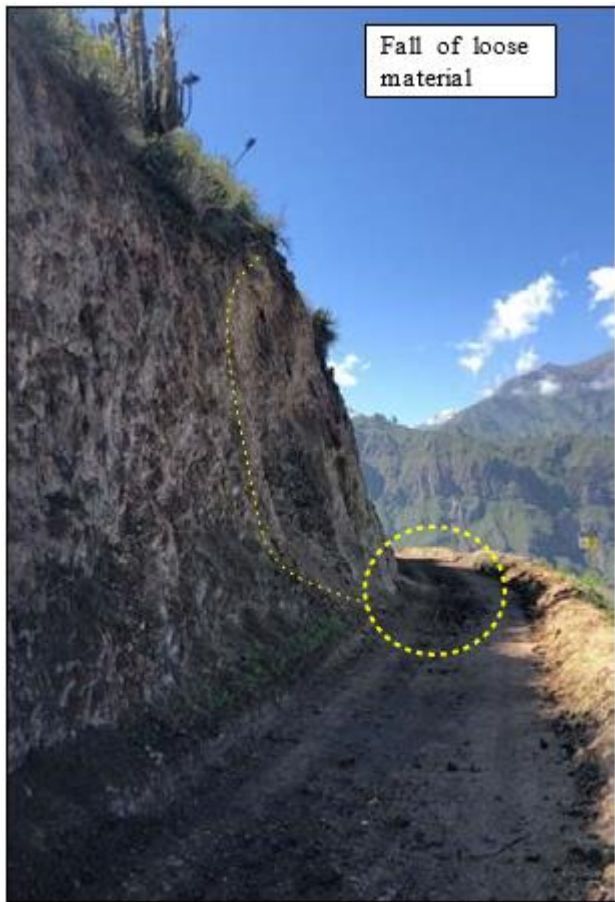
Figure 7. Slope in sector 8+270 - 8+290 in section 2

Figure 7 shows recently detached material in sector 8+270 - 8+290 in section 2, where there is a cut in the slope because of excavation for the pipeline shaft, material falling to the ground because of rainfall, landslides, and possible seismic events, indicating the need for constant monitoring to detect any signs of emerging instability in the slope.

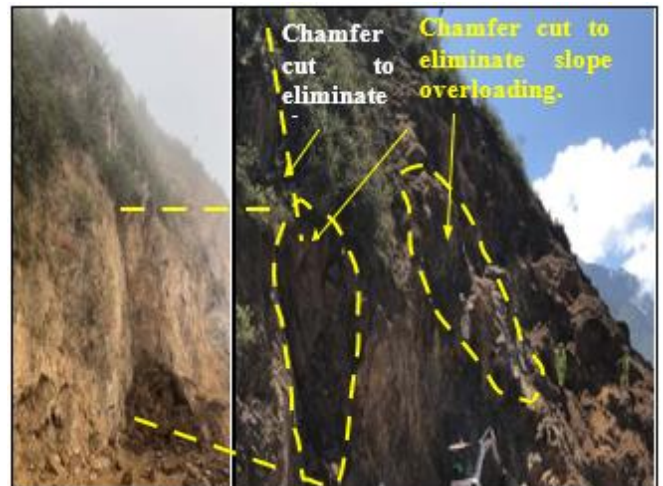
Figure 8. Slope in sector 10+210 - 10+260 in section 2

The analysis in sector 10+210 - 10+260 in section 2, shown in Figure 8, shows the slope cut as a result of the excavation for the pipe axis, rock fragmentation, fractured and altered material with simple compressive strength of 5 to 25 Mpa, where it is recommended to remove the material and remove the upper part of the overburden, making a 45° chamfer cut, as well as cutting the altered material at (0.33H:1V) in the subvertical cuts.

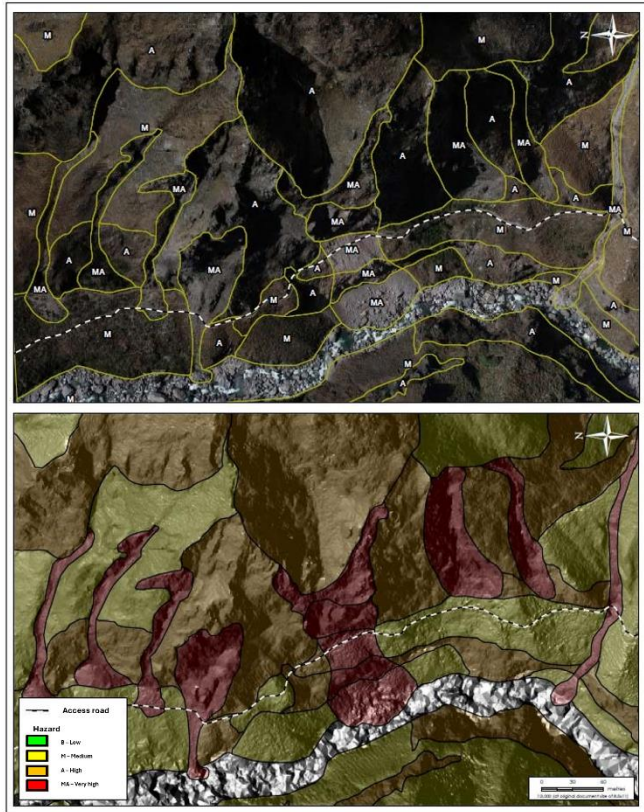
Based on geologic mapping, field observations and slope characteristics, analyses indicate that rock falls are mainly attributed to the intersection of discontinuities and formation of a blocky rock mass structure, where the failure modes are mainly wedge and planar instabilities with overturning associated with subvertical discontinuities in favor of the slope. Several rocks located in the landslide detachment zone (zone A) have been observed to be unstable, with very high rockfall hazard. These boulders vary in size from $\sim 0.5 \text{ m}^3$ to $\sim 2 \text{ m}^3$. Likewise, there are localized areas that have blocks or groups of blocks, with volumes greater than 100 m^3 . There are also landslide types: Low (B), flat to undulating topography, with minor mountainous parts, the terrain shows no evidence of previous landslide activity. Medium (M), slopes with old evidence of landslide activity, but which have not shown movement in the last 100 years. High (A), steep and abrupt relief, slopes frequently subject to landslide activity, landslide activation results when events with recurrence intervals of less than 10 years occur. Very high (MA), very steep and rugged relief, slopes with fault zones, intensely weathered and/or altered, saturated and highly fractured rock masses, actively

sliding slopes, movements may be continuous or stationary (see Figure 9).

Figure 9. Hazard map in interest (progressive 0+200 to 1+200)

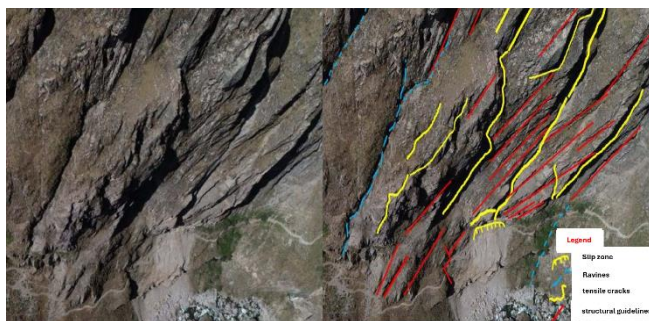
Figure 10. Landslide zone and geological structures

Locally there is the presence of diagonal fracturing with an inclination of approximately 90°, structurally they could be local geological faults, but their formation and deposition of the volcanic rock formed columnar structures of columnar disjunction type, where the degree of fracturing consists of vertical openings. Figure 10 shows the most important and

longest structures in the work zone, where very steep slopes to verticality are observed, presenting unstable blocks and structures in the form of vertical columns.

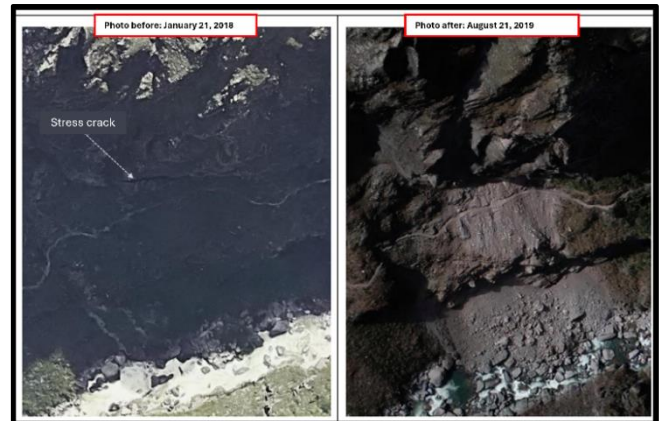
Some causes of triggering factors are the high level of weathering, presence of multiple faults and tension cracks which facilitate water infiltration and weaken the rock mass structure. Along the slope there is the presence of differential disintegration and erosion along the andesite and dacite contact zone (see Figure 11). The area investigated is characterized by high seismic activity. According to records of the Geophysical Institute of Peru (IGP), in the first three months of 2019, 11 earthquakes with magnitudes between 3.4 and 5.4 were reported within a radius of 100 km from the study site.

Figure 11. Level of weathering in the research area
