Road Damage Identification Using a Combination of UAV Quadcopter Technology and Subgrade Investigation

This study was conducted on the Waninggap Say Village Road, Merauke Regency. The research focused on 500 meters of damaged road surface at coordinates 8°20'57.3"S 140°30'22.9"E. The research was conducted over two months, from May to July 2024. The location of this study can be seen in Figure 1, which shows the area that is the object of research as well as a sample of road conditions.

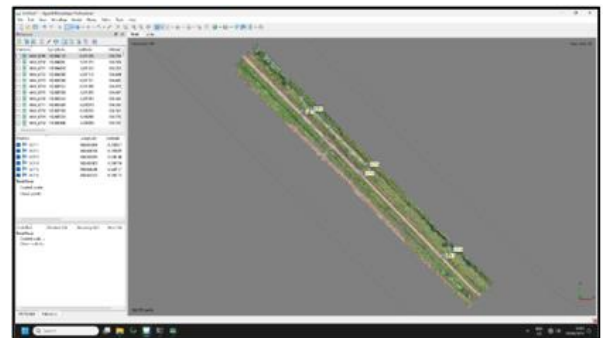
(a) Photos acquisition of photogrammetric images

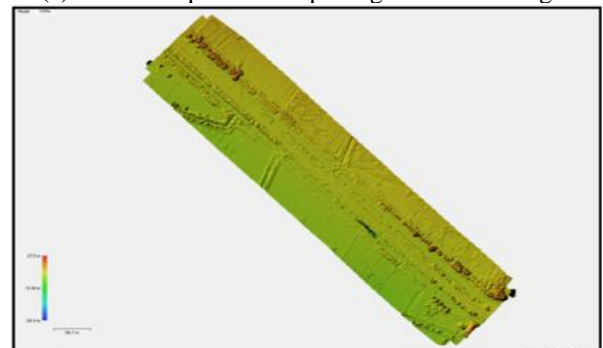
(b) Digital Elevation Model (DEM) from photogrammetric imagery

Aerial photos were taken from 08:00 to 12:00 WIT, considering weather conditions. This time was chosen because clouds had not yet formed, and shadows from the sun were visible on large objects. The coordinate system used in road damage mapping is WGS 84 or UTM zone 54S. After the aerial photos were collected, the next step was to process the data using Agisoft Metashape software. The software processes UAV aerial photos into orthophoto mosaics to identify road damage on Waninggap Say Village Road. Orthophotos were created in Agisoft Metashape through stages such as photo import, alignment, optimization, and dense point cloud construction. The resulting 3D models and texture models are shown in Figure 2(a) and DEM (Digital Elevation Model) in the creation of orthophotos. The resulting orthophoto provides high-fidelity data for road condition analysis, as shown in Figure 2(b).
