Diagnosing Construction Deficiencies in Roller-Compacted Concrete Pavements on a University Campus Using Unmanned Aerial Vehicles

Figure 1. Location of the Roller-Compacted Concrete Pavement (RCCP) pavement section evaluated

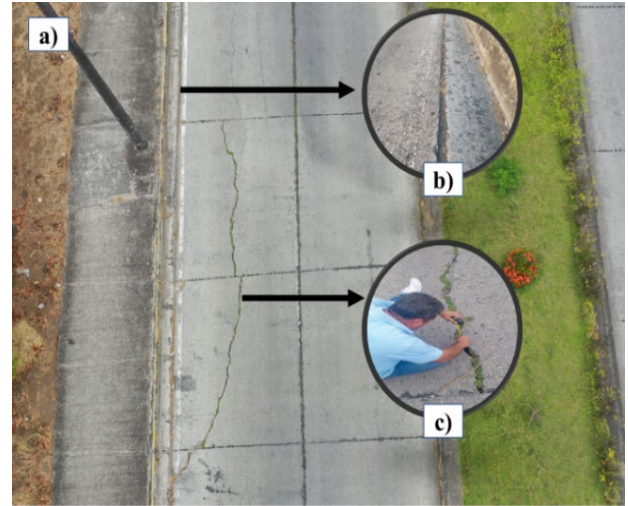
Field observations also revealed widespread cracking across the pavement slabs, including longitudinal, transverse, and corner cracks in all roadway segments. A critical case was observed at station 1+377, where three adjacent slabs exhibited full-depth cracking (Figure 10(a)). This crack developed next to a longitudinal slab-to-curb joint with an irregular 3 cm width (Figure 10(b)). The widespread cracking is attributed to a combination of factors, including deficiencies during RCCP compaction—affecting final strength—and the loss of slab support caused by pumping, aggravated by the oversized longitudinal joint, as further discussed in the following section.

The presence of severe full-depth cracking and the oversized longitudinal joint also enabled direct measurements of the slab thickness (Figure 10(c)). Thicknesses ranged from 19 to 23 cm, with an average of 21.81 cm (Table 8), evidencing

Figure 10. Construction deficiencies and full-depth cracking (station 1+340)

Station	Thickness (cm)	Observation
0+858	23	
0+861	22	
0+864	23	
0+869	21	
0+874	22	Gap of 3 cm between the slab and the curb
0+884	23	
0+886	23	
0+890	23	
1+340	22	
1+342	23	
1+343	22	
1+345	21	
1+345	21	Full-depth longitudinal crack affecting three slabs, maximum width 3 cm
1+349	20	
1+351	21	
1+352	19	
Average	21.81

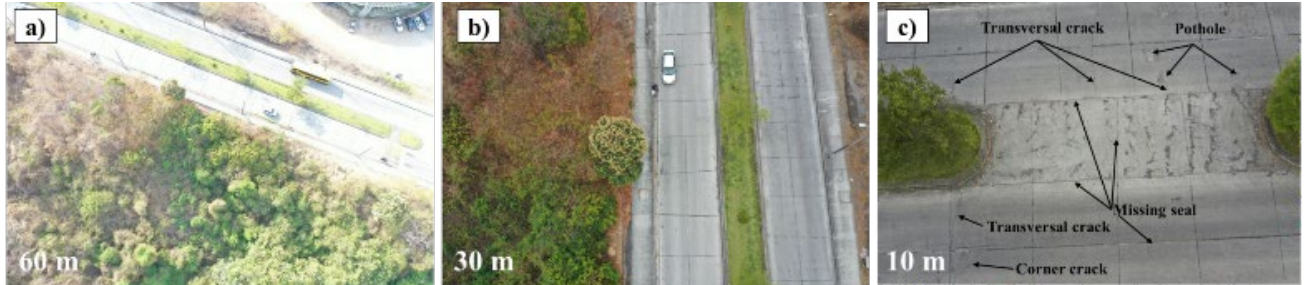
Using the drone model selected for the test, the flight at 60 m height did not allow identification of slab distress (Figure 11(a)). At 30 m, 78% of the distresses recorded during in-situ inspection were detected (Figure 11(b)). At 10 m, this percentage increased to 95% (Figure 11(c)). These results

Figure 11. Distress photographs captured with Unmanned Aerial Vehicle (UAV) at different altitudes (stations 1+309 to 1+359)

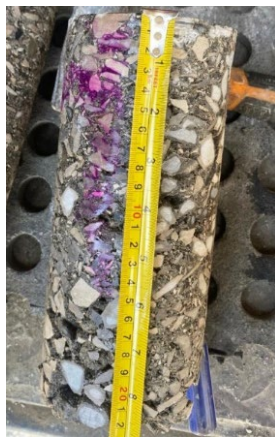
deficiencies. Core extractions provided the most reliable reference, yielding compressive strengths of 19.07 MPa at station 0+724 and only 8.14 MPa at station 1+460 (Table 10). Pronounced internal voids were clearly visible in the core extracted at the latter location (Figure 12).

Figure 12. Voids in concrete core (station 1+460)

This difference reinforces the hypothesis of irregular construction processes in the study pavement. The presence of internal voids observed in multiple specimens confirms problems with concrete compaction during slab construction.

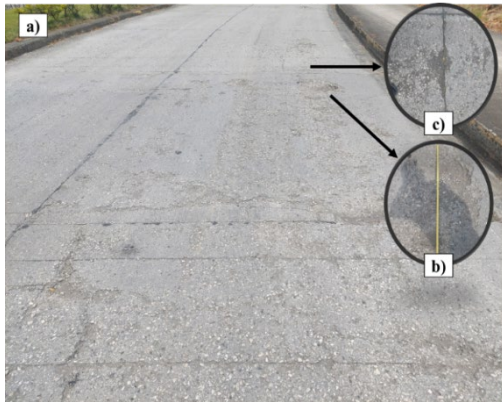
Potholes with depths of up to 10 cm were recorded, representing a high severity level (Figure 13(b)) and directly compromising the structural capacity of the slab due to their classification as serious damage. Potholes of this magnitude pose a significant safety hazard to users, potentially leading to traffic accidents, operational disruptions, and vehicle damage. Spalling appeared less frequently but was concentrated in the segments with the highest overall deterioration toward the end of the roadway. This type of damage typically occurs when joints lack adequate sealing, allowing the intrusion of incompressible material, which, under repeated loading, induces fracture stresses at the slab edges (Figure 13(c)) [38].

Figure 13. Surface distress on pavement slab (station 0+558)

For the surface distress group, the recommended solution is the partial-slab (full-depth) replacement or full-slab replacement, using hydraulic concrete with a compressive strength of 30 MPa, depending on the area and severity of the identified damage. The repair area must span the full width of the slab and have a minimum length of 220 cm (approximately half a slab) [31]. The repair work must include joint sealing, and, when loss of slab support is detected, reconstruction of the support layer using a Type 2 subbase. Partial-depth repairs are not recommended due to the thermal incompatibility between the existing RCCP slab and repair concrete [31], and because most slabs exhibit multiple deep and widespread distress. A seemingly simple solution, such as placing an asphalt overlay, would only provide temporary benefits and would not prevent reflective cracking or distress propagation from the underlying slab, as noted by Treviño et al. [40] and Riekstins et al. [41]. This condition is evident in the asphalt overlay applied over the pavement slab near the bridge crossing the ESPOL lake (station 1+040), where potholes and slab joints from the underlying concrete are already reflected (Figure 14). Therefore, it is necessary to apply rehabilitation techniques that restore the structural capacity of the existing concrete slab, as proposed in this study. In specific cases where slabs are affected only by a few localized surface distresses with depths less than 4 cm, partial-depth repairs using epoxy concrete may be applied [35]. In the case of localized slab settlement, since the existing differential

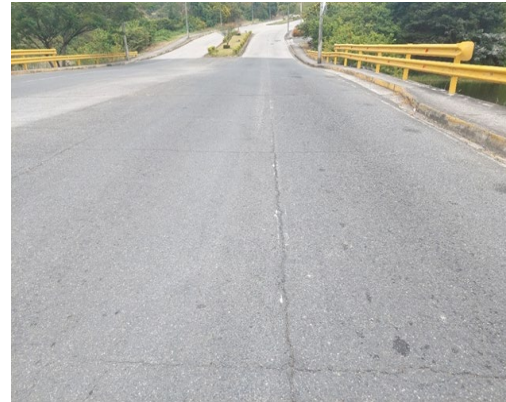
Figure 14. Slab joints and distress reflected on the asphalt overlay (station 1+040)

This condition aligns with field observations indicating the absence or severe deterioration of joint sealant material in several joints, promoting the progressive formation of spalling at slab edges. Moreover, it was found that in a roadway segment near the ESPOL lake (station 1+040), an asphalt overlay had been placed over the rigid pavement slab, which already reflects on its surface the joints, potholes, cracks, and wide cracks of the underlying slab (Figure 14).

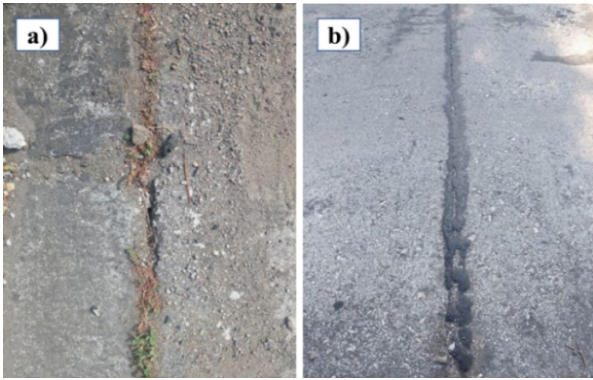
Progressive infiltration generated pumping under repeated traffic loads and accelerated loss of support at slab edges, contributing to the development of spalling associated with the pressure exerted by trapped incompressible materials (Figure

15(a)). In the transverse joints, a poorly executed maintenance process was observed, with sealant material accumulating on the slab surface and application performed without adequate surface preparation (Figure 15(b)). Such deficiencies

compromise the adhesion of the sealant and accelerate its loss due to traffic abrasion [39].

Figure 15. Joint sealant deterioration: (a) Station 1+414; (b) Station 0+085
