SEISMIC BEHAVIOR OF A MASONRY CHIMNEY RETROFITTED WITH COMPOSITE MATERIALS: A PRELIMINARY APPROACH

D. BRU, S. IVORRA & F. J. BAEZA
Civil Engineering Department, University of Alicante, Spain.

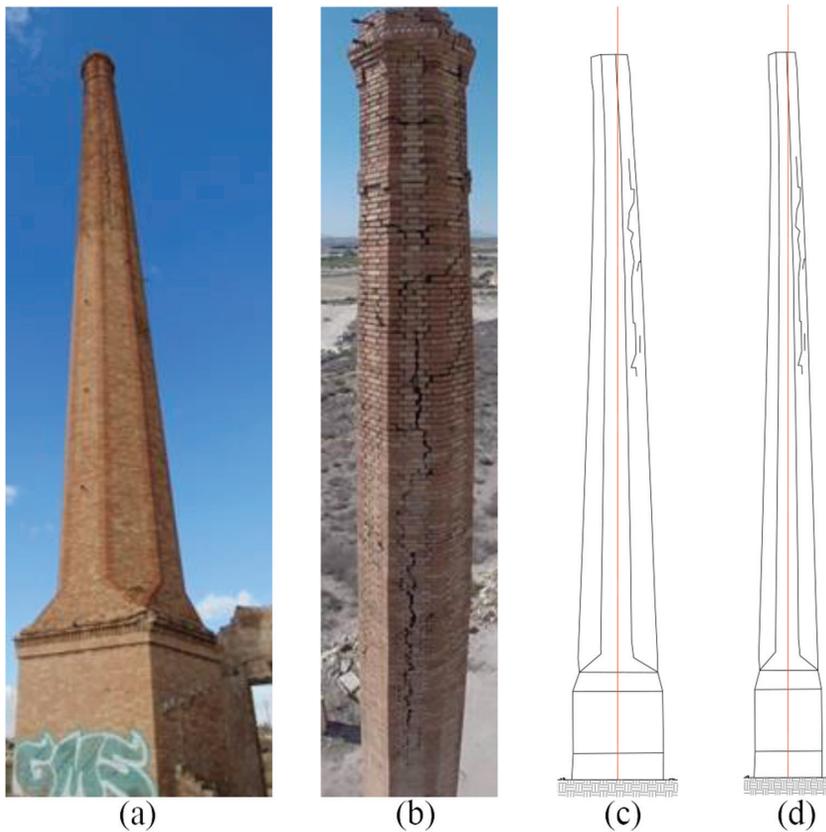
The chimney was built in masonry bricks (24x11.5x5 cm), with mortar joints (1.50 cm), for a total height of 24.70 m. It can be divided in three different parts: 2.84x2.84 m squared section base with 0.80 m thickness; and the stack and crown, both with a regular octagonal cross section with variable dimensions and thickness (from 0.6 m at the stack-base connection to 0.25 m at the crown). The main characteristics of this structure are the drift of the top of the shaft and the longitudinal crack on the central part of the chimney, Fig. 1. Nowadays, the top of the shaft has a slope of 3%, besides the 10 m of longitudinal crack in the shaft of the chimney that shows the lack of cohesion between masonry bricks.

Figure 1: a) General view of the chimney, b) vertical cracking pattern along the stack, c) and d) NE and SE elevations.

The reinforcement of the structure has been divided into several phases. First, the most damaged areas of mortar were repaired, i.e. all joints were cleaned with compressed air and damaged joints were completely removed. In the second phase, these damaged joints were repaired by means of new lime mortars, dosage 1/3 for slaked lime and 0–3 mm sand. In the third phase, the area where the cracks affected the whole wall thickness was repaired. In particular, all bricks near the crack were exchanged for new similar bricks and mortar.

After this preliminary repairing process of the masonry wall, the structural reinforcement was placed. The reinforcement comprised an internal textile reinforced mortar (TRM) and local reinforcement with longitudinal carbon fiber bands. In particular, one layer of fiberglass, Mapegrid G220, and Planitop Restauromortar were placed together. Regarding the carbon fiber reinforcement, eight internal and longitudinal FRP bands – Carboplate E170/100/1.4 and E170/80/1.2 – were placed along the whole chimney. A special adhesive, specifically Adhesilex PG-1, guaranteed the bonding between the carbon fiber laminates and the repair mortar. MAPEI provided all referred materials.

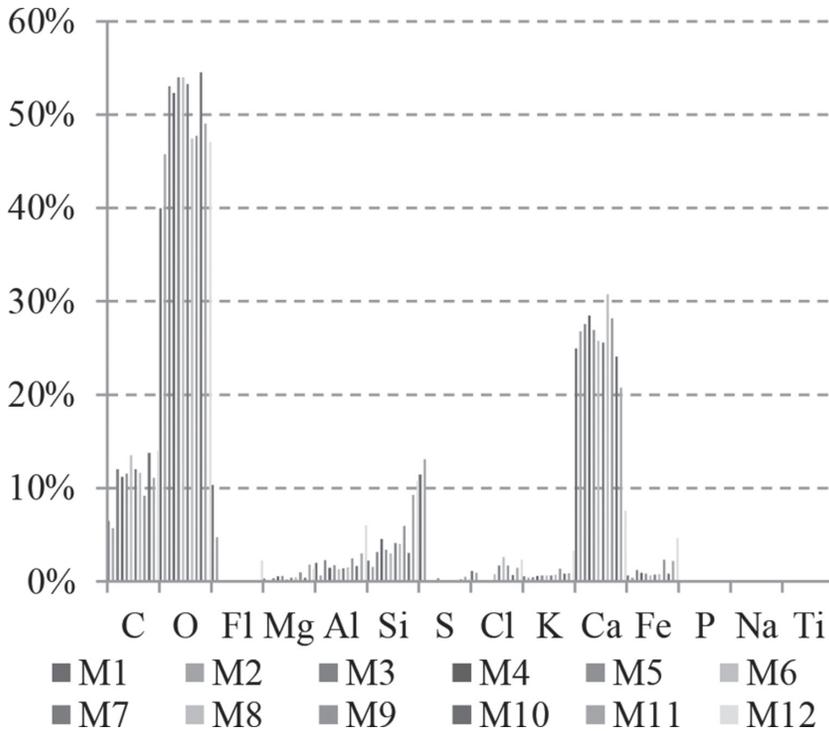
different positions. Samples number M1, M2 and M6 were taken from the inner part of the chimney. All samples were analyzed using scanning optical microscopy technique and X-ray diffraction. The results showed a high concentration of sulphur in the interior of the chimney, Fig. 2, due to combustion processes during the industrial activity of the facility. This fact caused significant mortar and brick deterioration due to the acid action of the sulphur, if water was present because vapor condensation. The mortar was a lime mortar with silica sand, as showed the X-ray diffraction results included in Table 1.

Figure 2: Results of SEM analysis.

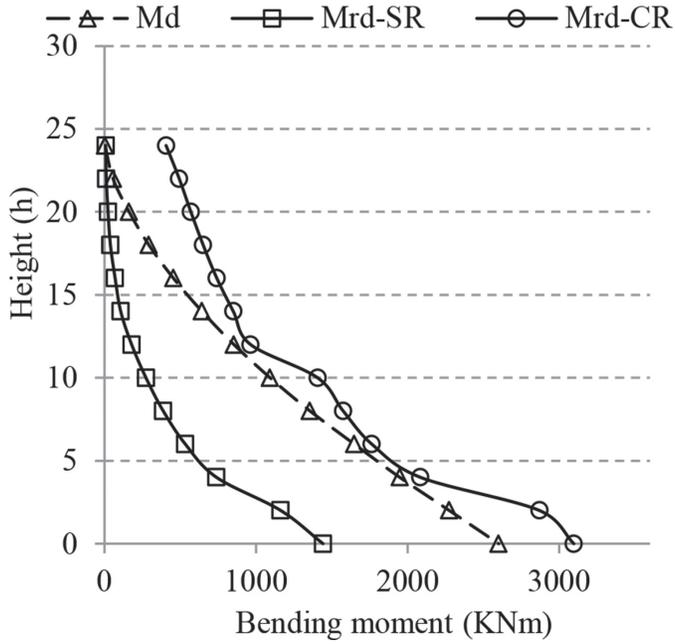
Figure 7 shows the bending results for linear analysis and bending resistance moment for reinforced and unreinforced structure. Before reinforcement of the structure, the masonry chimney shows high risk of bending collapse. However, for the reinforced chimney, all bending moments of the seismic actions are lower than the bending capacity of the reinforced sections. Furthermore, in case of shear seismic actions, Fig. 8 shows similar conclusions than bending analysis. In particular, the critical region is the upper 10 m of the masonry chimney.

Figure 7: Linear analysis results: Computed bending moment diagrams (Md); Moment resistance without reinforcement (Mrd-Sr); Moment resistance with reinforcement (Mrd-CR).

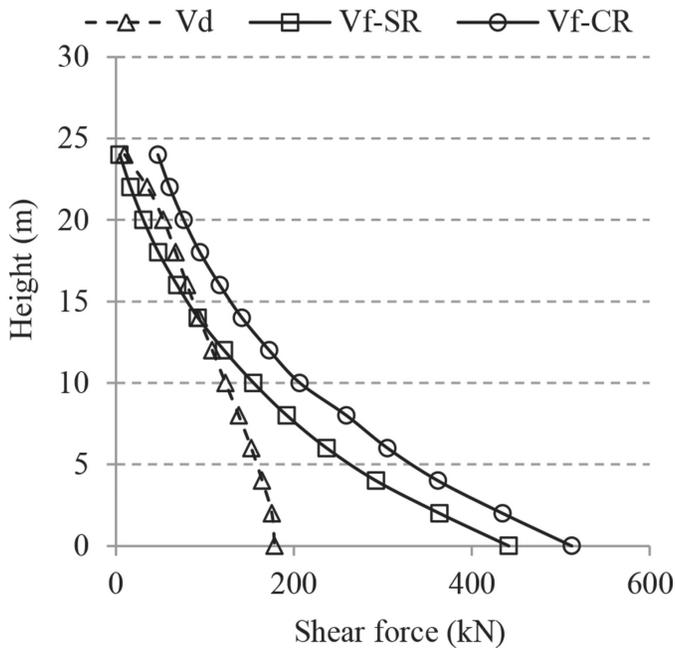
Figure 8: Linear analysis results: Computed shear force diagram (Vd); Shear resistance without reinforcement (Vf-SR); Shear resistance with reinforcement (Vf-CR).

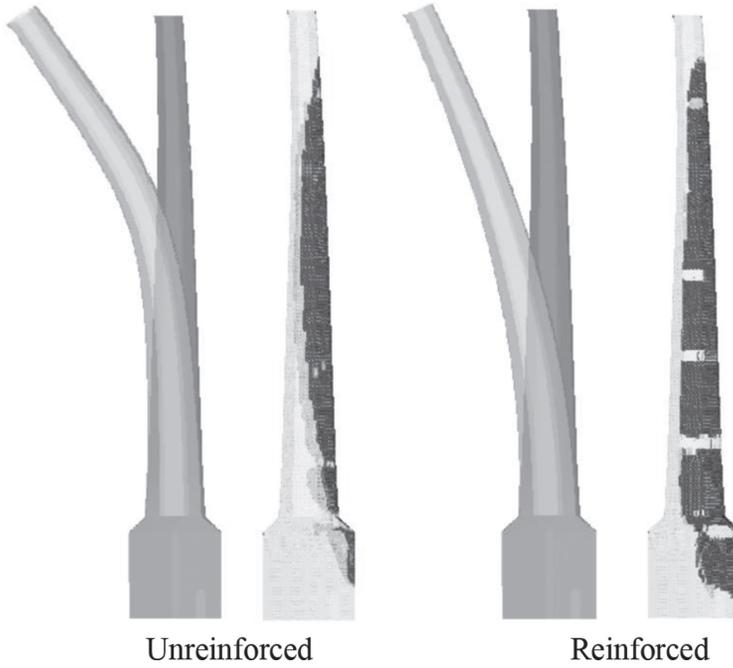
Figure 9 shows the capacity curve for reinforced and unreinforced first mode of vibration. The collapse point (CP), shows the maximum displacement, before the structure collapse due to the second-order effects. This failure mode is characterized by the cracking of the upper zone of the stack, Fig. 10, reaching the minimum value of the compression area, which prevents the collapse of the structure. Moreover, this failure mode shows that the structure has a small resistance capacity as cracked structure. The maximum displacement is seven times greater than the elastic displacement.

Furthermore, Fig. 9 shows that the stiffness of the cracked chimney and the maximum displacement for the reinforced structure are bigger than the unreinforced structure. In particular, the cracked stiffness of the reinforced structure is 1.45 times higher than unreinforced chimney. Moreover, reinforced structure shows a new crack pattern compared with unreinforced structure, Fig. 10. This new pattern has much more cracks at the bottom of the stack.

Figure 10: Cracking patterns for failure of pushover mode 1.
