HANDS-ON-EXPERIENCE ON SEISMIC RETROFIT IN FOUR DIFFERENT COUNTRIES

HAZIM YILMAZ & THOMAS HACHMANN
OBERMEYER Planen + Beraten GmbH, Munich, Germany.

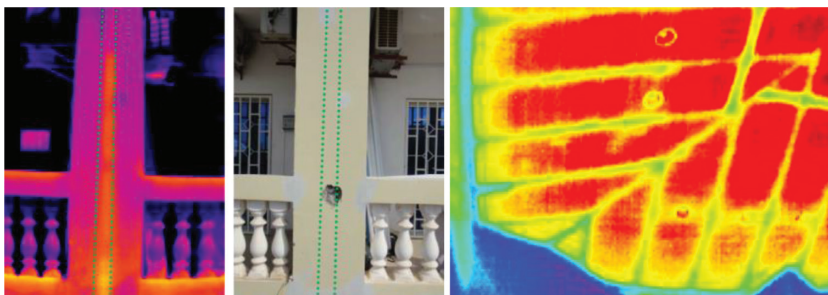
It is a very helpful tool in order to give the structural engineer an insight about the structure. Application examples can be seen in Fig. 3. The two left pictures show the existence of a joint between two building parts in the thermal image and afterwards verified by a destructive test. The destructive was done to determine the used material for the joint.

Figure 3: Use of thermal camera.

The right picture shows a load-bearing roof structure. The roof structure was covered by wooden panels from the inside but it was able to determine the metal construction by the use of thermal imaging.

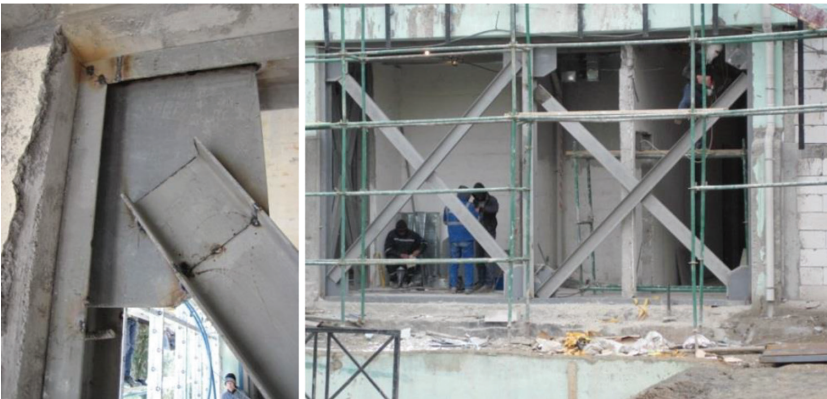
However, the construction company started to use steel bracings without the agreement of Obermeyer, which would definitely not substitute RC shear walls in terms of stiffness and strength properties. Additionally, the use of steel bracings needs a proper workmanship that was not available on site. Quality of welding seams was inappropriate as well as connection to reinforced concrete parts. The only way to react to these circumstances was the addition of supplementary steel bracings.

Figures 7 and 8 show the improper application of welding beams and bolted connections. Additionally, Fig. 8 shows the inadequate connection to existing reinforced concrete load-bearing parts.

Figure 7: Unplanned use of steel bracings.

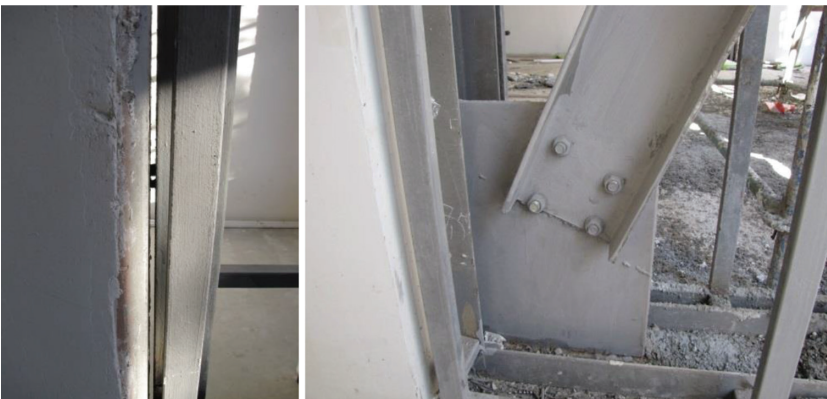
Figure 8: Inadequate workmanship.

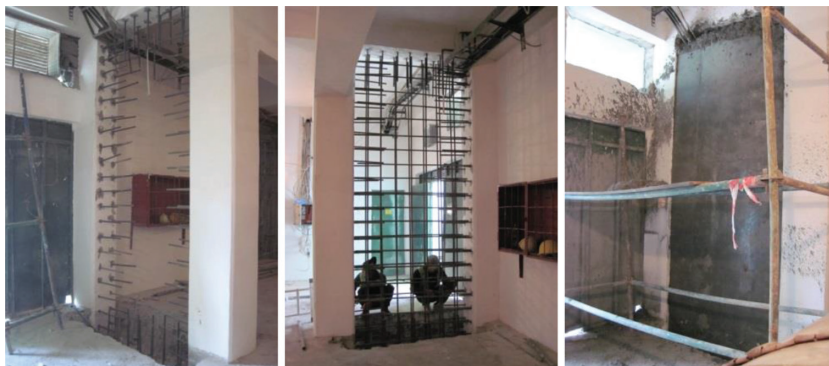
Figure 9: Shear walls made of reinforced concrete.

Figure 9 shows the non-consideration of the retrofit design by local HVAC and electrical installation.

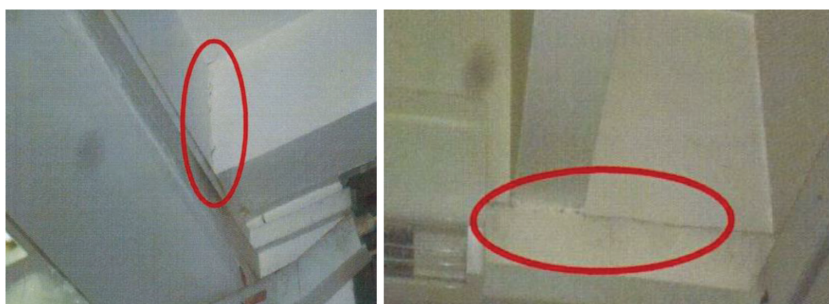
Building 1 experienced only slight damage. Mostly fine hair cracks were observed in column to beam connections.

Fine cracks were observed in beam joints, joints of beam and wall, and joints of shear wall and brick masonry wall in all storeys. In first floor slab experienced hair cracks (Fig. 10).

Figure 10: Results of damage assessment – building 1.

As a result of post-earthquake site survey building can be used for office occupancy. Retrofit of cracks is necessary.

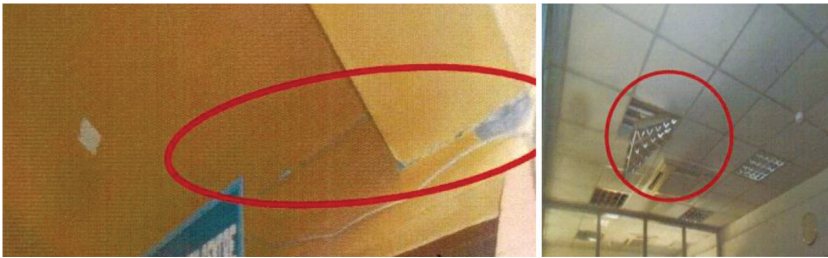
A retrofit of Building 2 was done prior to the assessment of Obermeyer in 2004/2005. Building 2 experienced damages but life safety criteria were still achieved.

Minor cracks on top of beam level and non-structural cracks were observed. Pounding happened between northwest staircase block and office building (Fig. 11).

Figure 11: Results of damage assessment – building 2.

Building can be used for office occupancy. Retrofit of cracks and staircase is necessary.

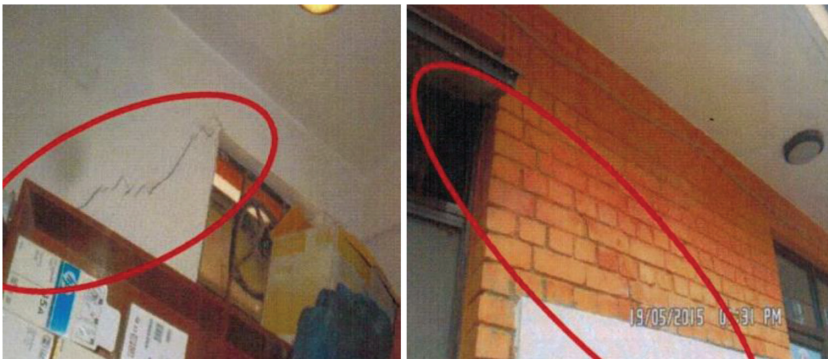
One storey building 4 experienced minor damage in form of cracks in non-structural walls.

Figure 12: Results of damage assessment – building 4.

Building can be used for office occupancy. Retrofit of cracks necessary by means of strengthening with injecting epoxy or grouting is necessary (Fig. 12).
