Degradation of AlGaIn/GaN Light Emitting Diodes caused by Carbon Contamination with Reverse-bias Stress Test in Water Vapor

Hsiang Chen, Yun Yang He, Min Han Lin, Shang Ren Lin, Sheng-Hao Hung,
Kun Min Hsieh, Shin-Jie Tsai and Yu-Cheng Chu

Department of Applied Materials and Optoelectronic Engineering, National Chi Nan University,
No.1 University Road, Puli, Nantou, Taiwan (R.O.C.) 54561

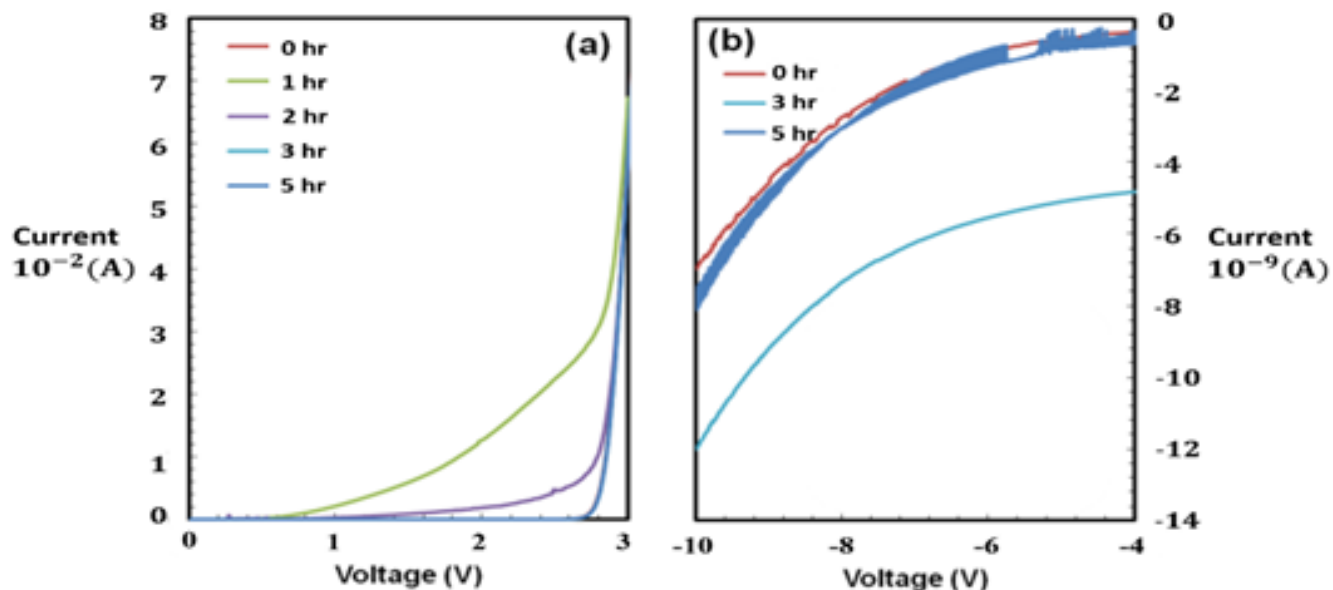
To observe the degradation of the device, I-V curves are taken to examine the change of the leakage current. Forward-bias and reverse-bias I-V curves as shown in Fig. 1(a) and (b) reveal that the leakage current increases and then decreases in the degradation process, which is similar with our previous study [5]. To further understand the failure origins, forward-bias and reverse-bias images as shown in Fig. 2(a) and (b) are taken to trace the degraded areas. The reverse-bias EL areas, which may result from high electric field and deformation of the electrode. Moreover, reverse-bias EL areas are forward-bias dark areas by comparing Fig. 2(a) and (b). To further investigate the reverse-bias EL areas (the degraded areas).

Figure 1. I-V curves after stressed water vapor conditions, a. In the forward-bias condition (0, 3 and 5 hr are overlapped), b. In the reverse-bias condition

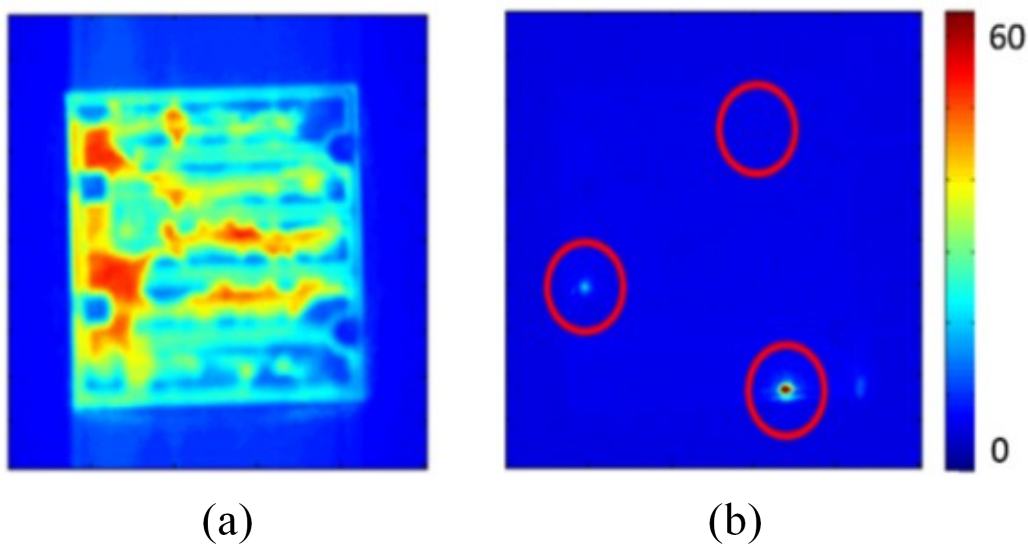
Figure 2. EL images for the device after water vapor stress, a. Forward-bias images, b. Reverse-bias images

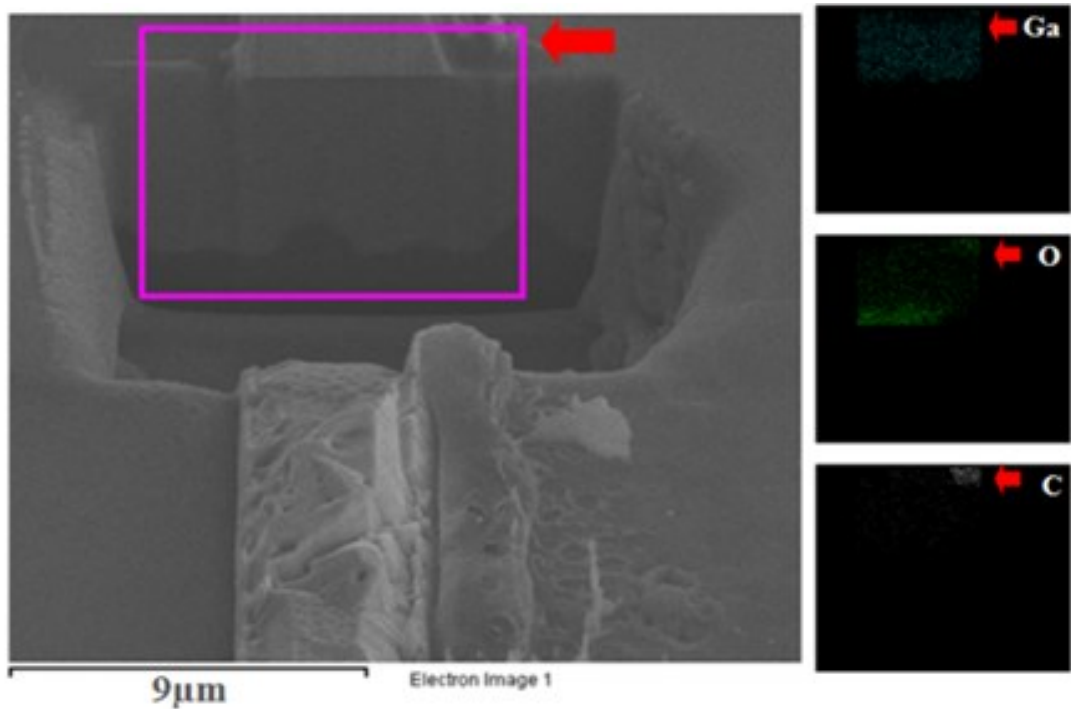
FIB is used to cut the areas and SEM is used to examine the cross section. Consistent with previous studies, deformation of the electrode can be observed by the cross section SEM image. To study the deformed object of the device (as pointed by a red arrow in the SEM image in Fig. 3), EDX analysis and mapping is used to investigate the composition of the deformed part. The Ga, O, and C mapping and EDX analysis indicate that the formation of

GaCO_3 may cause the deformation and strong electric field in the reverse-bias test. (The deformed object can be observed in Ga, O, and C EDX mapping). Since carbon-related organic solution may be used to clean or deposit during the fabrication process. Residues of carbon may be present on the surface of LED. During the stress process, the surface is heated up and GaCO_3 may be formed due to the high temperature. The electrochemical reactions may occur during the reverse-bias operations of the LEDs. Therefore, the GaCO_3 may be formed near the electrode and cause strong electric field reverse-bias EL. High temperature areas may be around the electrode. Therefore, GaCO_3 objects can be generated near the

electrode area and deform the normal electrode and strong reverse-bias EL can be observed around the deformed electrode.

Figure 3. A SEM image and EDX analysis for the stressed device
