Corrosion Behavior of Thermal Seamless Carbon Steel Boiler Pipes

Jamal Nayief Sultan^{1*}, Muna Khethier Abbas², Marwa Abd-al Kareem Ibrahim¹, Emad Toma Karash³, Adel M. Ali³, Hssein A. Ibrhim³

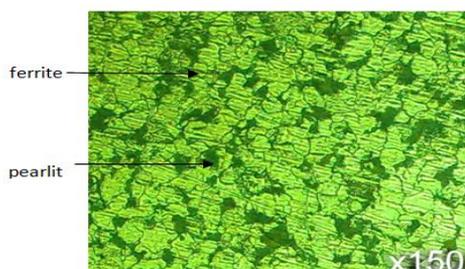
Figure 1 depicts a cross-sectional carbon steel microstructure pipe (A106 grads B-2 ASTM) sample.

The microstructure shown in Figure 1 was obtained after thermal treating process of the distorted samples in accordance with ASTM standards.

Figure 1. Ferrite and pearlite phases in carbon steel pipe

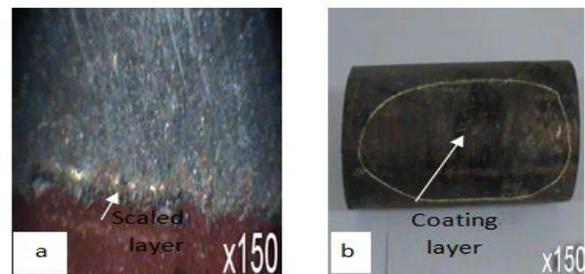
Water-side surface boiler pipes were coated after fabrication to prevent corrosion, but due to improper usage, some pipe areas missed their covering layer as depicted in Figure 3, which could be considered areas where corrosion began and advanced, as can be seen in Figure 4, where it appears to be a corroded surface of a cold side cross sectional pipe.

Figure 3. Macrograph viewing surface scales on the water side of seamless carbon steel pipe

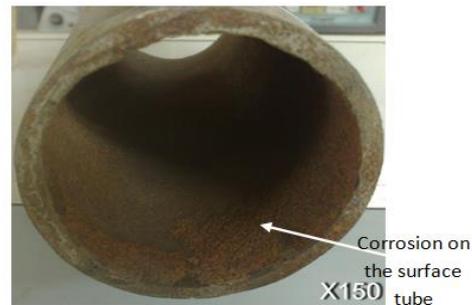
Figure 4. Water corrosion on the inside surface of carbon steel Pipe

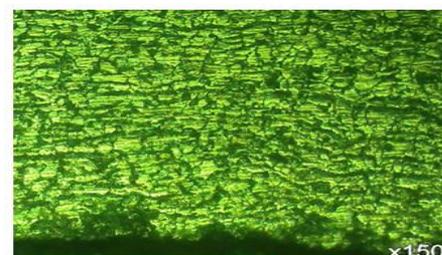
Figure 5 depicts a photomicrograph of a water-side microstructure with a ferritic phase and pearlite microstructure.

Figure 5. Internal surface of carbon steel pipe with a microstructure on the water side

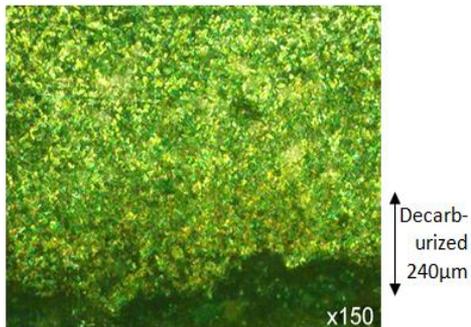
Figure 6 depicts a microstructure on the fire side of an express section. On the fire side of the boiler pipe, a decarburized zone of approximately 240 μm thickness containing a phase of few pearlites plus ferrite microstructure has formed, as shown in the figure.

Figure 6. Decarburized layer on the fire side surface of carbon steel pipe

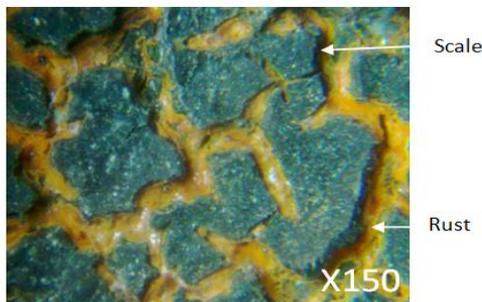
Figure 7 shows scaling corrosion on the water side as a result of high temperatures and water pressure.

Figure 7. Water-side climbing corrosion of carbon steel pipe

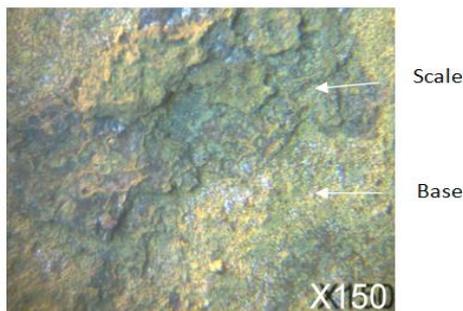
Figure 8. Scaling of carbon steel pipe and disconnected scale regions

Corrosion has resulted in the formation of a large surface oxidized zone with a diversity scale, as shown in Figure 8. They have become larger, broken and separated from the surface.

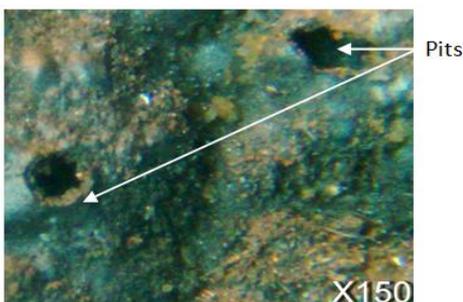
Figure 9. Water-side pitting corrosion of carbon steel pipe

Pitting corrosion occurs as a result of high temperatures and the contact of exhaust fuels with the water side surface, as seen in Figure 9.

Corrosion pitting happens in metals with a protective barrier, like as corrosive chemicals, or if a protective film deteriorates. When the exposed portion surface gives up electrons quickly, the reaction begins small pits with contained reactivity, allowing for fast cracking.

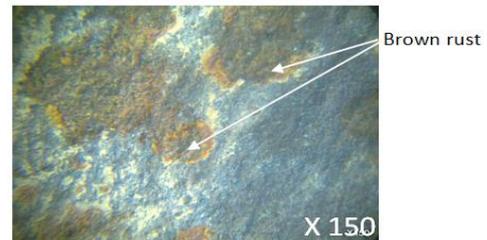
The presence of dissolved oxygen in water can result in brown spots of iron oxide and iron hydroxide.

Because there is an excess of oxygen in the water, it interacts with iron hydroxide.

As demonstrated in Figure 10, this might result in the development and precipitation of brown oxidize on the pipe surface.

Figure 10. Pitting corrosion with brown rust patches that is large and deep

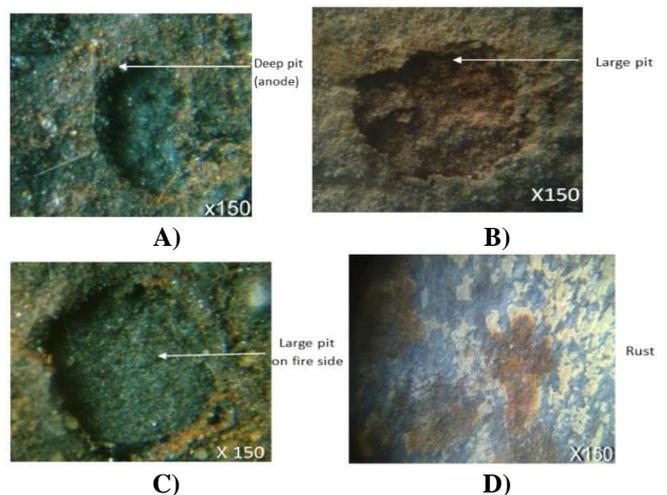
As a result of the brown oxidizes growing in size and covering a large area of the water side surface pipe, and detaching from the pipe surface, pitting due to corrosion develops as seen in Figure 11 (A, B, C, D).

Figure 11. Pitting on the surfaces of carbon steel pipes
 A- Carbon steel pipe with deep pitting on the fire side
 B- Pitting with significant depths
 C- Significant pitting of carbon steel pipe
 D- Carbon steel pipe pitting due to corrosion rust

Pitting on the seamless carbon steel pipe surfaces (Figure 11). A-Deep pitting of seamless carbon steel boiler pipe on the fire side B-Pitting with a lot of depth C-Boiler with large pitting of seamless carbon steel pipe D-Corrosion rusting on seamless carbon steel boiler pipe. Because of the intensity pits existence, and floor layer pipe scales, and a decrease in PH value, the ones pits, as well as scales grew larger, as proven in Figure 12.

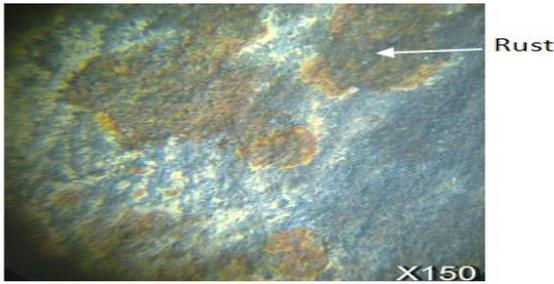
Figure 12. Carbon steel surface pipe with deep and wide depths

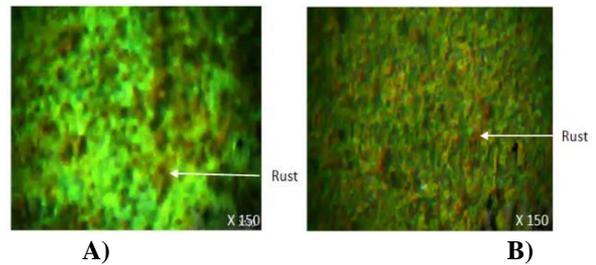
The development of oxidation in corroded samples is illustrated in Figure 16A, which shows that small sizes with low amounts of oxidation formed in the surface layers at low pH values, but their size and quantity grew substantially at pH values elevated, as shown in Figure 16 B.

Figure 16. Corrosion oxides on carbon steel pipe surfaces
