Causes and Prevention Measures of Bright Pitting Defects on Surface of Hot-Rolled Galvalume Steel Sheets

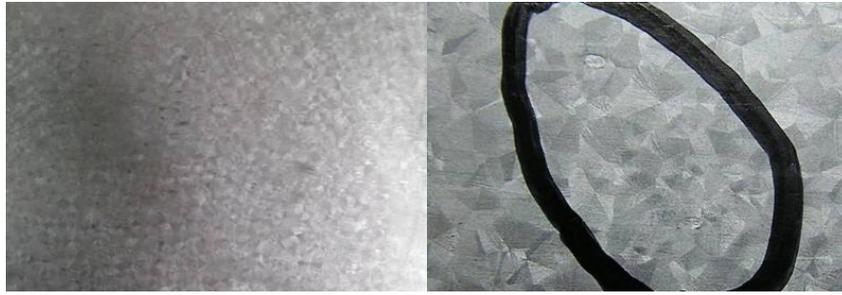
Type-I bright pitting defects are shown in Figure 1. The concave defect areas have clear boundaries with surrounding areas, they are mostly fingernail-shaped bright-colored pits or spots with different sizes. Bulges and dents could be felt when touching with hands, namely the defects "have a hand feeling" [22].

Figure 1. Macroscopic appearance of Type-I bright pitting defects

of this type of defects are: first, after the strip steel has left the zinc kettle, due to improper setting of the air knife during blowing process (unmatched air knife height, distance, blowing pressure, or strip speed), a large turbulent flow would form in the blowing gas, making the plating solution splash and bring the dross particles from the plating kettle to the surface of the strip underneath the air knife; after the dross particles contact the strip, they are directly bounced back to the plating kettle, or blown off by the blowing gas when passing through the air knife, however, the decreased temperature at this time makes the viscosity of the zinc fluid increase, the fluidity decreases and cannot level off completely, so dent-shaped defects are formed. Second, since there're many dross particles in the zinc kettle, some directly adhere to the surface of the strip, when passing through the air knife, they will be blown off by the blowing gas, thus forming the dent-shaped defects. Since the coating layer in the defect areas is thinner, when using INCA EDS for component analysis, the alloy layer in the middle and the steel substrate could be detected, so certain amounts of Fe and Si could be detected in the defect areas [23-25].

- 1) Adjust the speed of the equipment unit, the height of air knife and plating solution surface, the distance between air knife and strip steel, and the blowing pressure of the air knife according to the thickness of the product strip and the thickness of its coating layer, so as to ensure their matching and prevent plating solution from splashing.
- 2) Enforce strict monitoring and management of dross in the zinc kettle, regularly picking up bottom dross and irregularly picking up surface dross remaining in the kettle to prevent dross particles from sticking to the surface of the strip steel.
- 3) Strictly control the deviations of the compositions of the

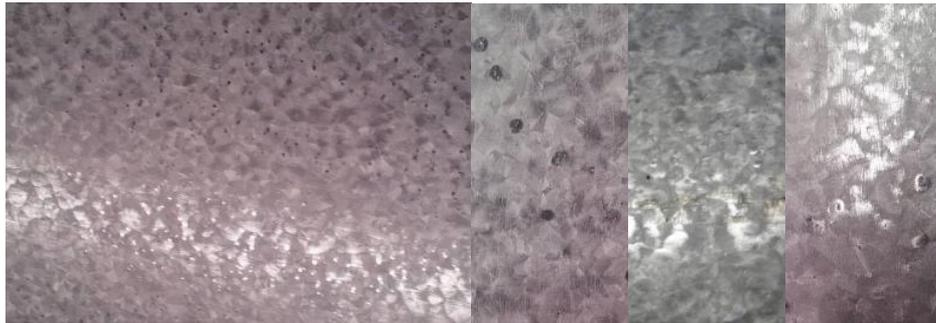
Type-II bright pitting defects are shown in Figure 2. The defects present as bright (or dark) blobs at certain light angles. Boundary lines between the defect areas and the normal areas are irregular, and the defects are of varied shapes and sizes. The defects seem to be convex when observed with naked eye, but bulges or dents couldn't be felt when touching with hands, namely the defects "have no hand feeling" [22]. The defects are more likely to appear on the surface of strip steel sheets with blur zinc texture (the three-dimensional effect of the zinc texture is not obvious), and there're small black dots in the center of some defects.

Figure 2. Macroscopic appearance of Type-II bright pitting defects

For Type-II bright pitting defects, according to the aforementioned characteristics of the defects, it's preliminarily inferred that the defects are caused by the suspended dross particles or intermediate alloy particles in the plating solution brought into the coating layer; some particles form tiny bumps directly, and some form large protruding aluminum-rich dendritic crystals since they have interfered with the normal nucleation and growth of the crystallization of the coating, so bright or dark spots would form due to the friction between the particles and the contact roller after plating, which exhibit as bright pitting defects macroscopically (Table 2 and Figure 4).

Al-Zn ingots and check the technical conditions for the procurement of raw material Al-Zn ingots, so as to control the contents of impurities such as Ca and Si.

4) Tighten the monitoring and management of plating solution to ensure its compositions are within the scope of process regulations; regularly clean the dust in the kettle to ensure the uniformity and purity of the plating solution, thereby lowering the formation probability of suspended particles or intermediate alloy particles.

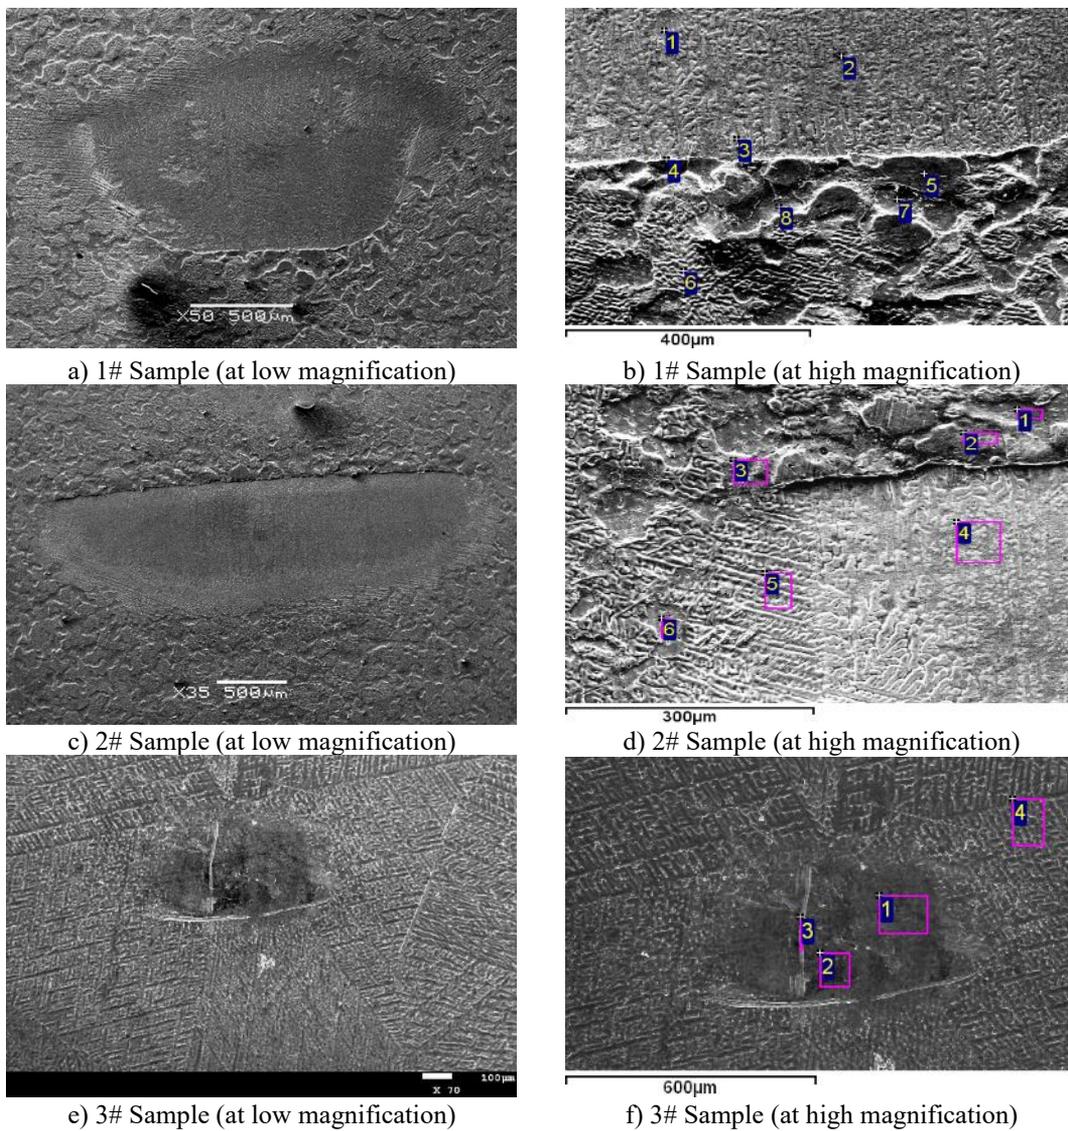
The model JSM1600-LV SEM and INCA EDS were used in the experiment to analyze the microscopic characteristics of the Type-I bright pitting defects, as shown in Figure 3. The EDS was used to analyze the elements of the Type-I bright pitting defects, and the component analysis results of the defect areas and normal areas are given in Table 1. SEM photos show that some defects are concave and form pits, some defects are concave at one end, but the depth of the pit gradually decreases until the other end levels off with the normal area, showing a fingernail shape. The Fe content in the deep pits of the defect areas was significantly higher than that in the normal areas, Si had been detected in the defect areas of some samples.

Figure 3. Microscopic characteristics of Type-I bright pitting defects

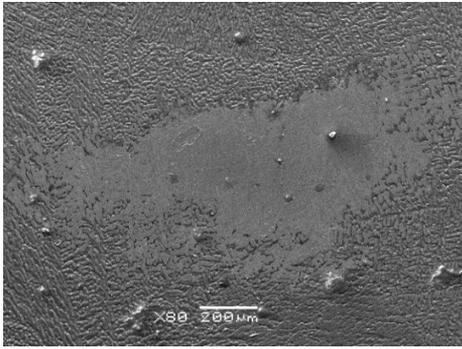
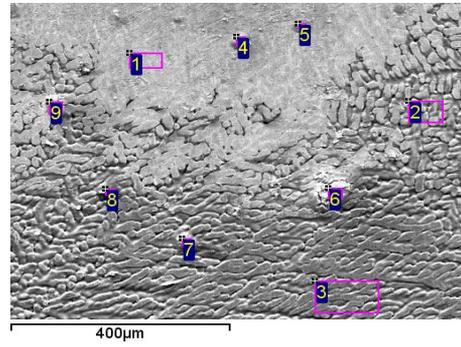
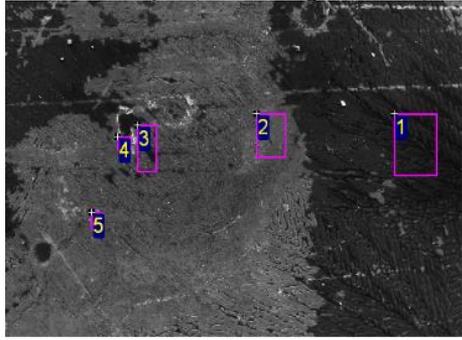
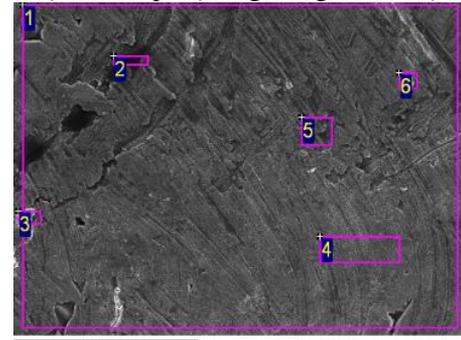
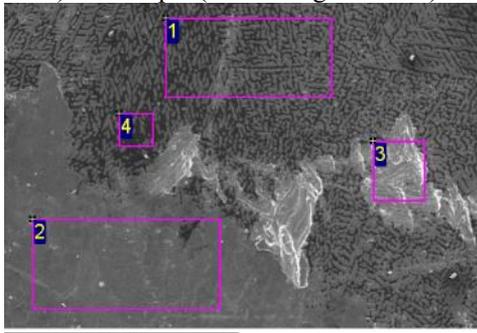
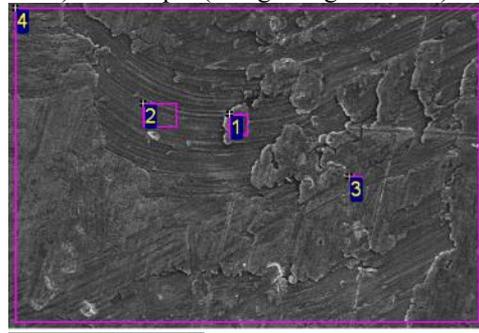
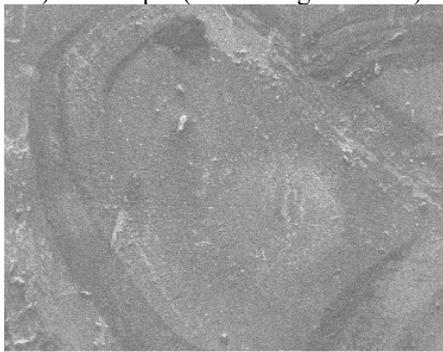
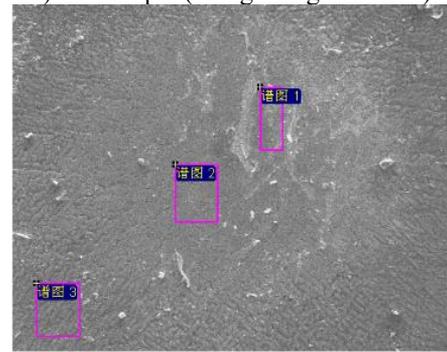
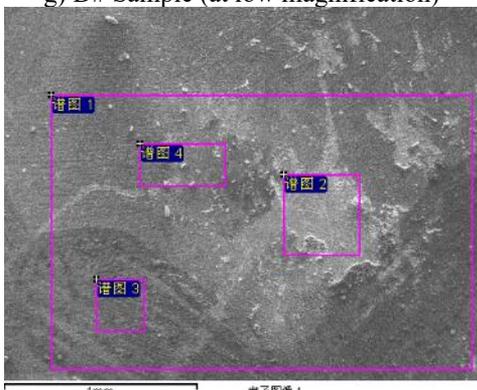
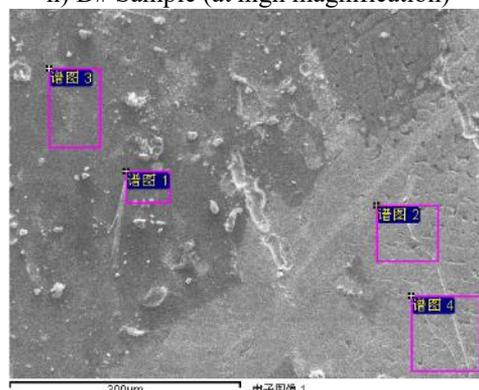
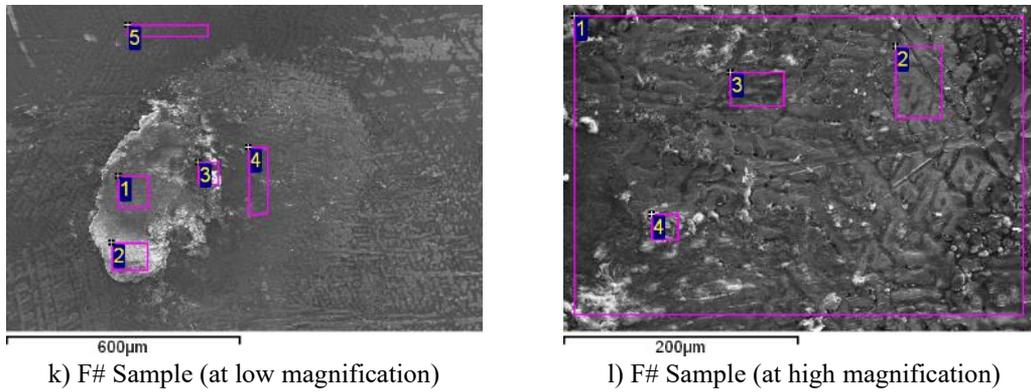
Figure 4. Microscopic characteristics of Type-II bright pitting defects

As can be seen from the SEM photos, the defect areas are smooth and level off with the normal areas (no dents or bumps). Friction marks were observed in the defect areas of most samples, the normal crystalline appearance (dendritic crystal) of the Al-Zn coating was absent. For Type-II bright pitting defects without small black dots in the center, besides common elements such as Al and Zn were detected in the defect areas, high contents of Ca, Fe, and Si particles had been also detected in some defect areas, and the Al and Zn contents of the defect areas were higher than those of the normal areas. As for the Type-II bright pitting defects with small black dots in the center, besides common elements such as Al and Zn were detected in the defect areas, high contents of Fe, Si, and Ca particles had been detected in some defect areas, and the Fe and Si contents of the defect areas with small dots in the center were higher.

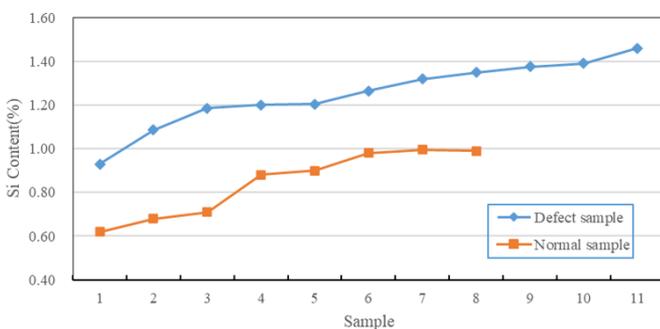
According to above data, the plating solution has a large content of impurity Ca, the content of impurity Si fluctuates greatly, and the Si content of the coating of the defect samples is higher than that of normal samples, indicating that the plating solution is rich in Si and Ca particles. Ca should come from the refractory materials (of the annealing furnace and plating kettle) and dust, etc., its entrance into the zinc kettle might break the balance among metal compounds in the plating solution, forming more suspended particles [19].

Figure 5. Comparison of Si content in the coating of samples
