Resilience Ruler for Energy Efficiency: An Evaluation of Social Housing Refurbishment

This study evaluated refurbishment focusing on energy efficiency to improve the resilience of the built environment of social housing from five and ten years ago. Both residential complexes studied were built by the Brazilian social housing program “Minha Casa Minha Vida” (“My House, My Life” in English) in the city of Uberlândia, Minas Gerais state, Brazil. Design science research (DSR) and post-occupancy evaluation (POE) were applied to the energy audit process for built environments. This work aimed to study energy efficiency, behavior, and resilience in the built environment; to introduce the concepts related to the development of indicators and a questionnaire on energy efficiency; and to develop the Resilience Ruler (RR) for energy efficiency and its application in two social housing complexes located in Uberlândia. This paper presents a methodology for energy efficiency resilience assessment (RR) and its result. The RR was developed to measure the resilience level in the built environment based on energy efficiency indicators. The main results indicated that the materialities in the refurb

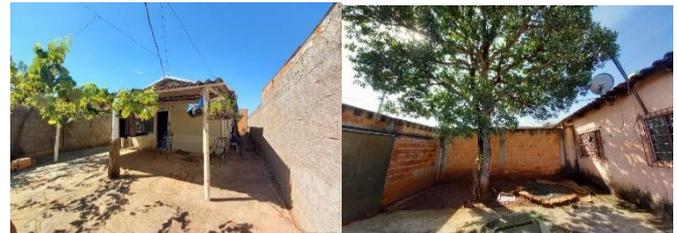
Figure 7. Vegetation inside the lots

To analyze the behavior indicator, we compiled the main results that show the behavioral profile of the residents. In the social housing context, passive building strategies play an important role and are partially controlled by the resident. The housing units were delivered with window shutters in all bedrooms, but some were replaced in the refurbishment. In Shopping Park, 11.45% of the housing units no longer have window shutters, while 3.85% in Pequis ignore the use of window shutters. Most residents use window shutters for lighting control (darken the room) and natural ventilation (refresh the room). We also observed that most residents in both neighborhoods close the glass window at some point, 61.54% in Shopping Park and 80.77% in Pequis, either to stop the ventilation (> 34%) or for security measures (> 26%). Analyzing the green space, we considered the presence of vegetation inside the lots and on the sidewalk, as shown in Figure 7. Plants and tree cultivation can help filter the air and provides shade. We observed plants in the houses, and the residents understood their importance to the environmental quality of the house. Most houses had permeable spaces with grass, shrubs, trees, or potted plants (more than 79%).
