## Post-Landslide Liquefaction Analysis: A Case Study in the Kupang Regency Area, Indonesia

Paul Gabriel Tamelan<sup>1\*</sup>, Doppy Roy Nendissa<sup>2</sup>, Denik Sri Krisnayanti<sup>3</sup>, Remigildus Cornelis<sup>3</sup>, Elsy E. Hangge<sup>3</sup>, Partogi H. Simatupang<sup>3</sup>, Noni Banunaek<sup>4</sup>

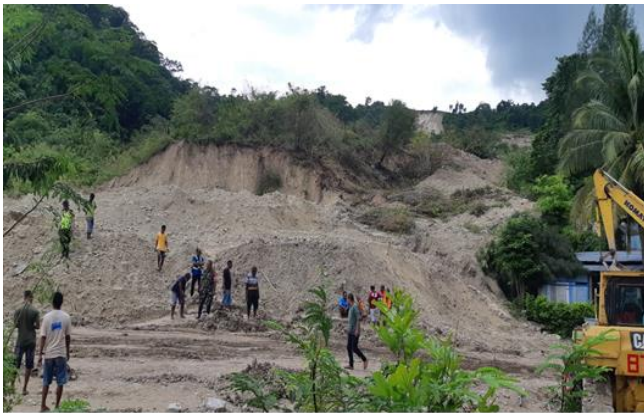
the landslide phenomenon experienced in Noelmina Village, situated within the Takari District of Kupang Regency, adhered to the rotational/slide type, specifically delineated as a curvilinear slide, as depicted in Figure 2. This event was precipitated by the translocation of soil masses comprising silt

and clay dimensions, which proceeded to glide across the slip plane associated with Bobonaro clay, characterized as Expansive Clay. The arrival of the rainy season exacerbates this condition, as the notably low permeability of Bobonaro clay impedes water filtration, resulting in the overlying soil strata reaching a state of saturation. This saturation induces a reduction in friction, thereby rendering the area prone to slipperiness and instigating landslide occurrences, culminating in the downward movement of the upper soil mass. Contributory factors to landslides within Noelmina Village include the lithological characteristics, geological structures and soil taxonomy, the gradient of the terrain, alongside hydrological influences, notably the incidence of elevated rainfall.

**Figure 2.** Rotational landslide or curved slide on the Takari landslide

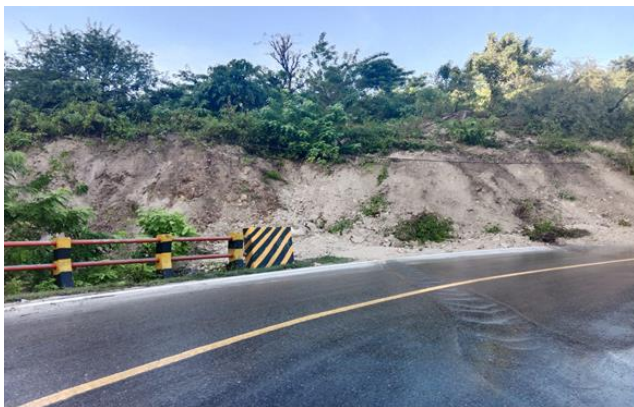
**Figure 3.** Springs that formed at the foot of the slope before the Takari landslide occurred

In the days leading up to the landslide event in Takari, as recounted by a local observer, Mr. Beni Polin, the area experienced rainfall, and notably, a spring emerged at the slope's base adjacent to the roadway, as detailed in Figure 3. This phenomenon suggests that the soil strata reached a saturation point, with its pores fully inundated, causing rainwater infiltration to manifest as spring runoff. The underlying stratum, composed of Bobonaro Clay - a layer impervious to water-further impedes the downward movement of rainwater. Consequently, the emergence of springs can be attributed to the saturation of soil and its minimal permeability. Such conditions serve as preliminary signs of potential soil mass movements. This is due to an increased load on the soil

from infiltrating rainwater, coupled with a reduction in soil shear strength from water-induced softening, facilitating the disintegration of inter-particle bonds within the soil and its slip plane. These processes lead to the formation of increasingly slippery layers of Bobonaro silt and clay, thereby instigating landslides.

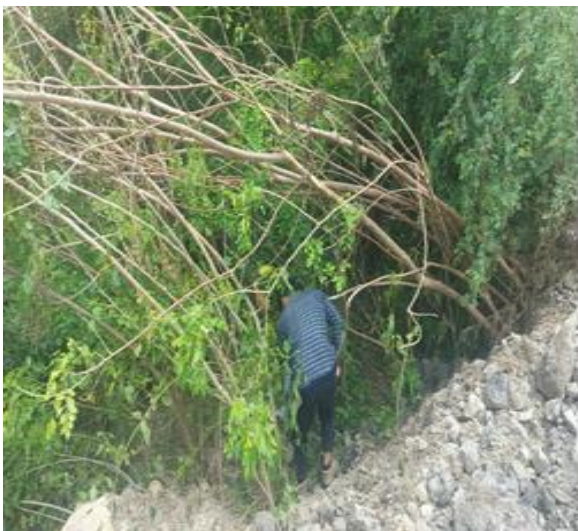
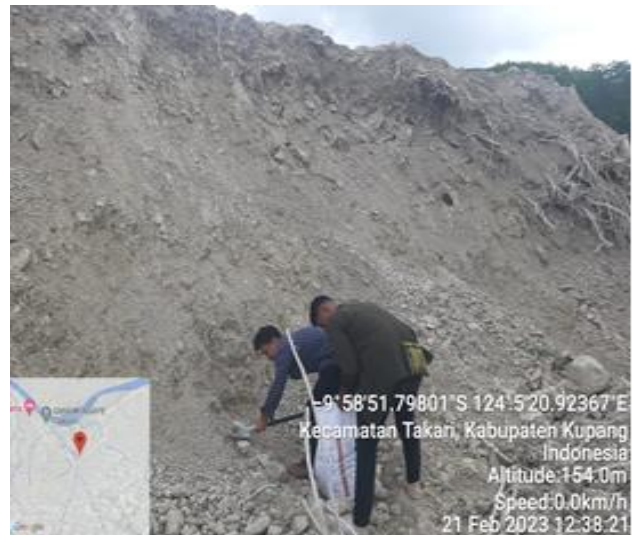
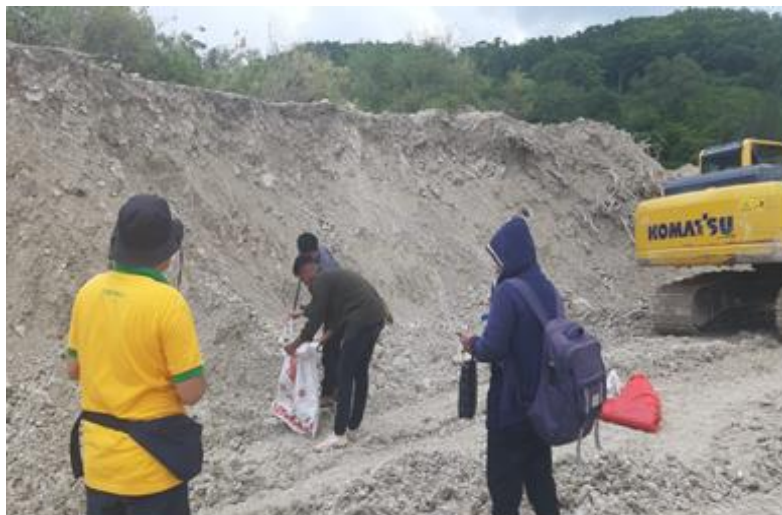
**Figure 6.** Soil sampling for laboratory

(a) Original soil sampling (UDS)

(b) Point landslide debris sampling 1

(c) Point sampling of landslide debris 2

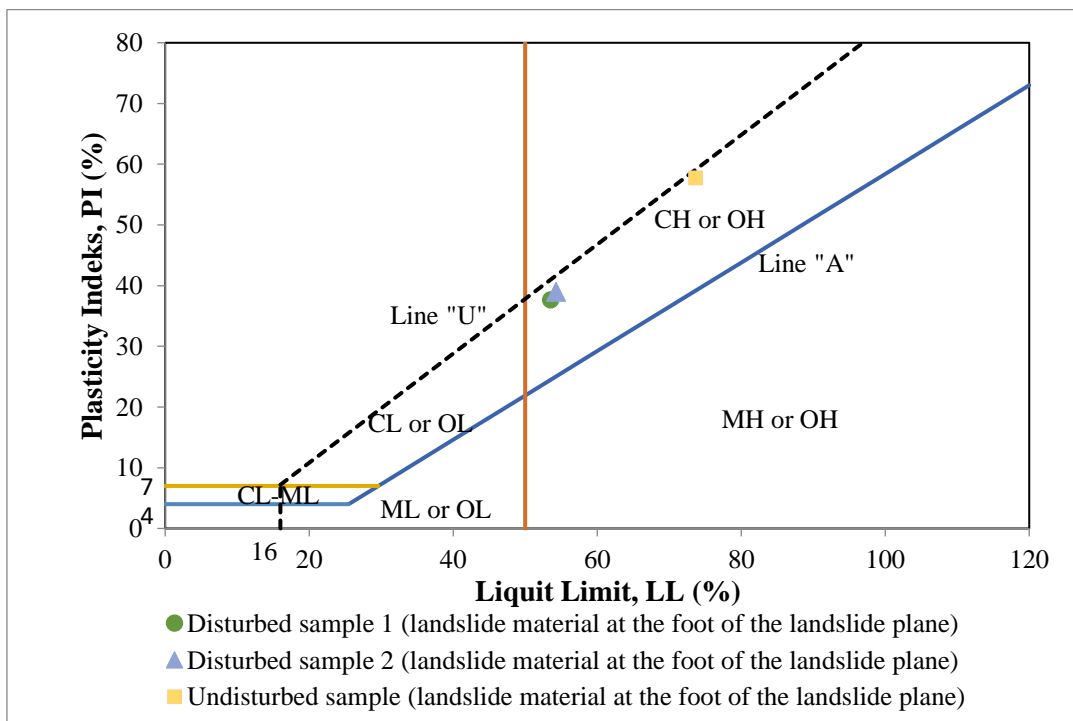
strength tests on the UDS, indicating a cohesion value of 0 kg/cm<sup>2</sup> and a consequent diminution in soil shear strength. This degradation in shear strength, precipitated by increased pore water pressure due to rainwater infiltration, directly contributed to landslide occurrences (T. Disturbed 1 and T. Disturbed 2). Classification of these soil samples, based on their Liquid Limit (LL) and Plasticity Index (PI) values within the Unified Soil Classification System (USCS), places them in the CH category, denoting non-organic clays with high plasticity (Figure 7).

The shear plane or sliding surface in the Bobonaro clay soil (expansive clay, UDS) manifests due to its high plasticity index value of 57.77%, significantly exceeding the 35% threshold. The inherent properties of Bobonaro clay soil, characterized by pronounced swelling and shrinkage with variations in moisture content, exacerbate this condition. During arid periods, desiccation and subsequent cracking occur as moisture evaporates from soil pores, whereas the wet season sees these cracks facilitating water infiltration, leading to soil expansion. Such hydrological dynamics at the slope's base weaken inter-particle cohesion, precipitating landslides as a result of diminished soil shear strength, rendering the soil exceedingly malleable.

Figure 7. Soil classification based on the USCS system

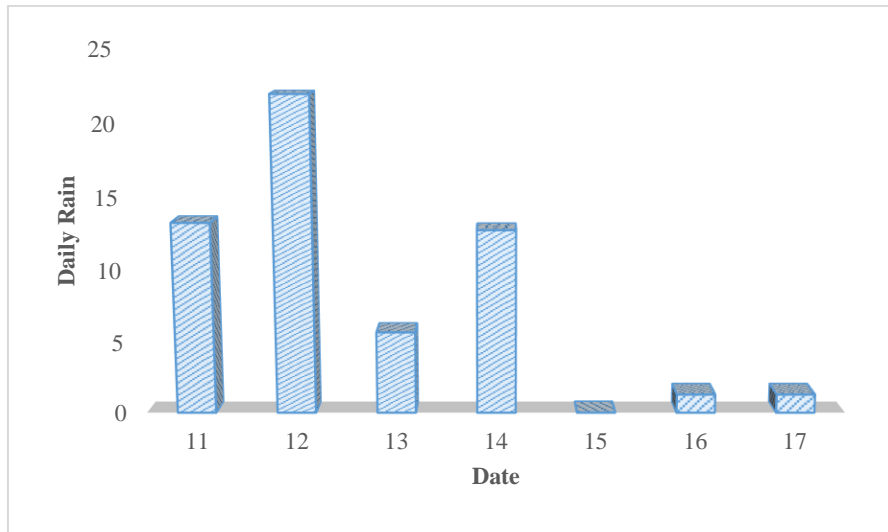
As can be seen from Figure 9, there is unmeasured rain data and this makes it difficult for subsequent hydrological analysis. The initial moisture value (antecedent moisture conditions) can determine whether the moisture condition is in dry conditions (AMC I), normal conditions (AMC II) and wet conditions (AMC III). This can be seen in Table 3.

**Figure 9.** Location of landslides in the Takari sub-watershed in the Noelmina watershed

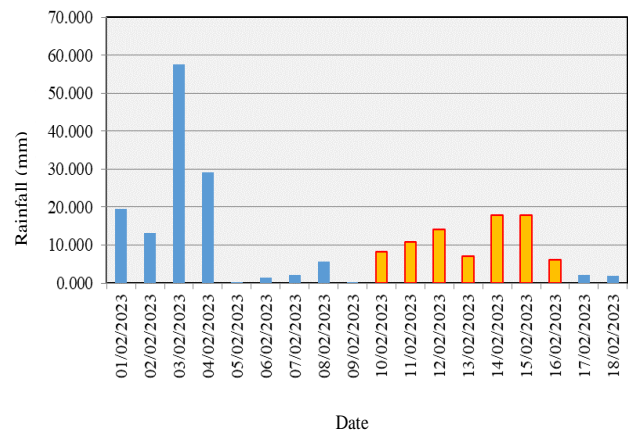
Based on Figure 11, it can be seen that 6 days before the landslide, the amount of rain reached 74,008 mm and after

**Figure 11.** Satellite rainfall data in the Takari sub-catchment
