## Novel Technique for Measuring Erosion in Riverbanks: Tigris River Case at Baiji City-Iraq

*erosion process, river management, Tigris River, river mechanics, long-term monitoring*

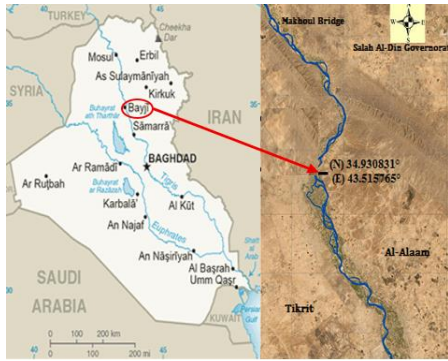
**Figure 1.** The location of the riverbank erosion study was conducted

Additionally, climatic changes and human activities contribute directly or indirectly to increasing erosion rates. The aerial image in Figure 1 shows the location of the riverbank where the erosion measurements were taken, situated in a contraction area within the Tigris River. This contraction zone of the Tigris River, where the channel width narrows, leads to an increase in flow velocity and hydraulic shear stress, thereby raising the likelihood of erosion processes occurring in these regions. When contraction zones are compared to wider sections of the river, they are found to be more susceptible to morphological changes due to the increased flow velocity and the river's enhanced capacity to transport sediments. Therefore, the location of the study area

within a contraction zone is one of the contributing factors to the occurrence of erosion processes observed during the study period.

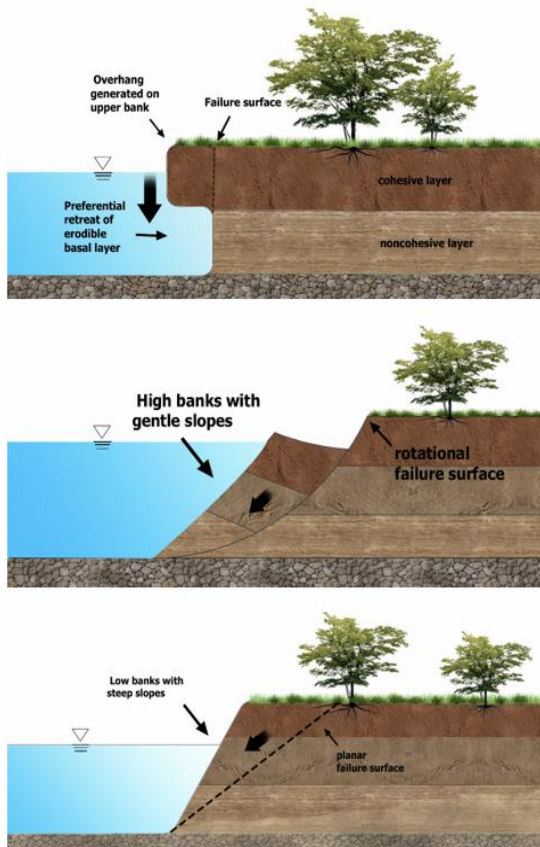
**Figure 2.** The mechanism of the failure due to erosion [11]

Erosion occurs as a result of both hydraulic action and mass failure acting together. This process begins with erosion at the toe of the riverbank caused by hydraulic action, leading to changes in the slope and height of the riverbank [19]. These changes cause gravitational forces to exceed the cohesive and adhesive forces between the soil particles of the riverbank. When water levels rise, the increase in water velocity and shear stress further erodes the lower portion of the riverbank (the toe). As water levels drop, the riverbank becomes overhanging and unsupported from below, ultimately resulting in mass failure.

This high-water velocity enhances the water's capacity to mobilize sediments and erode the soil. The water then transports the eroded particles downstream until they reach areas where the water velocity decreases, allowing the particles to settle. It is well known that water velocity decreases as it approaches the riverbed mass failure of the riverbank occurs when a large section of the riverbank soil separates at once and collapses into the river, as shown in Figure 2.

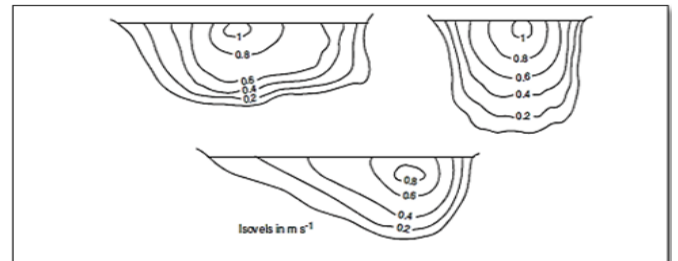
**Figure 3.** Distribution of water velocities in natural rivers [7]

Consequently, on the channel sides, the shear stress varies as it depends on the slope rather than the width. Therefore, when studying riverbank erosion, calculating boundary shear stress alone is not suitable for estimating riverbank erosion, as the distribution of shear stress is not uniform along the channel's cross-section [20]. In fact, the water velocity varies with depth. The velocity is highest at the center of the flow, where the shear stress is zero, while the velocity near the riverbed is the lowest, approaching zero, and the shear stress is at its maximum due to friction. The distribution of velocities in rivers can be observed as shown in Figure 3.

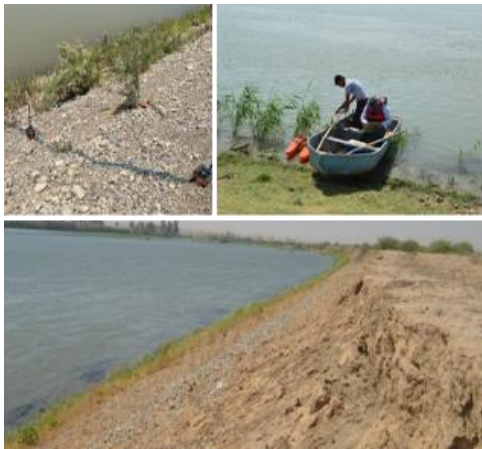
**Figure 4.** The measurement process for cross-section

To measure the extent of riverbank erosion along the Tigris River in the city of Baiji, Salah Al-Din Governorate, the specific riverbank section selected for measurement was marked with fixed reference points. These markers were established to ensure that measurements and observations could be conducted at the same locations with regular maintenance and periodic care, as shown in Figure 4. It allows for an accurate assessment of erosion over the research period; also, the selected cross-section for studying erosion is located near the Baiji discharge gauge.

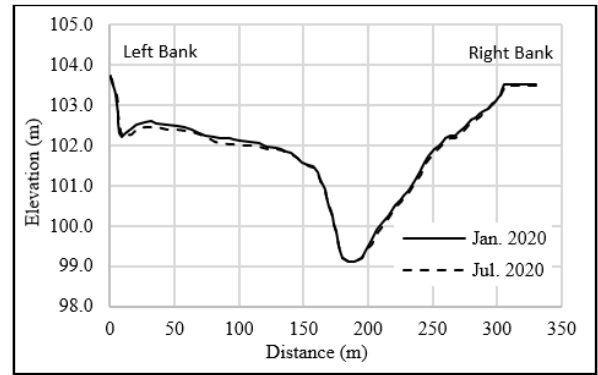
**Figure 5.** The geometry of the selected station in Jan. 2020 and Jul. 2020

First of all, Figure 5 represents the geometry of the cross-section for the firm time between January 2020 and July 2020.

It is clear from the collected data shown in Figure 5 that there is a change in the river bed elevation at a certain point along the cross-section, which indicates that some of the materials were washed or eroded from this cross-section.

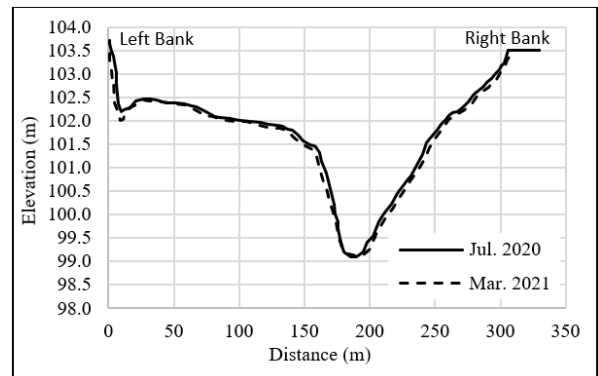
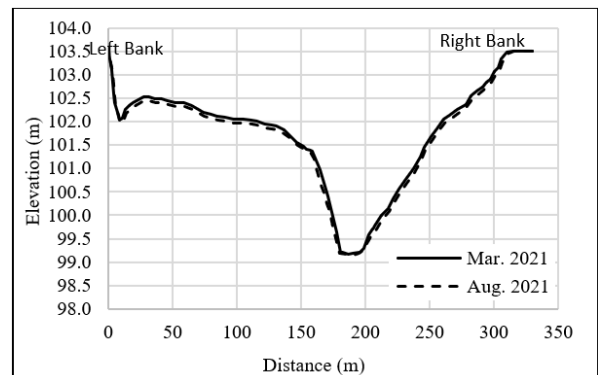
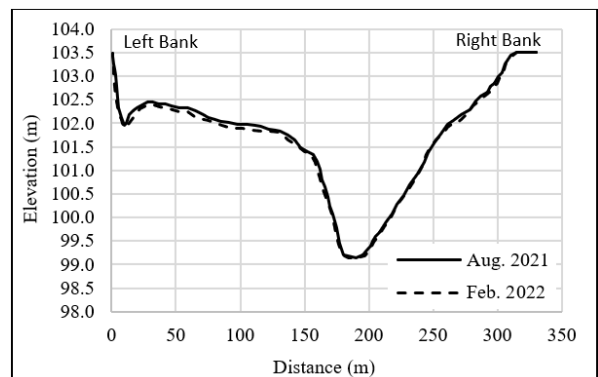
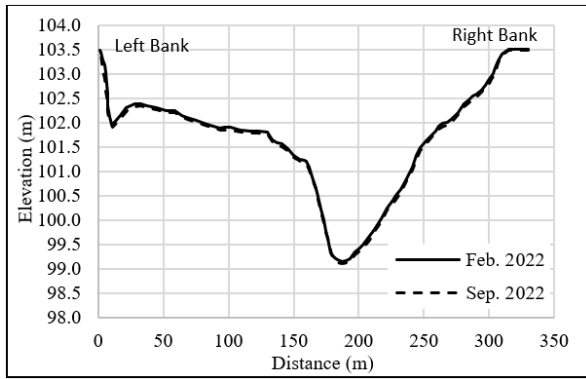
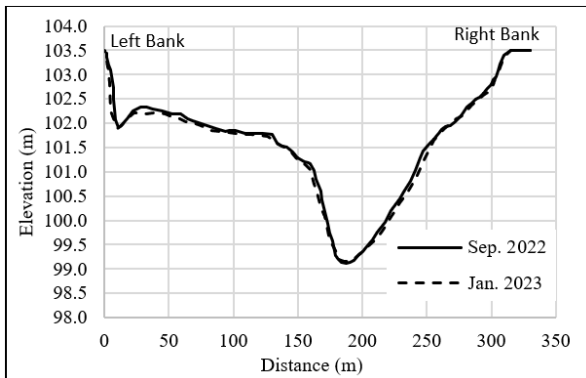
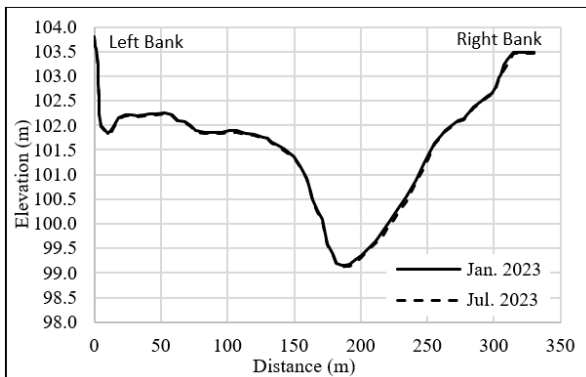
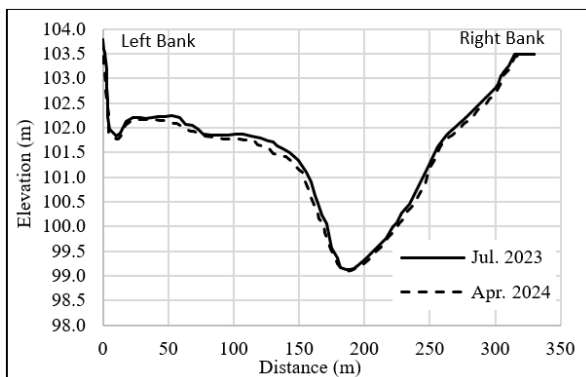
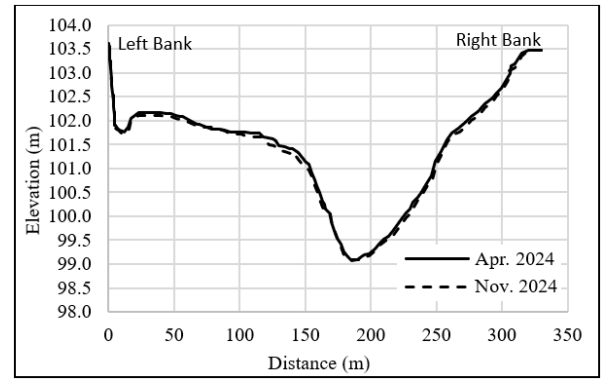
**Figure 6.** The geometry of the selected station in Jul. 2020 and Mar. 2021

**Figure 7.** The geometry of the selected station in Mar. 2021 and Aug. 2021

**Figure 8.** The geometry of the selected station in Aug. 2021 and Feb. 2022

**Figure 9.** The geometry of the selected station in Feb. 2022 and Sep. 2022

**Figure 10.** The geometry of the selected station in Sep. 2022 and Jan. 2023

**Figure 11.** The geometry of the selected station in Jan. 2023 and Jul. 2023

**Figure 12.** The geometry of the selected station in Jul. 2023 and Apr. 2024

**Figure 13.** The geometry of the selected station in Apr. 2024 and Nov. 2024

For the same purpose, the following Figures 6-13 illustrate the variation in the local station during different periods.

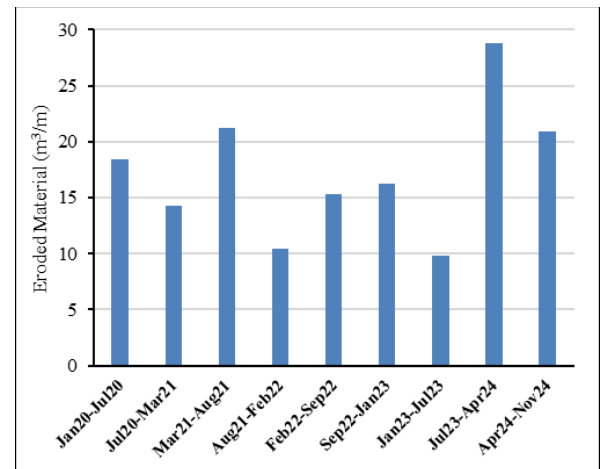
**Figure 14.** The cross-section erosion during the study period

It was clear that erosion phenomena would remain and produce a change in the cross-section geometry during the study period. The value of sediment erosion from the studied station may vary over the duration of this study. Thus, a practical measurement for estimating the amount of eroded material between each record was summarized and illustrated in Figure 14.

It can be observed from Figure 14 that the difference in eroded areas depends on and varies based on the duration of the measurement and the time of year. Furthermore, during the time of the study, the regular maximum discharge was recorded in the years 2020 and 2021. However, the flood event during the spring of 2024 influenced the amount of sediment eroded from the cross-section and reached its maximum during this time. Finally, the recording of data and monitoring of the station remained for approximately five years, from January 2020 to the end of November 2024, as shown in Figure 14; as evidenced from all these measurements, the extent of riverbank erosion in the river that is determined by comparing the measured profiles over the five years showed the total erosion during this period reached approximately 62 cm.
