LEED GOLD BUT NOT EQUAL: TWO CASE STUDY BUILDINGS

F.D.F. BAJA, S. BAJRACHARYA, M.A. FREEMAN, A.J. GRAY, B.T. HAGLUND, H.R. KUIPERS & O.R. OPATOLA
Architecture Program, University of Idaho, USA.

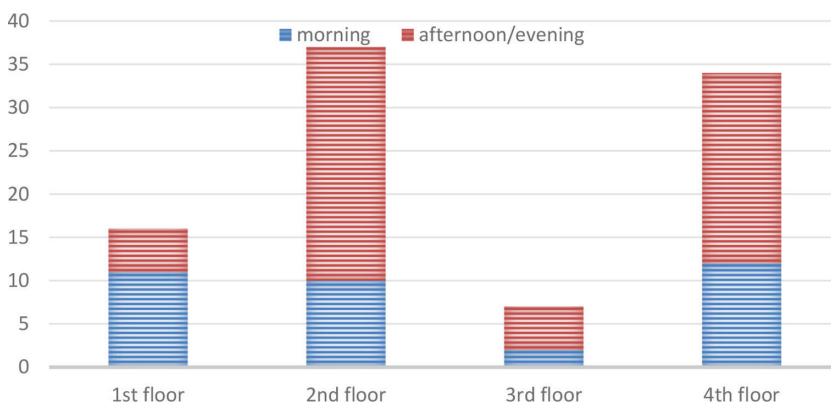
Figure 1: Chart showing occupancy on different floors/different times.

Activities that take place in the west-facing wing of the building were observed. In this study, most of the spaces are classrooms with adjacent study spaces in the wide west-facing hallways. The study was limited to the second and fourth floors, which are most used (Fig. 1). Also, the class schedule shows that more classes are held between noon and 1pm, which increases the potential study space use during this time. Data loggers were placed in two different locations on the 2nd and 4th floor towards the western edge of the study spaces near the windows. The hobo data loggers collected the temperatures and relative humidity of the space at 30-minute intervals. From the readings, it can be seen that the temperature of the lobby rises from 9 am to noon, to 6 pm, while relative humidity dropped by 20–25% during these hours. This change is due to increased activity and solar gain during afternoon hours.

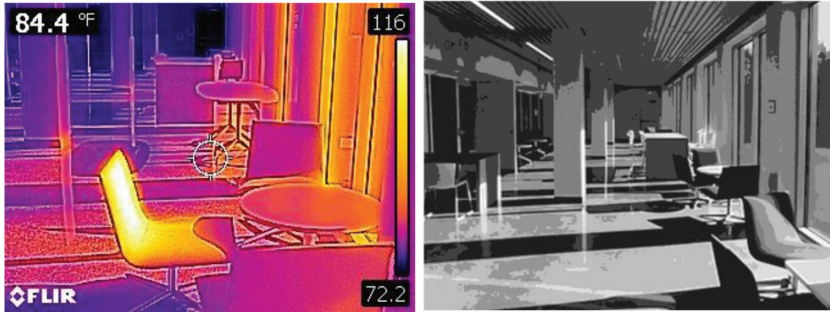
Figure 2: Infrared image and glare analysis for west-facing study space: hot spots and glare are present.

Using the Infrared Camera set for the default emissivity of most building materials, the surface temperature of the plastic lounge chair in this lobby measures as high as 116°F/47°C and the concrete floor 84°F/29°C on a sunny ~50°F/10°C spring day, which is thermally uncomfortable for its users (Fig. 2). Also, reflective surfaces like the polished concrete floor

promote glare in the space. To analyse the glare issues, photographs were taken of the study spaces (second and fourth floor) at different times of the day and weather conditions. Glare analysis of the photos using the Schiler method (Cuplite and Rascal) [5] shows that a large amount of glare is experienced on sunny afternoons for this building exposure, ironically, especially where furniture is positioned for people to sit and study (Fig. 2).

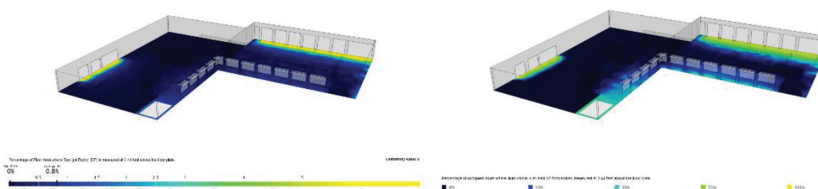
Figure 4: Sefaira analysis after redesign for improved shading – (a) annual exposure to direct sunlight, (b) daylight factor: direct sun greatly reduced.

In conclusion, careful analysis of the use of the western study spaces, the hypothesis proved false as the study spaces are used more in the afternoon due to the heavier afternoon class schedule. With the introduction of shading devices, visual and thermal comfort of the users could be achieved and should increase the use of the space for studying (Fig. 4).

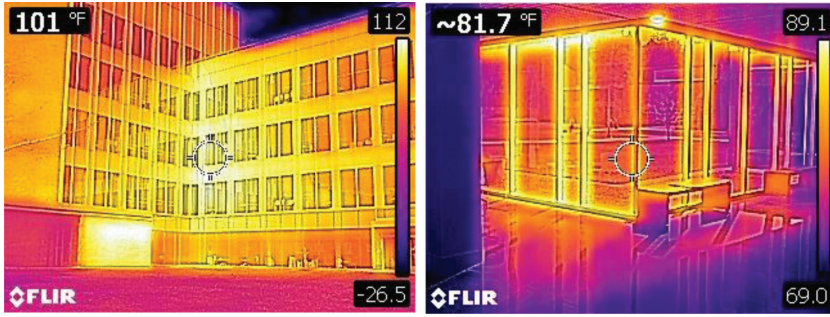
Figure 5: Late afternoon infrared images of glare: external (south- and west-facing curtain walls) and internal (study space along those walls).

Approaching the building from the southwest, one observes harsh glare from the aluminium façade panelling and the low-e glass curtain wall (both materials reflect light and heat). Inside the building and moving through the hallways at late afternoon hours can be visually unpleasant as sun penetrates the glazing of the south and west façades at a sharp angle near eye level. The polished concrete floor and bare aluminium bounce light off their reflective surfaces and concentrate glare within the interior seating spaces (Fig. 5).

As seen in the above images (Fig. 5), late afternoon sunlight strikes the highly reflective surfaces of the Education Building at such an angle and intensity as to promote glare, and create an unpleasant thermal and aesthetic experiences. The L-shaped building reflects light and heat into the adjacent façade, thus intensifying the sun’s effect.

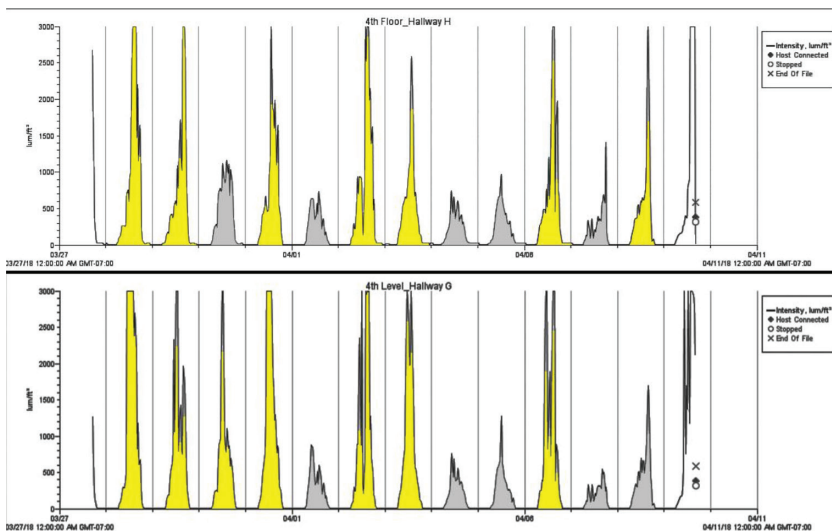
Figure 6: Data logger results: level 4 South (G) and West (H) study space light levels: daily afternoon temperature spikes on sunny days (yellow) in both spaces.

The data logger results (Fig. 6) show that the seating spaces along both the south and west façades received an intense amount of lighting – above the average visual comfort level, and

above what would be expected for early spring. The results also show that usually both west- and south-facing spaces are in the direct sun at the same time, negating occupant migration as a strategy for avoiding visual and thermal discomfort.

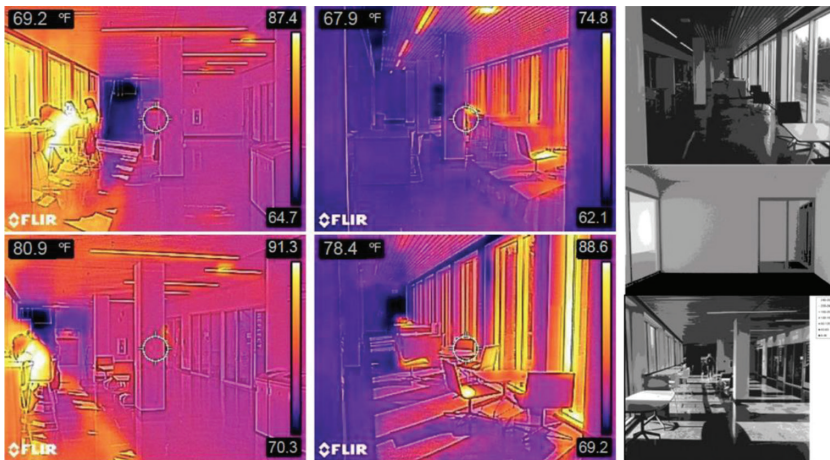
Figure 7: Infrared camera and glare analysis: glare present.

In this study, the research was limited to a single (typical) floor of the Education Building. This floor contains classrooms, offices, conference rooms, and student study space. The focus was on the issues of glare (Fig. 7), thermal heat gain (Fig. 7), and the excessive illuminance (Fig. 8) in the space. The root of each of these issues stems from the direct sunlight on the polished concrete floor, which causes a rise in temperature in the concrete, the furniture, and

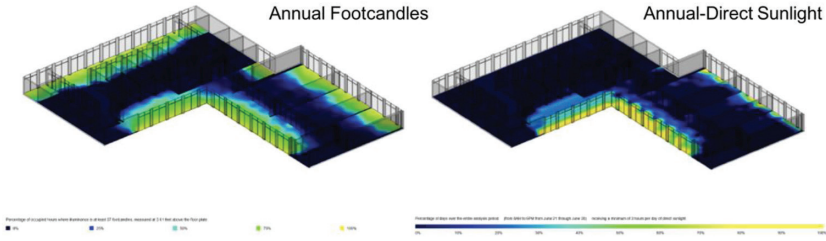
Figure 8: Original Sefaira analysis: considerable direct sun (yellow) in study spaces.

The first shading intervention proposed is a light shelf. This would shade the interior from the direct sunlight, and diffuse the ambient light deeper and more evenly into the space. Comparing the original Sefaira analysis (Fig. 8) to the light shelf Sefaira analysis (Fig. 9), it is evident that the light is partially diffused, but glare and heat gain are still major issues.

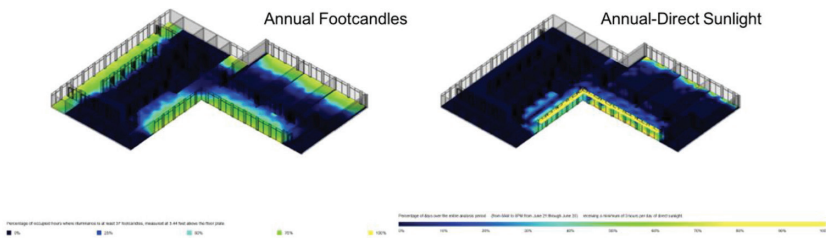
Figure 9: Iteration 1, Sefaira analysis of light-shelf: reduced direct sun.

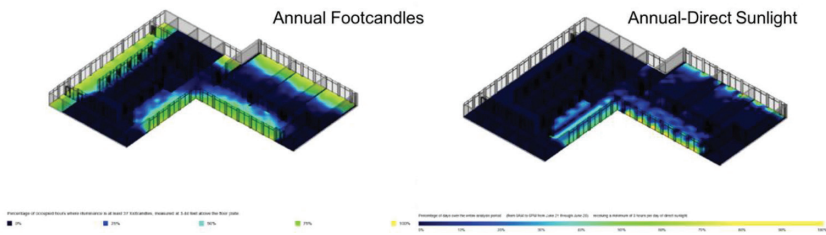
Figure 10: Iteration 2, Sefaira analysis of overhang: reduced direct sun.

The second shading intervention is an exterior overhang, or horizontal louvre. This combined with the light shelf, will further shade the interior from direct sun, while increasing the surface area for light diffusion into the space. Again, in comparison (Fig. 10), the direct sun penetration was mitigated on the south-facing glazing wall, but not on the west-facing

glazing wall. Because of the continued direct sun from lower sun angles, the issues of glare and thermal heat gain are still unresolved.

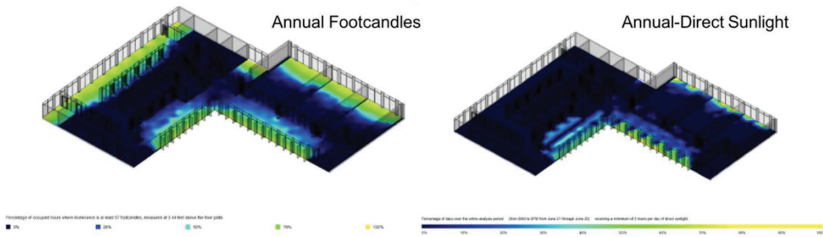
Figure 11: Iteration 3, Sefaira analysis of fin: better daylight, reduced direct sun.

The third shading intervention is an exterior vertical fin. This shading device, again combined with the interior light shelf, essentially creates an interior/exterior hybrid egg-crate shading device. The vertical fins diffuse the majority of direct sunlight on the west-facing glazing wall, while the light shelves compensate for that on the south-facing glazing wall (Fig. 11).

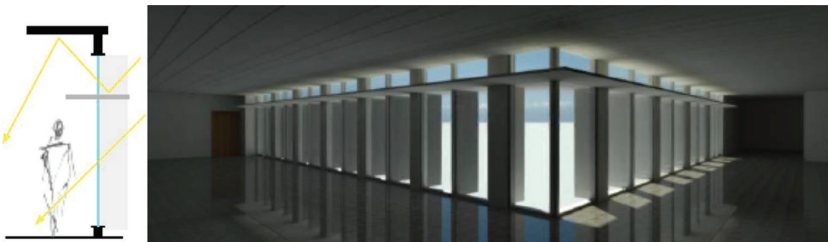
Figure 12: The solution diagram and rendering @ 1pm in April.

The vertical fin intervention was the most successful in mitigating the direct sunlight on the west-facing façade, but the horizontal louvres were most successful on the south-facing façade. To reconcile the two, the vertical fins and the light shelves were both used, but with elongated the shelves on the south-facing façade to increase the overall overhang (Fig. 12). This solution mitigated the annual direct sunlight exposure to satisfactory levels (Fig 13). With this intervention, the issues of glare, heat gain, and excessive brightness are greatly improved, and there is a greater possibility for visual comfort in the space.

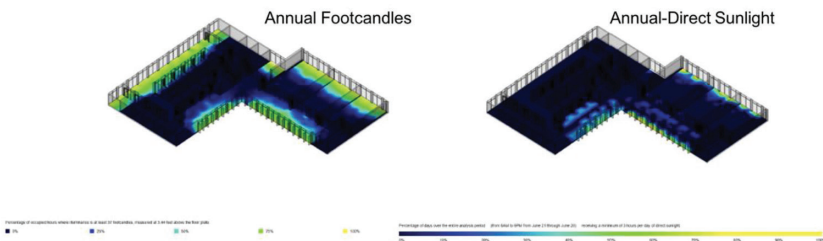
Figure 13: Sefaira analysis of integrated shading: adequate daylight, much reduced direct sun.
