A NOVEL FAULT TREE ANALYSIS APPROACH TO INVESTIGATE UNCOMMON ACCIDENTS IN QUARRIES: A CASE STUDY.

D. LIPPIELLO, G. ALFARO DEGAN & M. PINZARI
Department of Engineering, University of Roma Tre, Rome, Italy.

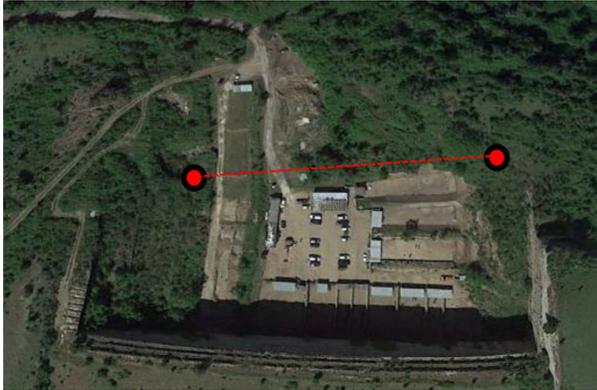
Figure 1: An aerial view of the quarry processing yard indicating the position of the high voltage cable and pylons in red.

A high voltage (HV) power line (132kV) crosses the quarry processing yard shown in Fig.1 in which the two pylons have been indicated with red dots and the red dashed line represents the HV power line between the two. The power line is at a height of between 7 and 8 metres above ground level. When the mobile screen plant (shown in Fig. 2) is not in use it is driven along the site road to the parking area crossing underneath the HV power line. The mobile plant is a versatile piece of machinery that is equipped with moveable conveyor belt arms. These may be extended to 12 metres in length in addition to being raised or lowered according to requirements of the task to be undertaken.

where the material is being extracted. An aerial view of the quarry processing yard is shown in Fig. 1.

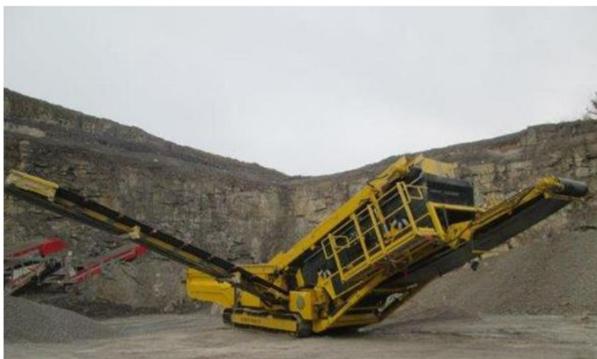
Figure 2: The mobile screen plant.

Should the mobile screen plant be driven back to the parking area with its conveyor belt arms in their vertical position, the arms would inevitably come into contact with the high voltage power line due to their height, thus triggering arcing and resulting in harmful

In this case, the event was due to the presence of the high voltage (HV) power line (132 KV). The radio-controlled mobile screen plant, while being moved to the parking area, exceeded the safe levels of proximity to the power line. This reduction in distance between the moving plant and the HV power line triggered electrical arcing through the ionisation of the aeriform fluid between them.

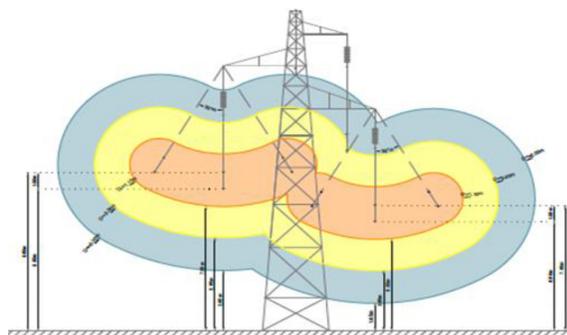
Figure 3: The pylon and distances from ground level.

Figure 3 below shows a diagram of one of the pylons and the relative distances between the power lines and ground level, indicating that the minimum clearance is approximately 7 metres at the lowest point in the catenary curve of the lowest power line.

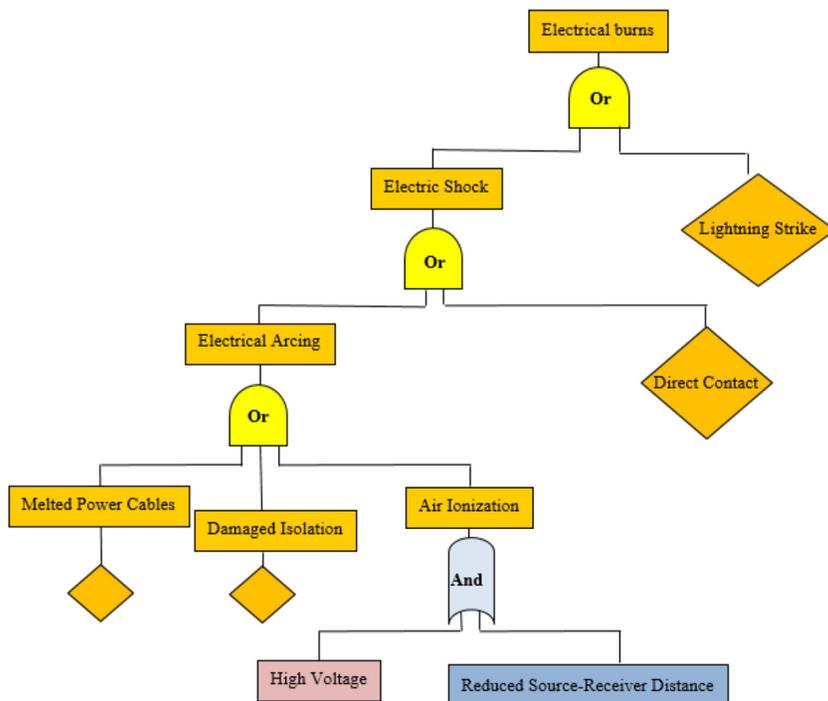
Figure 4: The integrated fault tree part 1.

The application of the method applied to the specific site, determined the following tree, which is divided into two different sheets, see Figs 4 and 5, in order to be better appreciated.

Tracing back through the tree, the action of exceeding the safe proximity levels are due to three different types of causes: material causes, human causes and organisational causes.
