## HERITAGE ARCHITECTURE AS DOMESTIC SPACE: A TALE OF THREE BUILDINGS IN ILE-IFE, NIGERIA

C.O. OSASONA

Department of Architecture, Obafemi Awolowo University, Ile-Ife, Nigeria.

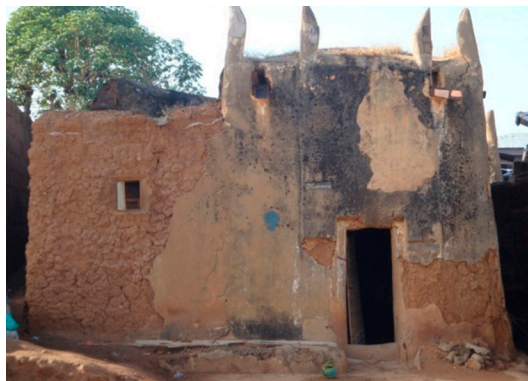
Figure 1: Typical Hausa architecture. Zaria, northern Nigeria. (C. O. Osasona, 2009).

In parts of the country where a rocky terrain predisposed, stone walling (covered with a conical thatch roof) provided the prevailing archetype. Where an abundance of grass was available (such as in the Sudan Savannah area), it could be woven to produce matting for fence-walling, as enclosure for buildings of more substantial material. Swampy terrain automatically generated lightweight architecture using bamboo for walling and palm fronds for roof-cladding; such structures were supported above the marshes on stilts. Similarly, lightweight architecture (but predicated on impermanent materials such as stalks of sorghum) was used in parts of the Sahel Savannah region of the country (see Figs 1–5).

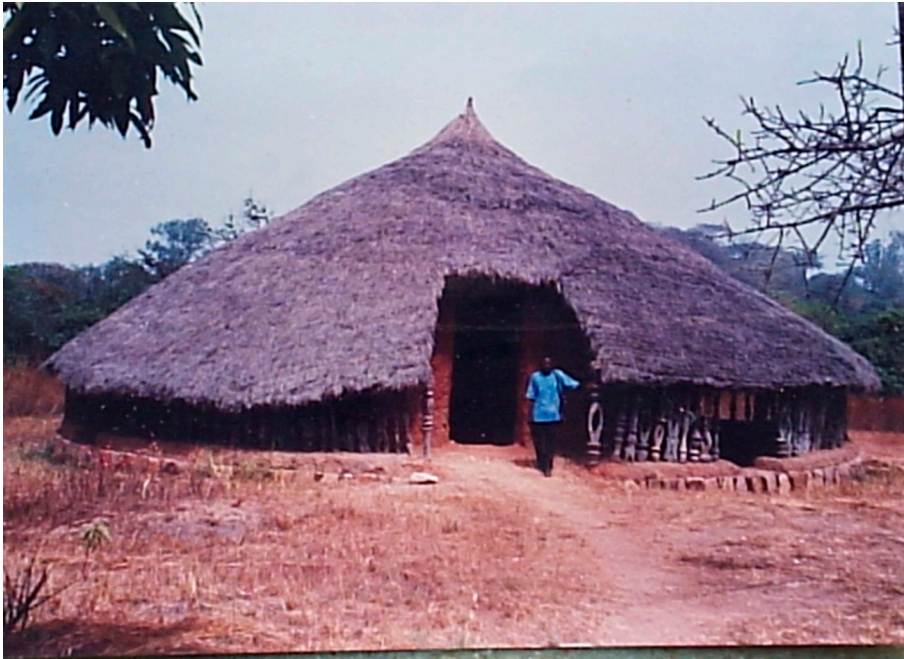
Figure 2: A reception hut. Nupe architecture. Middle Belt. (C. O. Osasona, at Museum of Traditional Nigerian Architecture, MOTNA, Jos. 1993).

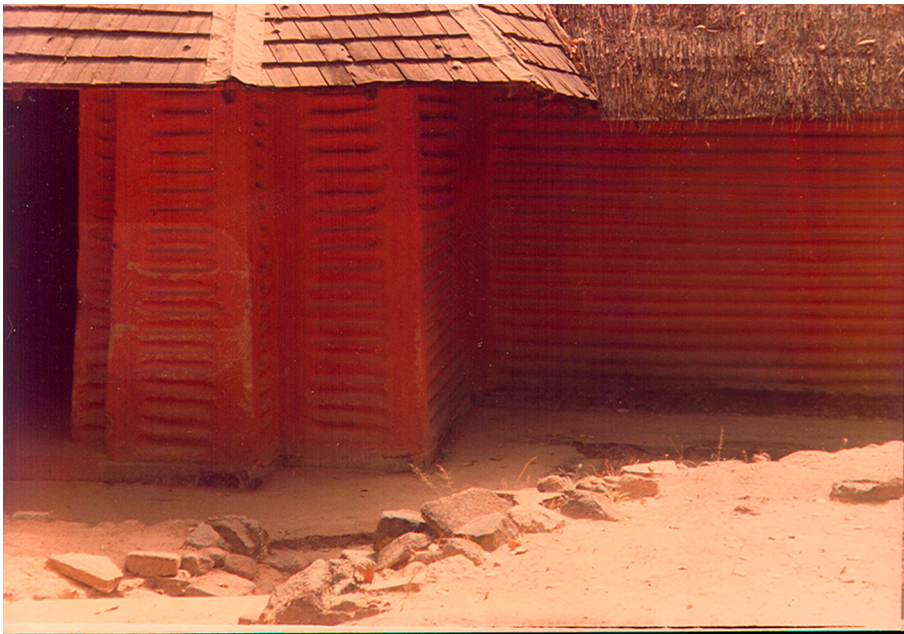
Figure 3: Bini (Edo) architecture, of Mid-western Nigeria. (C. O. Osasona, MOTNA, Jos. 1993).

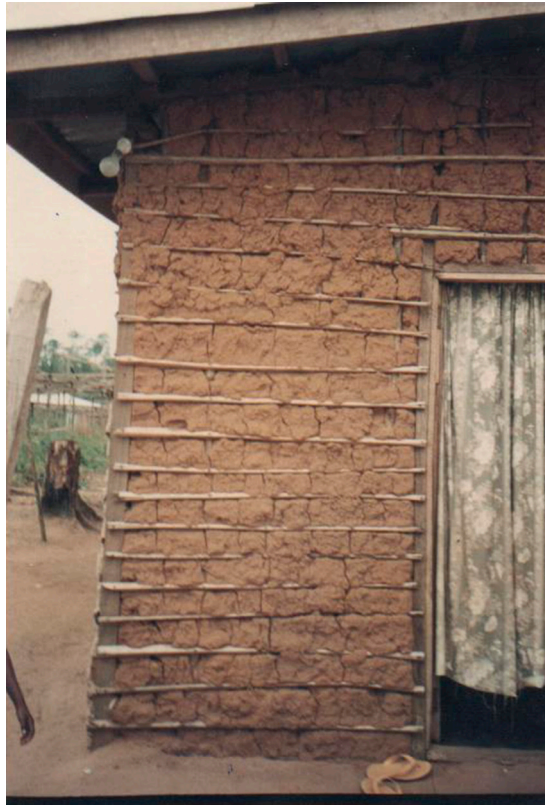
Figure 4: Wattle-and-daub construction. Eastern Nigeria. (E. Ikhuria, 2007).

The commonest building material is earth; this was traditionally expressed as either monolithic layers of cob, adobe (or terra-cotta) or wattle-and-daub construction. Roofing could be similarly of earth (in the northern areas using shallow-domed roofs and vaults because of relatively little rain) or of vegetable matter over a timber framework. For reasons of inability to cope with large spans (due to lack of iron reinforcement) and environmental control, such openings were characteristically under-sized; eaves were also pronounced to facilitate sun-shading and general protection of walls. Such structures dotted more than 60% of the traditional built-scape.

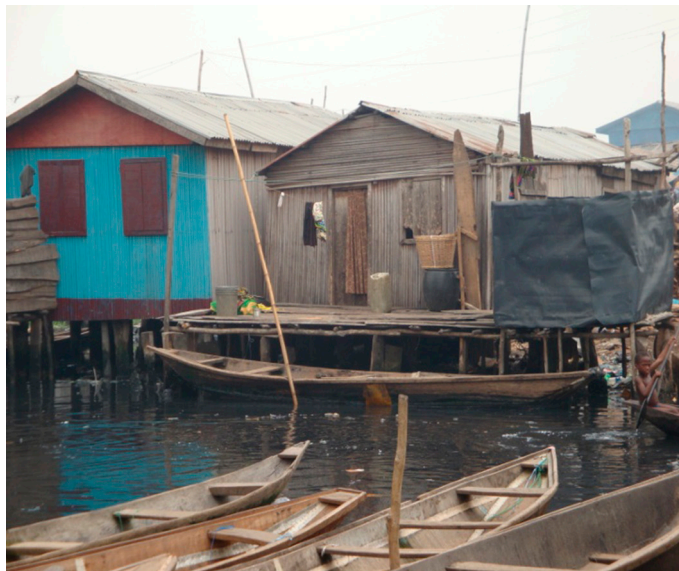
Figure 5: Riverine architecture. Makoko, Lagos; creek area. (C. O. Osasona, 2009).

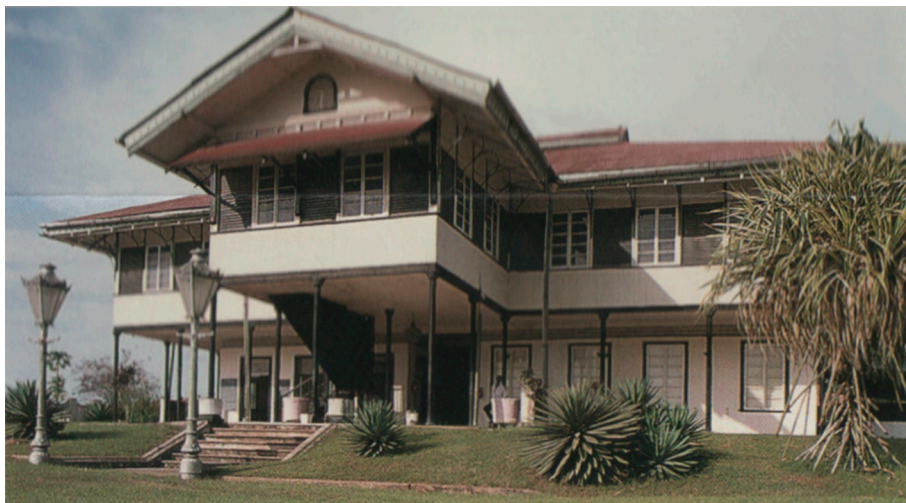
Figure 6: The Residency (Old Consulate), Calabar, 1883. (Source: LEGACY, 1999).

Later tropicalizing elements on colonial buildings included sun-shading devices (such as window hoods, fins, pronounced eaves and the use of verandas); an east-west orientation for the shorter side of buildings; fenestration to ensure cross-ventilation and rapid air changes; exaggerated indoor head-rooms to assist interior comfortability; steeply pitched roofs for quick rainwater run-off; rhones (roof gutters) to harness the vast quantities of such rainwater, and the use of light-coloured paints to enhance thermal comfort within the buildings. The domestic typology – that which constituted the locus of much of the colonialist’s activities – necessarily received major consideration in this regard (Fig. 6).

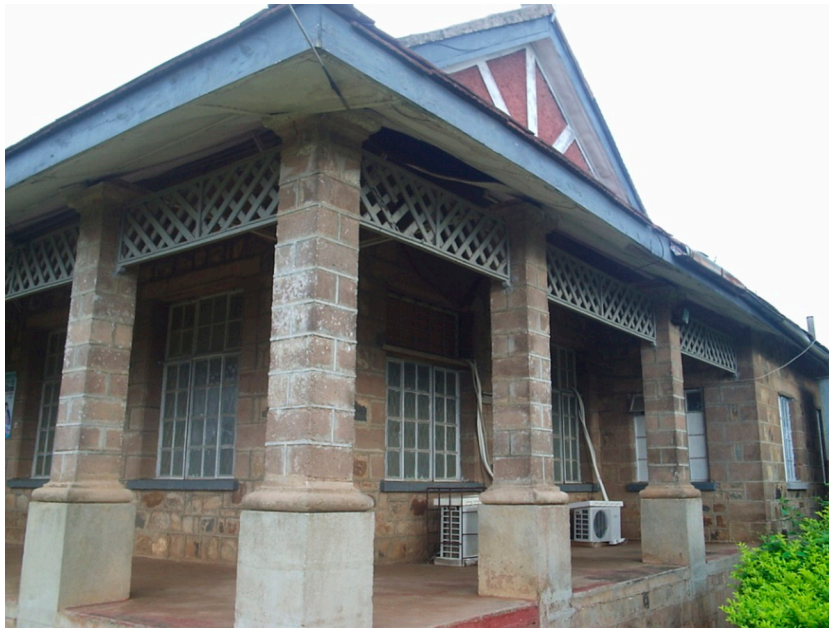
Figure 7: Saro-type bungalow, with framing veranda and timber fretwork at eaves. Modakeke, Ile-Ife. (C. O. Osasona, 2006).

Apart from their own direct intervention vis-à-vis the built-scape, the British were responsible for creating the enabling milieu for other cultures to intervene, architecturally, in Nigeria. With the arrowhead they constituted in the abolition of the obnoxious Slave Trade, it is not surprising that they were also in the vanguard of repatriation of former slaves. Slaves who had formerly worked in Britain were taken back to Africa, where the British settled them in Freetown, Sierra Leone, in 1807. However, many of them, convinced of their Nigerian ancestry, agitated until they were eventually brought to Lagos. Locally, they became known as *saro* (pidgin for their real name) and specialized in a building type very similar to that characteristic of the British occupation; additionally, the *saro* archetype featured fretwork at eaves and carved fascia-boards (Fig. 7).

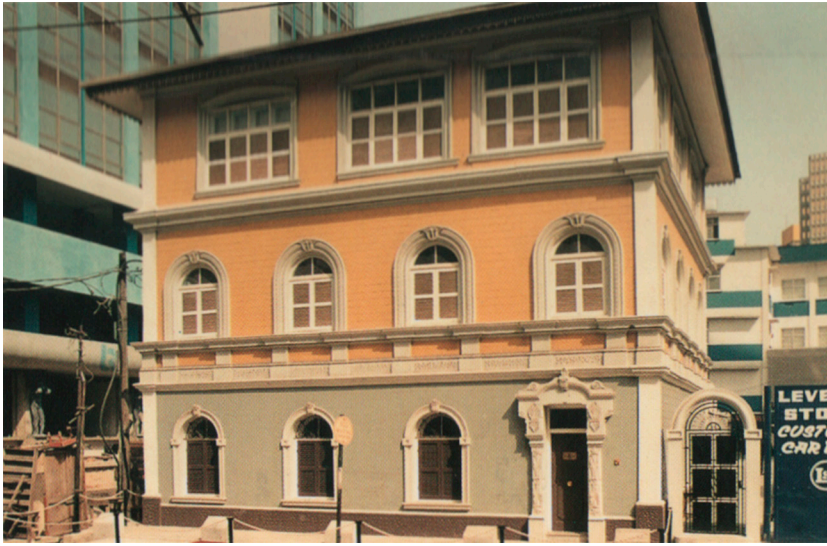
Figure 8: William Lumpkin House, ca. 1880. Abibu-Oki, Street, Lagos. (Source: LEGACY, 1999).

The other group of returnee slaves to Africa who settled in Lagos, were the *emancipadoes* from Latin America (mostly from Bahia in Brazil, and from Cuba). Just as the *saro* established the ‘*Saro Quarters*’, these repatriated slaves founded the ‘*Aguda Quarters*’, building multi-storey structures that were known for heavy ornamentation and complex roof configurations incorporating the attic. In addition, the Brazilian style was characterized by a prominent central corridor, with the living spaces deployed to the left and right, and conveniences and other utilities as detached, ancillary structures behind the main building. Fired brick, well-seasoned hardwood and stucco were the favoured materials. The elaborate characteristic decoration was expressed as stucco artwork (on column capitals and bases, quoins, plinths/dadoes, door- and window-openings, balusters/balustrades and as relief murals), and also as carved work (turned timber posts, newels, handrails, door and window panels, and ventilation screens; see Fig. 8).

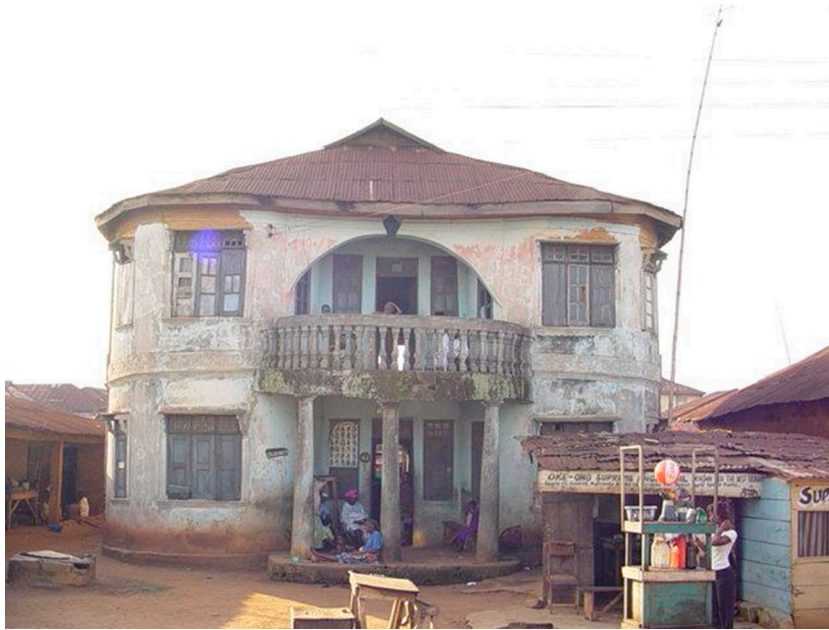
Figure 9: Ologbenla House 1. No. 55, Moore Street, Ile-Ife. View from the road. (S. Oluwole, 2003).

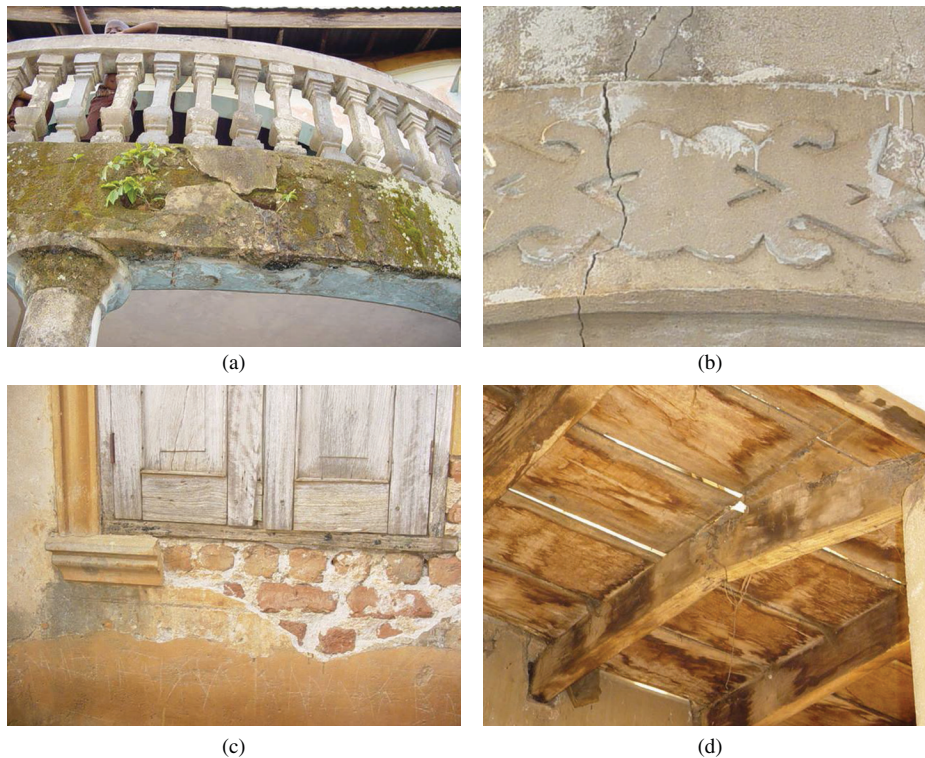
Figure 11: Evidence of decay: (a) stucco-work on base of balusters displaying growth of lichen, and chipping; (b) deep crack on external wall; (c) peeled-off plaster and moulding, exposing fired brick walling; (d) broken timber joist supporting external wooden floor. (S. Oluwole, 2003).

Presently, Ologbenla House (1) is in very bad shape (see Fig. 11 for details). As at the time of the fieldwork, it was occupied by an aged widow (the erstwhile youngest wife) of the house owner, with a few members of different generations of her offspring, as well as some paying tenants; certainly,

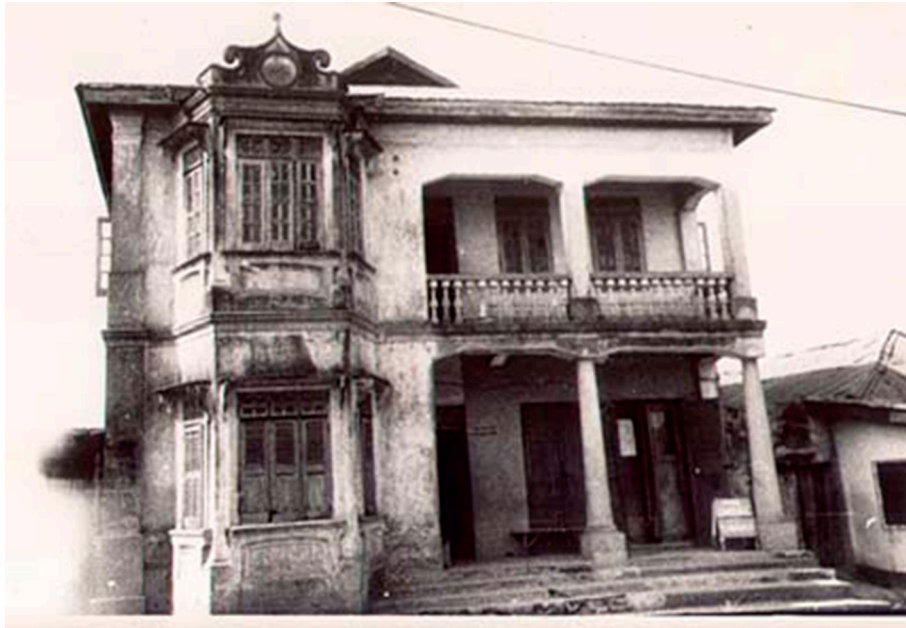
Figure 12: View of Ologbenla House 2, No. 53, Moore Street, from the road. (C. O. Osasona, 2003).

Michael Aderin Ologbenla, was a well-educated and successful Lagos-based civil servant, working majorly with the Nigerian Railway Corporation until his retirement. As his retirement plans got underway, he consulted some master builders in the *Aguda* Quarters of Lagos Island (who were essentially descendants of the original Brazilian repatriate slaves); they were able to furnish him with the design which, between 1953 and 1957 (when he actually retired), he implemented at No. 53, Moore Street, Ile-Ife (Figs 12–14).

An analysis of the physical characteristics of Ologbenla House (2) reveals that, apart from the issue of date (locating it many years after the first wave of Brazilian-type construction took place in Nigeria), some other features within its morphology position it several generations down the line.

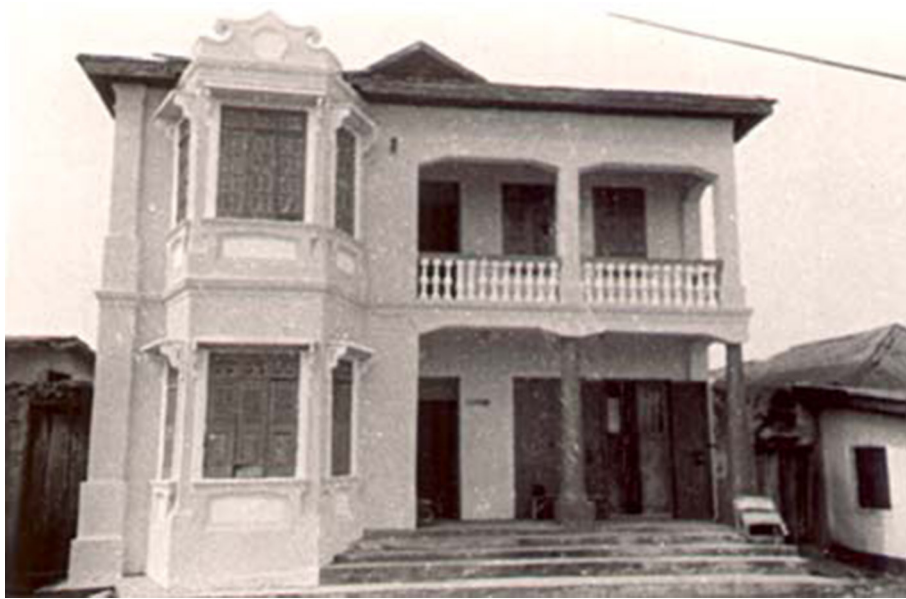
Figure 14: Ologbenla House 2, after the tentative restoration intervention in 2003. (C. O. Osasona).

University, Ile-Ife, about six years ago, initiated restoration work on the building, hoping it would snowball into the heritage structure gaining attention for a more comprehensive intervention to take place; however, sadly, these expectations were never realized (see Fig. 14). Rather, the effects of the previous intervention have virtually all faded, while the parts that were overlooked then, continue their downward march to total dereliction – as a result of negligence, on the one hand, and genuine financial incapacity, on the other.

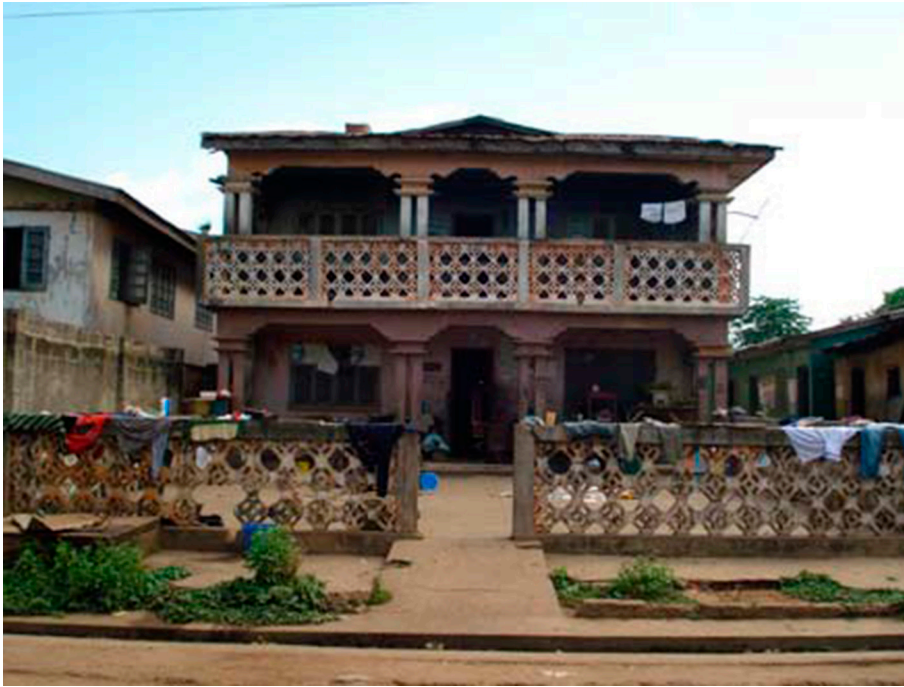
Figure 15: Ile Alubarika. View from the road. (A. Makinde, 2006).

Located at No 13, Eleiyele Street (along the link road between Eleiyele and Oluorogbo Quarters) this building – even in its near-derelict condition – presents an imposing, delightful facade on this road (Fig. 15). Until less than 10 years ago, it made the greatest visual impact in its vicinity; that is, before Celebration Hotel (a multi-storey commercial concern) sprung up on the corner, gaining both locational and formal advantage over it.

typical – except for the perforated block finish to the upper veranda balustrade, a concession to the trend in the construction of such, at the time (see Figs 15–17). Despite its relatively young age (making age a non-issue as a criterion for justifying an investment in conserving/restoring the building), *Ile Alubarika* is architecturally significant in its own right. Clearly – and despite the fact of local artisans being used in its execution – it demonstrates high-quality craftsmanship. It is tastefully proportioned on the major facade, to offset the pronounced linearity on the flanks. In addition, the fencing of the premises signalled the genesis of a post-Civil War phenomenon that was soon to be commonplace in not just property delineation, but more significantly, security pro-activeness.

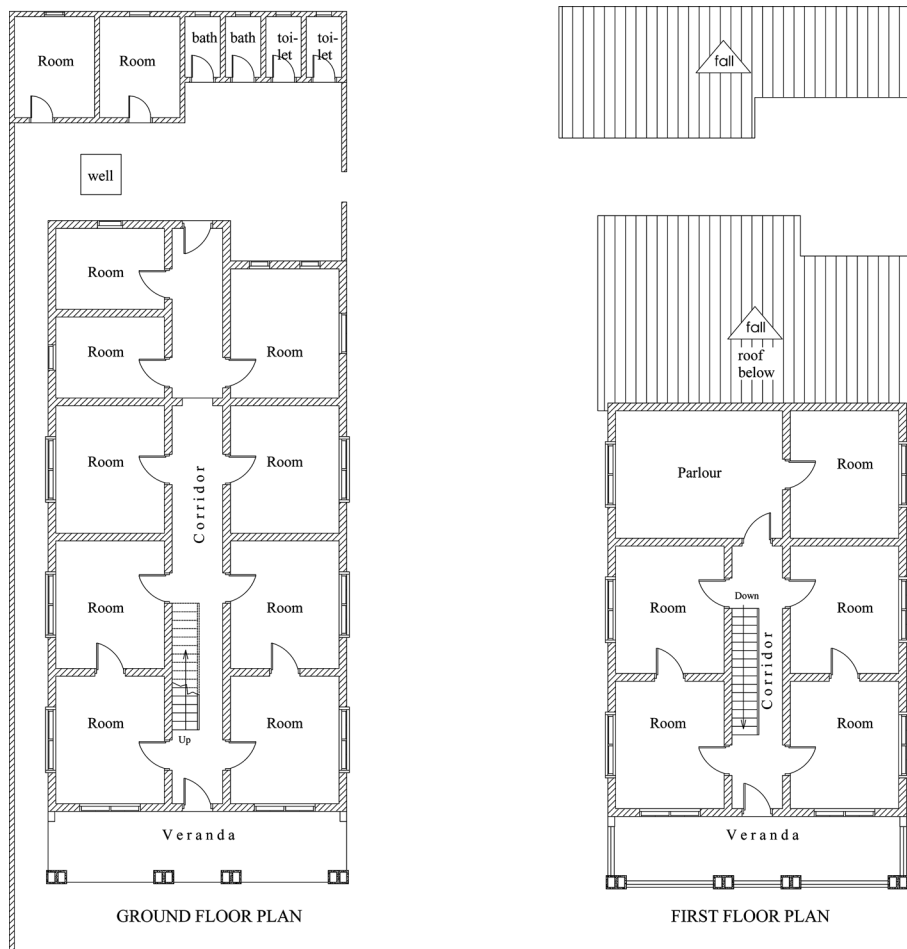
Figure 16: Ground- and first-floor plans of Ile Alubarika. (O. Oyeyipo, 2013).

In its morphology, *Ile Alubarika* is quite basic: it is pronouncedly rectangular, along a north-south axis and features the characteristic central corridor flanked by rooms on both sides. Again, utilities (covering conveniences and storage) are deployed as detached, back-of-the-house spaces, generating a service backyard for the compound. In typical Brazilian fashion, the staircase leading to the upper floor is embedded within the corridor; also, all building materials are

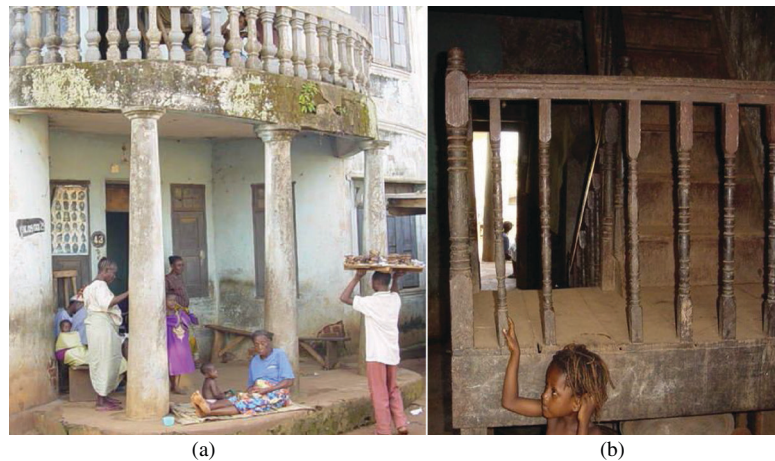
Figure 18: Ologbenla House (1), as domestic space: (a) the porch is a place of relaxation, traditional hair-dressing and interactions with trades people, among other activities; (b) a little girl at home in the staircase lobby. (S. Oluwole, 2003).

and personalized majorly in a domestic context. Figures 18–20 attest to the fact that, despite the decrepit condition of these buildings, they are *still* home to several people, cutting across the different age-groups. Resident elderly family members contribute to the domestic set-up as babyminders (and general superintendents of older grandchildren), while more vibrant, younger family members coordinate tenant-related issues in the household. Regardless of public opinion and implicit (or conferred) community status, the residents carry on their daily lives as if their building were no different from their neighbours'; any real (or imagined) intrinsic value of their shelter is significantly lost on them. For the aged among the present occupants (who are in a position to recall the heyday of any of the buildings), the most they appear to do is to bemoan the passing away of such glory, and to philosophically conclude that the present dispensation has no use for such relics. Obviously, certain phenomena are responsible for such a state of affairs, and need to be considered.

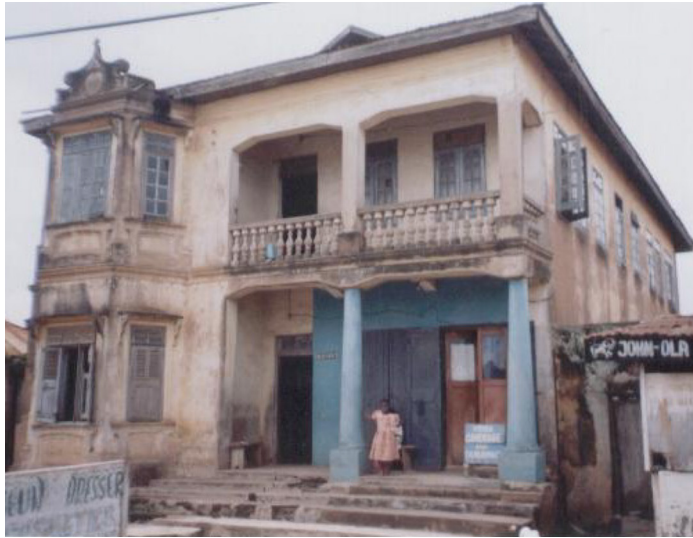
Figure 19: Ologbenla House (2) portraying ‘living-and-selling’: a little girl (who lives there) stands in front of the shop (right-hand side of the frontage) used by a professional photographer/ videocamera man. (A. Dimowo, 2003).

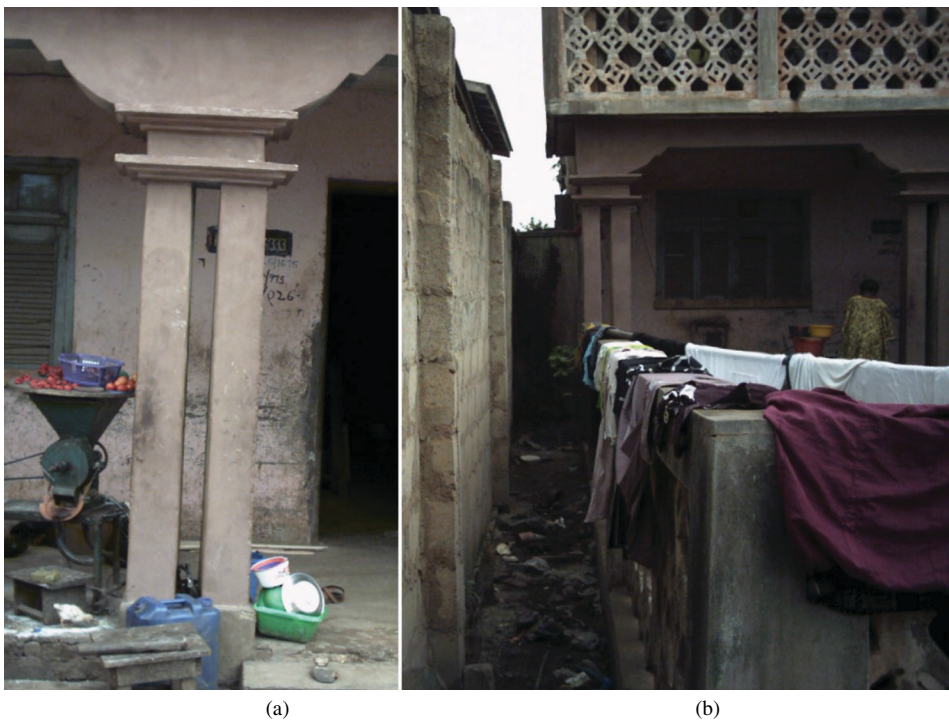
Figure 20: Evidence of domestic activity at Ile Alubarika: (a) commercial ‘pepper-milling’ on the veranda; (b) clothes spread out to dry on the perimeter fence. (A. Makinde, 2006).

Like the earlier case studies, *Ile Alubarika* is in very bad shape, presently. The house is bedevilled by chipping off of chunks of masonry, heavy soiling, wood decay and roof-leaks (Fig. 17). Yet – in spite of these issues that should generate serious concern for the building’s welfare – it is occupied. The youngest wife of the erstwhile house owner was in residence as at the time of the survey, with some grandchildren, as well as a few other members of the extended family and tenants. They carry on with their lives as best they can, engaging in various activities (such as petty trading) as a means of livelihood. In particular, here, one of the tenants makes a living out of commercial pepper-milling (see Fig. 20).
