## Monitoring of indoor microclimatic conditions of an eighteenth-century church, with wireless sensors

Mauro Cannistraro<sup>1\*</sup>, Roberta Restivo<sup>2</sup>

### **ABSTRACT**

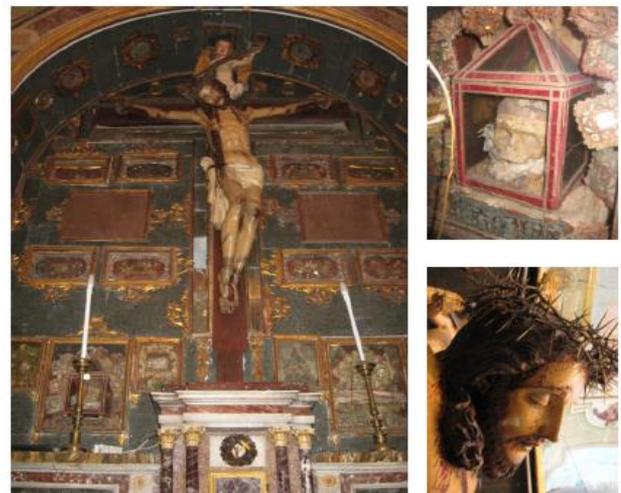
**Figure 1.** The Niche and the Crucifix of SS. Crucifix Church of Milazzo (ME)

The shrines visible around the crucifix are made up of wooden frames decorated in gold leaf, protected by glass, some almost completely broken, others made opaque by time. Many of them show loss of adhesion with fragile support frames.

The shrines are intended to contain bone relics attributed to various saints, ancient scrolls, vestments, and votive offerings of precious metal.

The continuity solutions due to the low glass resistance therefore allow outside air to bring all manner of airborne pollutants within the shrines.

This amplifies the outdoor thermo-hygrometric variations creating harmful effects of inner surface condensation in the semi-enclosed areas of shrines themselves.

The shrines, as shown, are set into in a large wooden painted panel placed as a background of the SS. Crucifix sculpture.

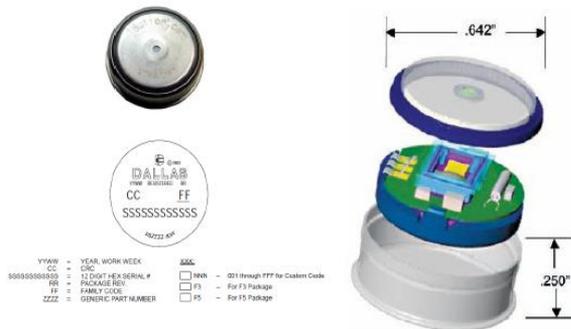
**Figure 2.** The Button-Thermochron, section of the internal components

For monitoring of the values of temperature and air humidity, were employed Button (see Fig.2), they are sensors, of computer encased in stainless steel capsules of 16 mm of diameter, small to be installed in environments and on surfaces, for measured the climatic parameters.

After recording, the data is downloaded to a PC via a special interface.

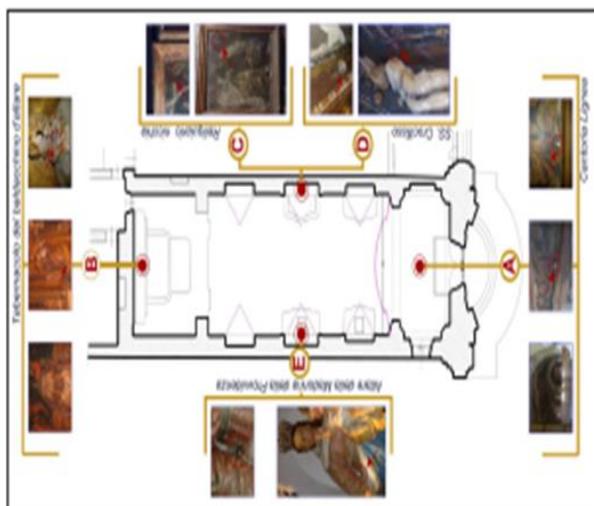
**Figure 3.** Positioning of the I-Button ® ThermoChron

Temperature and relative humidity parameters' oscillations have been monitored in the five selected station points whose location is indicated in Fig. 3.

For convenience of detection it has been attributed to sensors some alphabet letters, the code, allows the correct recognition during the acquisition phase of the monitored data. Below, the positioning areas of each sensor is provided:

- "A" Button: located at the top of the seventeenth-century wooden choir, about 9 m height from the nave's floor, set in a position very close to the vault's frescoes and the windowed lunettes. he frescoes, in particular, are suffering from diseases of apparent separation, discoloration and florescence from the substrate.

- "B" Button: placed inside the wooden tabernacle behind the altar, at about 2.50 m height from the floor. The thermo-hygrometric trend detected by the sensor in object can be considered representative of the entire transept area, being light surrounding perturbation causes.

- "C" Button: placed inside the shrine, set on the right side of the background wooden panel of the niche of the SS. Crucifix, at 2.00 m height from the floor, approximately. The sensor was suspended inside the shrine, respecting as much as possible the presence of bare bones and votive in cloth and metal lying there.

- "D" Button: installed on the surface of the cross, inside the niche, external to the shrines.

- "E" Button: placed inside in the wooden statue of Our Lady of Providence, at about 3.50 m height from the nave's floor on the left altar, on the diametrically opposite side to the niche of the SS. Crucifix.

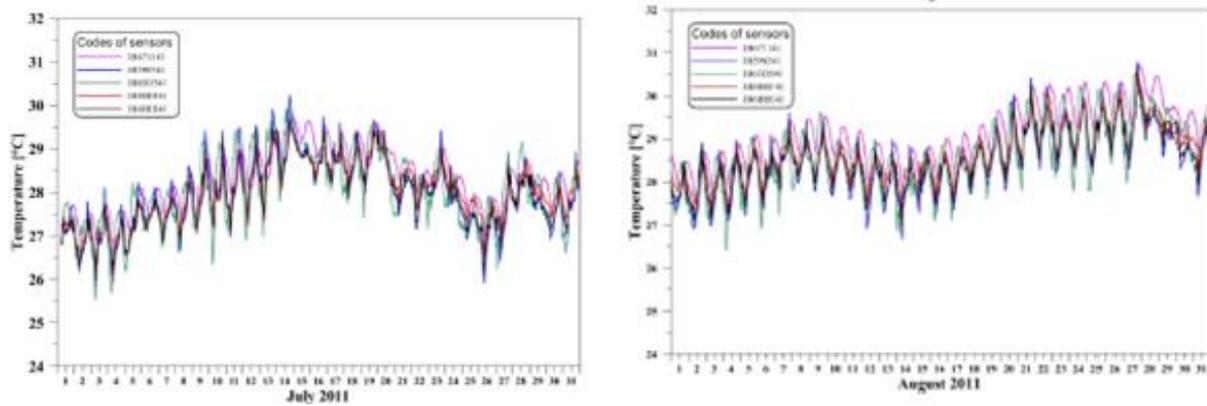
Figure 4. Evolution of the temperature profile acquired by the 5 sensors - July and Aug. 2011

The monitoring interval chosen for the temperature and relative humidity parameters analysis is represented of the two central months of the summer period. This in order to acquire data, that show interesting excursions. The temperature and relative humidity values obtained by the sensors during the two months of monitoring are graphically expressed by the following figures. As can be seen in Fig.4, the trends of the temperature profile, at less than obvious differences of the peak values, are more or less overlapped.

This trend may be strongly affect by a continues thermal flow coming from high and wide windows in the choir, open during the entire day.

The effect of potential thermal wave damping - created by perimeter inertia of walls of the Church. As shown by the following graphs, all obtained values are well above the range considered optimal, as suggested by the UNI10829/99 concerning the conservation of the sculptures in painted wood. Different trend is logged in relation to the relative humidity rate [Fig.5].

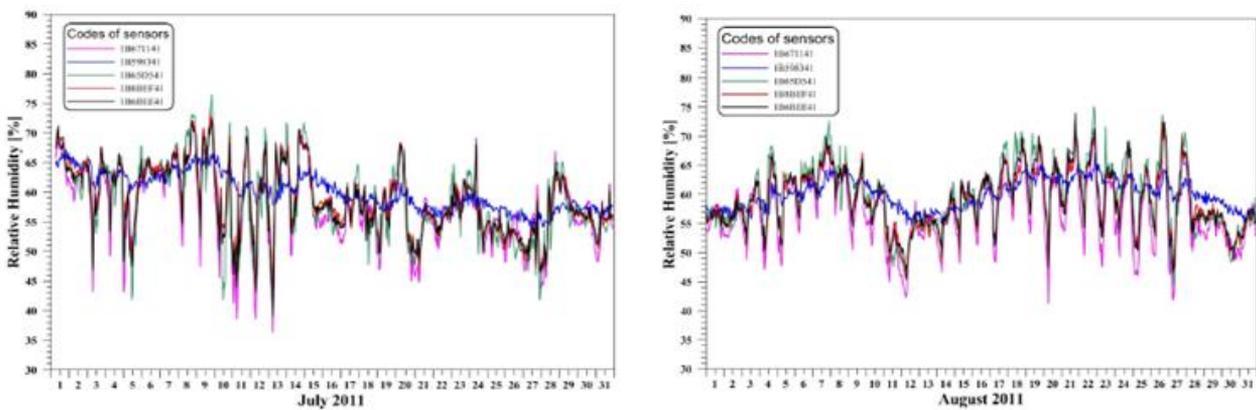
Figure 5. Evolution of the relative humidity profile acquired by the 5 sensors - July and Aug. 2011

The most pronounced peak hygrometric and thermal values belong to the sensor (magenta color) placed on the statue of

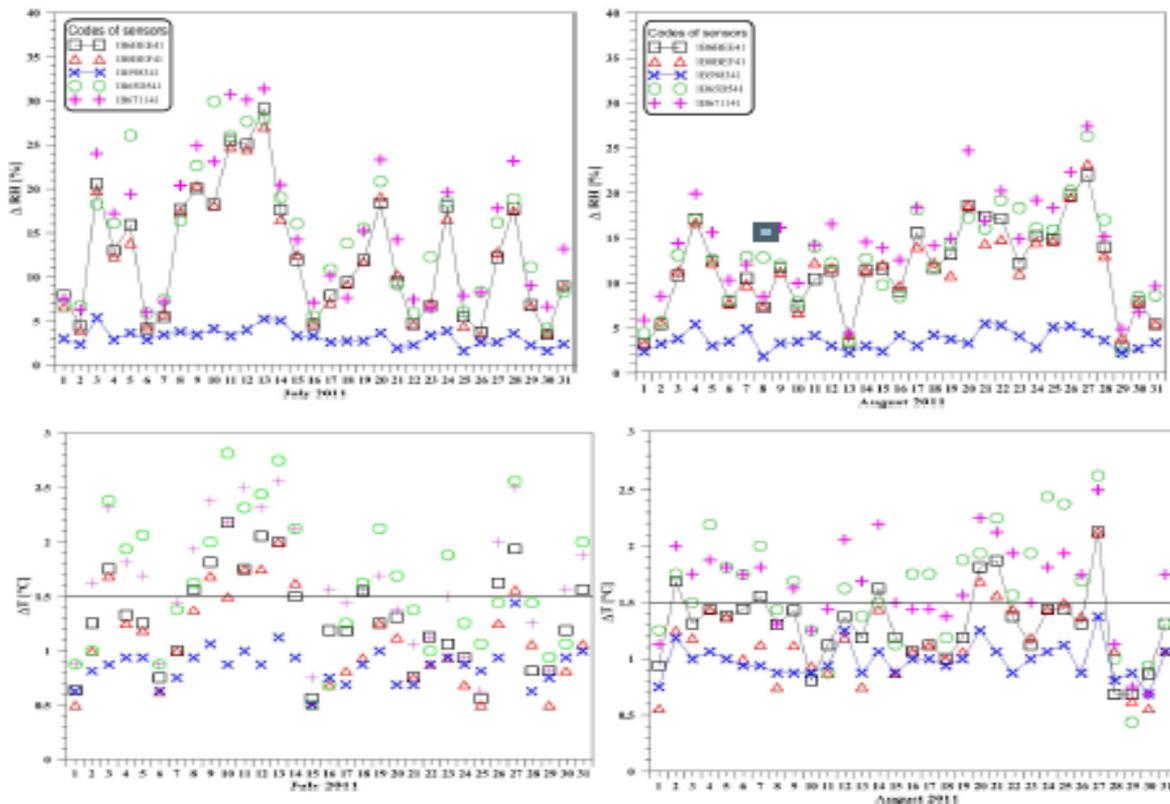
Figure 6. Evolution of hygrometric thermal excursions derived from the 5 sensors - Ju-Aug 2011

Both performance hygrometric and thermal excursions, are expressed in the graphs by Fig. 6.

It is clear that almost all of the hygrometric excursions, derived from monitoring data, fall well beyond the maximum recommended by the Standard UNI10829/99:  $H_{max}=4$ .

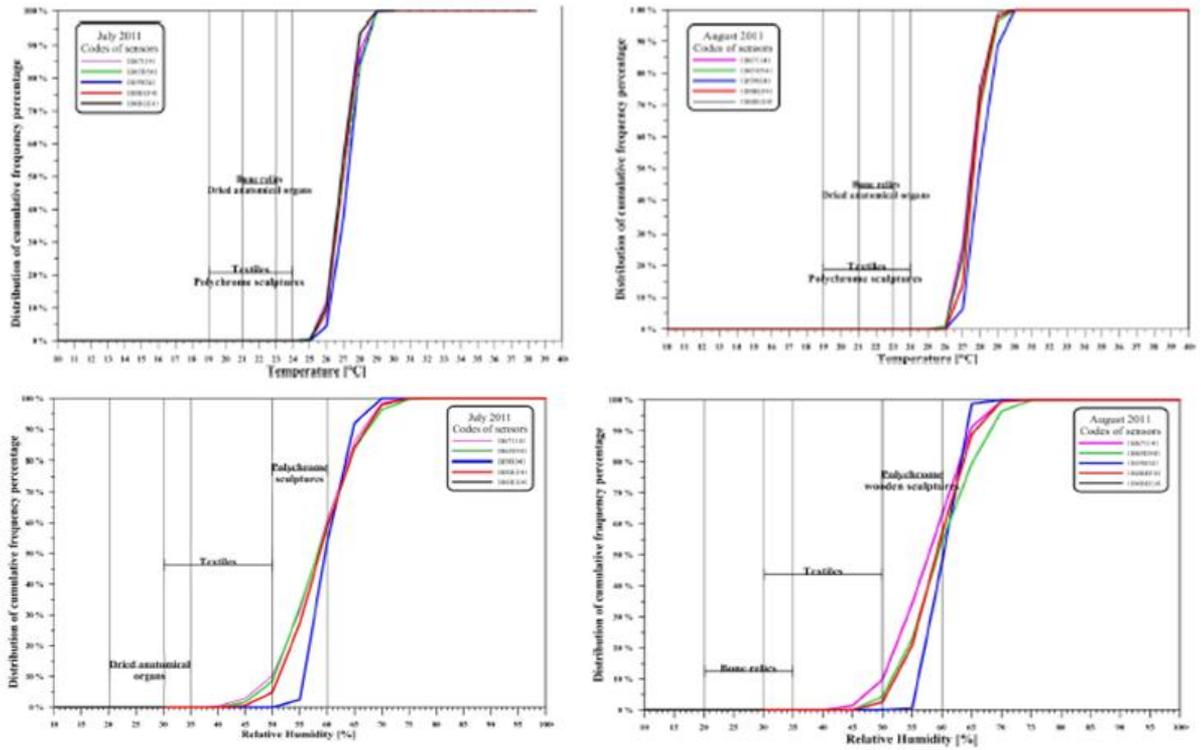
Figure 7. Percentage distribution of cumulative frequency -Temp and Hum. July-August 2011

A further analysis of monitoring results is provided by graphs of cumulative frequency distribution [Fig. 7] and by the associated indicators of deviation [Fig. 8]. Both during the monitoring in the month of July, than in August [Fig. 7], you can see how thermal values recorded are located well beyond the range of values considered optimal by the reference standard.

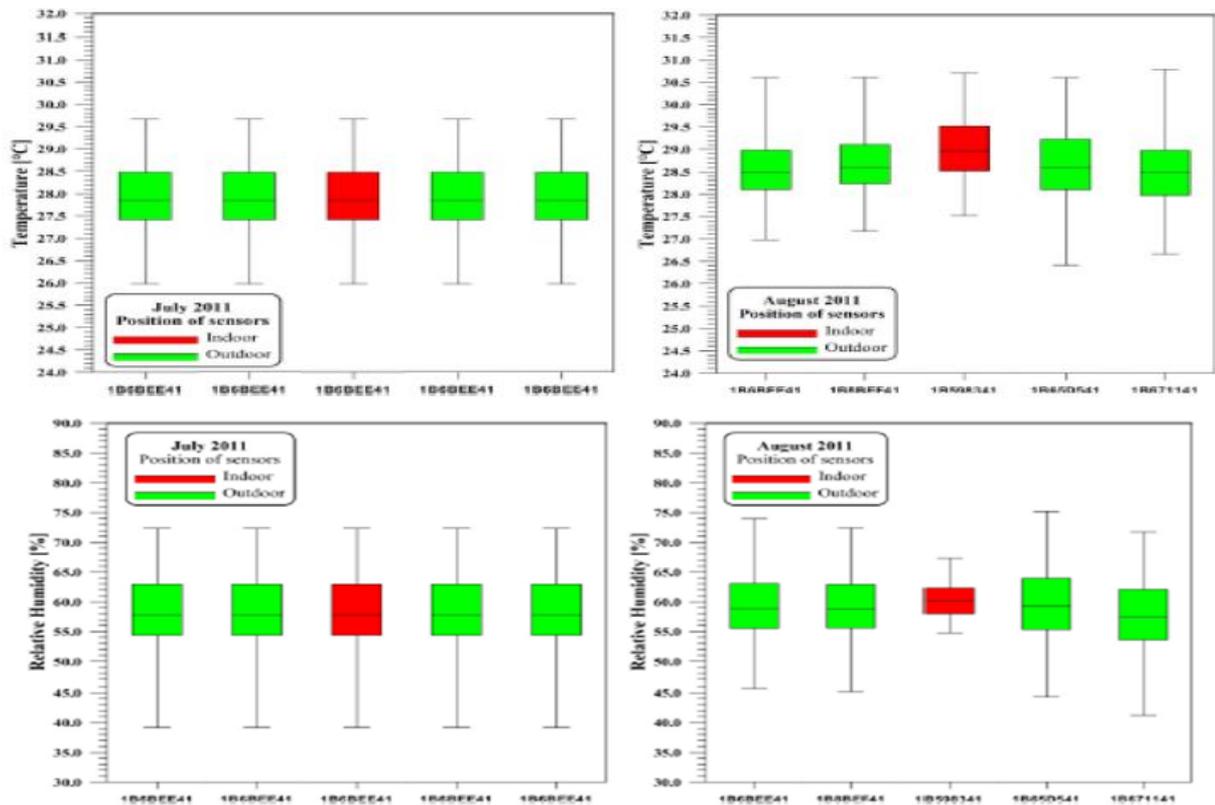
Figure 8. Deviations indicators of thermal and hygrometric data July and August 2011

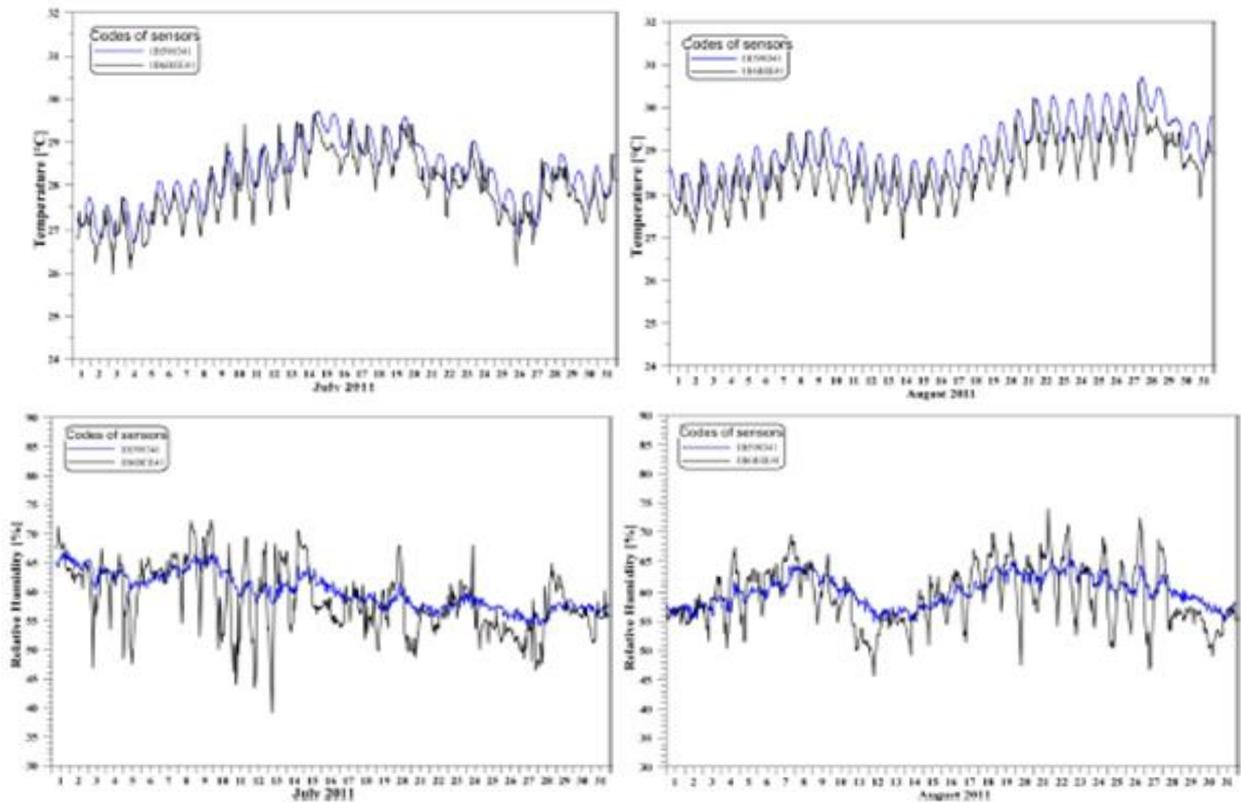
**Figure 9.** Evolution of temperatures and humidity profile obtained July-August 2011

the wooden panel of the same niche bottom. The following Fig. 9, show the parameters of thermal and hygrometric performance. The interpretation of results can not ignore the present preservation state, it requires action of monitoring. The shrine is not provided with laminated glass firmly fixed to the wooden support, nor it is equipped with the traditional technical devices suited to ensure the "seal" to the outside air penetration.

As is shown by both temperature trends and humidity, with rather muted oscillations of both parameters. The shrine pays an evident state of degradation: the frames display a great solution of continuity with the eighteenth-century glass, which is extremely thin, corroded, cracked and badly placed to the back support.

The glass sheet high transmittance, makes the thermal trends recorded by the two neighboring sensors fairly overlapping; this to underline how the shielding offered by the

shrine to the thermal fluctuations on the environment outside can be low and deficient [see Fig. 9].

On the contrary, the shrine has a higher resistance to fluctuations in relative humidity, only due to the glass protection, at penetration of the steam rate inside the air/steam mixture.

This condition makes the "sensor Humidity", with a profile almost homogeneous marked by damped oscillations daily. Similar considerations can be applied to the temperature daily and at humidity trend about the reference standard indications, Fig. 9 and Tab. 3.

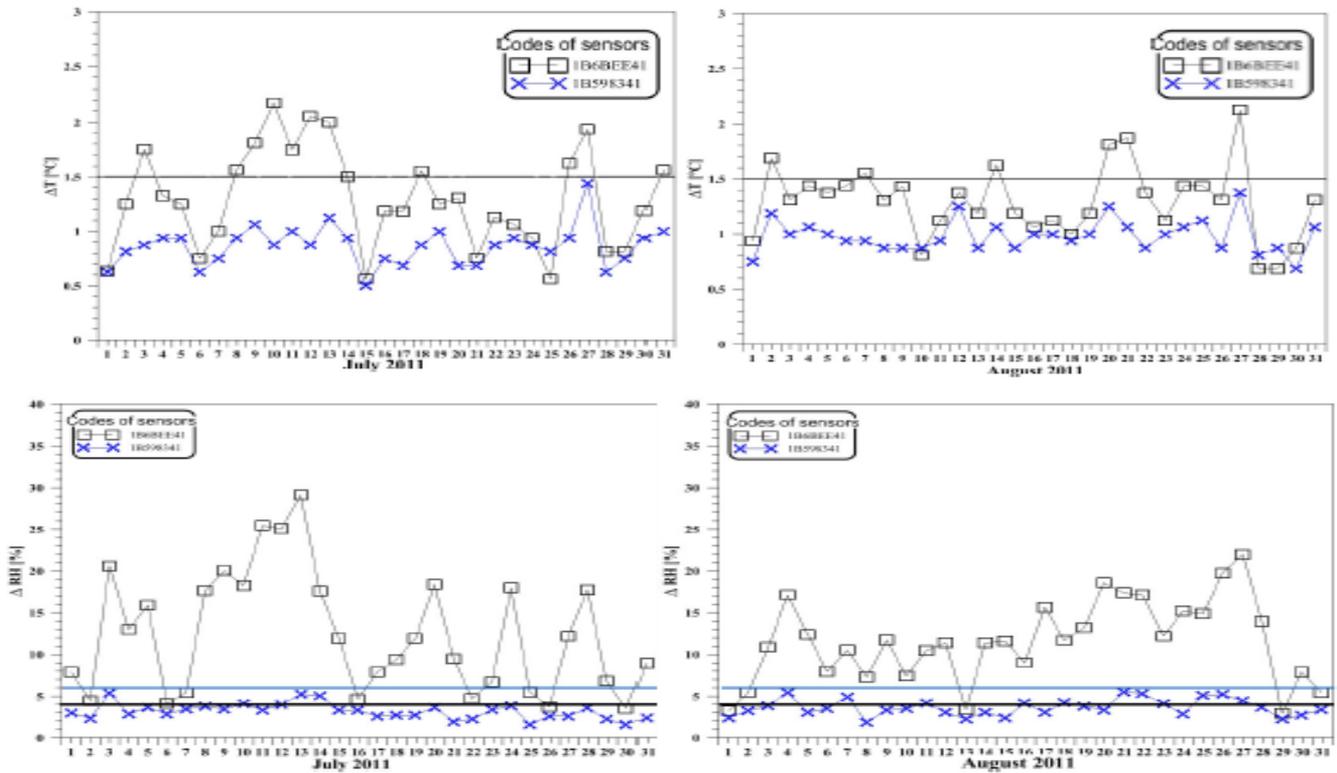
**Figure 10.** Air temperatures and humidity excursions for sensors (C and D)

As you can appreciate, the daily thermal excursions [see Fig. 10]- represent the temperature values logged by the sensor inside the shrine, remain below maximum value indicated by the standard ( $\Delta T_{max}=1.5$ ), in both months. The outside sensor, shows that the 37% of values have exceeded, for the month of July and 20% in August.

As regards the excursions of the hygrometric performance [see Fig. 10], legislation gives the value of  $\Delta H_{\max}=6$ , for antique textiles and robes (blue line on the chart) and equal to  $\Delta H_{\max}=4$  for the polychrome sculptures in painted wood (black line on the chart).

The rules standards don't give any indication about humidity excursions, concerning bone relics. It is noted that the sensor outside the shrine, reveals for almost all hygrometric excursions, values far superior to that reported as a maximum in the standard.

Instead the performance of inner sensor remains steadily below by standard parameters.
