STABILITY OF THE NEW ALLUVIAL FAN OF EL PARTIDO STREAM, LOCATED IN THE EASTERN SIDE OF EL ROCÍO VILLAGE IN THE DOÑANA NATIONAL PARK (SPAIN), AFTER THE ACTIONS CARRIED OUT TO RESTORE ITS HYDROLOGICAL REGIME

J.A. MINTEGUI AGUIRRE, J.C. ROBREDO SÁNCHEZ,
C. DE GONZALO ARANO & P. HUELIN RUEDA

Departamento de Ingeniería Forestal, Escuela Técnica Superior de Ingenieros de Montes,
Universidad Politécnica de Madrid, Spain.

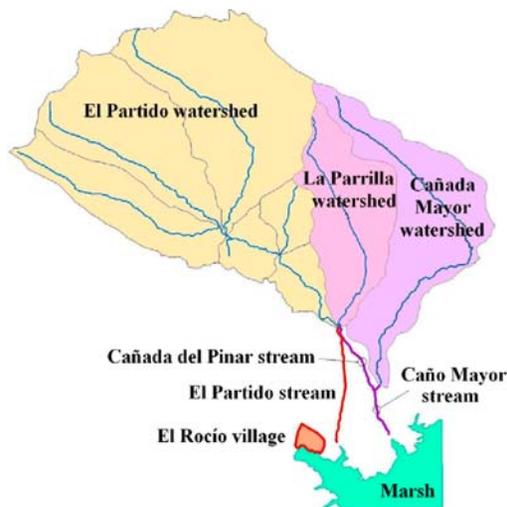
Figure 1: Watersheds and drainage networks of El Partido, Parrilla-Cañada del Pinar, and Cañada Mayor streams. In flood events the last reaches of the streams that interchange the flow permits the Cañada del Pinar stream to perform as a drainage channel of El Partido alluvial fan.

A main aspect to be noted is that prior to the stream channelization, El Partido and the Parrilla streams had their own drainage channels, and their catchment areas were split (Fig. 1); but both streams shared a single alluvial fan, and therefore they naturally interchanged their streamflow during major flood events. This effect permitted the Parrilla stream (in this area the name Parrilla stream changes to Cañada del Pinar stream) to behave as a drainage channel of the El Partido catchment area. In 1981, the channelization connected the Parrilla stream to El Partido channel; thereby preventing the Parrilla stream from working as a drainage channel.

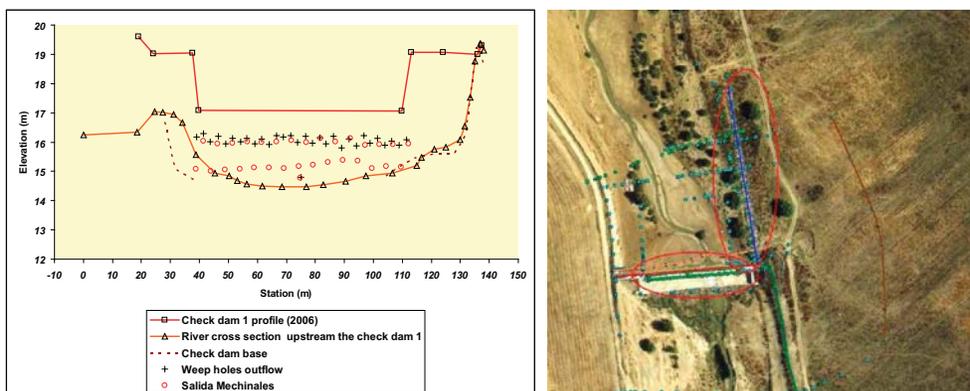
Figure 2: Left: Elevation view of the CD1 over El Partido stream in 2006. Right: Aerial photograph (2008) of the CD1 and plan view. The frontal spillway is highlighted with the red line and horizontal ellipse and the lateral spillway is highlighted with the blue line and vertical ellipse.

The specific objectives of the CD1 are: a) controlling retrogressive erosion processes upstream its location and b) distributing the streamflow between the Arroyo del Partido channel and the flood–lamination–sedimentation area. The CD1 crest height is 2.6 m above the current streambed. Originally, the frontal spillway (which is an overflow spillway or broad-crested weir) was 2.0 m high, 70.0 m long, and 2.0 m wide, situated at an average crest height of 16.7 m a.s.l. 31 weep holes, with 0.3 m in diameter, crossed the structure from the upstream to the downstream face, draining the water volume stored behind the structure. The weep holes were arranged in two rows (of 15 weep holes each) and a single bottom drain (Fig. 2). The lateral overflow spillway was placed immediately upstream of the structure along the left riverbank, coated with a rocky breakwater and a cyclopean concrete lining in order to prevent erosions when the diverged flow passes over it and comes into the flood–lamination–sedimentation area. The lateral spillway has a length of 140 m and its crest altitude ranges between 16.70 and 16.77 m a.s.l. due to its roughness.

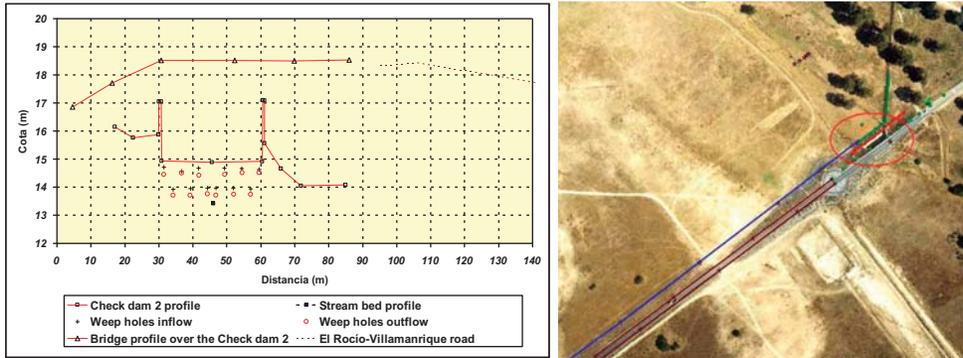
Figure 3: Left: Elevation view of the CD2 over the Cañada del Pinar stream in 2006. Right: Aerial photograph (2008) of the CD1 and plan view. Its spillway is highlighted with the red ellipse.

The CD2 mission is to regulate the flood level in the floodplain, ensuring a subcritical flow regime within this latter. The CD2 is 1.5 m high at the crest and was built immediately upstream of the bridge over the Cañada del Pinar stream, on the road connecting El Rocío and Villamanrique (Fig. 3). The overflow spillway is 29.5 m long, 2.0 m high, and 3.0 m wide,

with an average crest height of 14.62 m a.s.l. The structure is crossed by 12 weep holes, with 0.3 m in diameter, draining the volume stored behind the check dam, arranged in two rows (of six weep holes each).

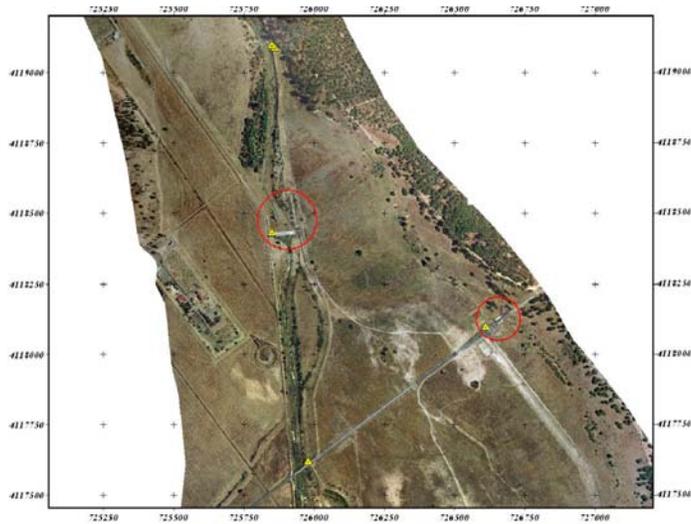
Figure 4: Aerial photograph (2008) showing the northern section of the flood–lamination–sedimentation area recovered with the A3. El Partido stream drains along the left side of the image and the Cañada del Pinar stream drains along the right side.

The flood–lamination–sedimentation plain is composed of two different areas. In Fig. 4, the northern section is shown, with an area of 57 ha, which is the first part being flooded. For this reason a geometric leveling of its perimeter was performed on 19 July 2003. In the same

figure, CD1 and CD2 are marked with red circles. The southern boundary of this first floodplain is defined by a paved road connecting El Rocío and Villamanrique villages, crossing the floodplain from west to east. The mentioned stretch of the road (between the two bridges over the two streams in study) operates as a discharge threshold in extreme flood events, so that a geometric leveling of it was performed on 18 October 2008. The southern floodplain (gathered only partially in Fig. 4) is located downstream of the paved road, having an area of 227 ha and extends up to the end of the former sedimentation fan, which could be demarcated by means of aerial photographs taken before channelization.

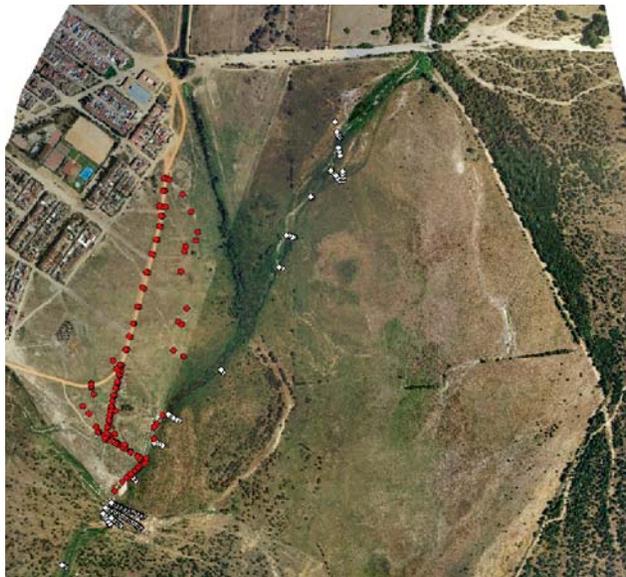
Figure 5: The routing of El Partido stream is marked with white dots from north to south over an aerial photograph of 2008. The dots in the image correspond to topographic survey made in 2007 (red) and 2008 (white).

1997–98, a levee was built up, which can be distinguished at the left side of Fig. 5 (highlighted with red dots). In this same image, the J-shaped levee-end is appreciated in the left side of the image, encircling the urban area of El Rocío. At the top of the image is the Cañada Real, crossing from the Ford–Ajolí Bridge section (right) to the bridge over the Caño Marín stream (left). In the lower right corner of the image, the pumping station of El Rocío village is located, next to the DNP marsh boundary (southwest). In the center of the image, the confluence of the Caño Marín and El Partido streams can be distinguished.

This flood event on 11 February 2007 warned of the need to undertake corrections of the original design of the discharge sections of the CD1 directed to El Partido stream, referred to in Section 3.1. As an immediate solution it was adopted: a) to repair the pipes and b) to extend the protective J-shaped embankment of El Rocío village toward the marsh, from the point of bending to the west. Figure 5 shows this extension that splits the streamflow of El Partido from the urban flow of El Rocío. The road connecting the mentioned protective embankment with the pumping station had a protective effect as well during the major flood events of the last hydrological year 2009–10. In compliance with the protocol fixed for the monitoring, the levees were topographically surveyed with a total station on 19 November 2007, and thus the heights of the protective levees were redefined. These operations are represented with red dots in Fig. 5.

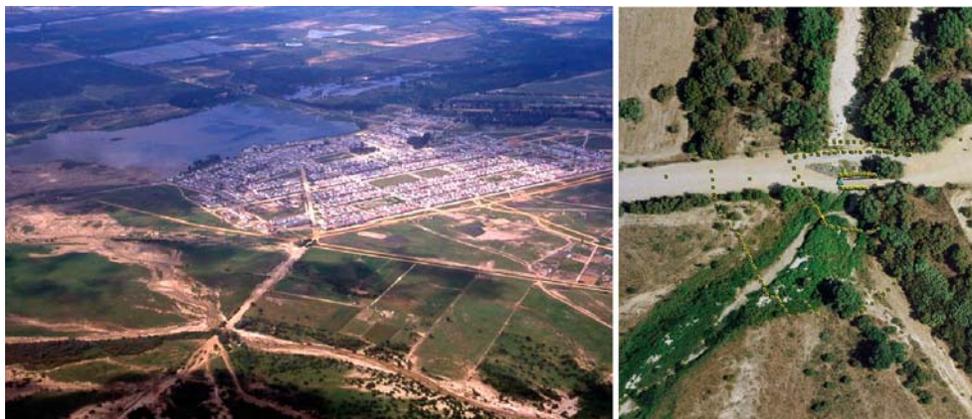
Figure 6: Left: Overview (from east to west) of the new sedimentation fan apex of El Partido (2006). Right: Plan view of the Ford–Ajolí Bridge section (2008) from north to south (top to bottom) with the Cañada Real road at the picture center.

The images in Fig. 6 show: a) on the left side an overview (from east to west) of the start of the new sedimentation fan of El Partido. The marsh and El Rocío village appear in the background; El Partido stream, crossed by the Cañada Real pathway, can be distinguished in the foreground. (2006); b) on the right side, a plan view of the Ford–Ajolí Bridge section from north to south (top to bottom) in an aerial photograph of 2008, with the Cañada Real pathway at the picture center (green dots highlighting topographical operations carried out in 2009). The stream branches out downstream the bridge; the non-operating channel appears on the right side and the new channel (operating since the winter 1997–98) on the left side.

In this section, the new alluvial fan apex of El Partido is located. Before the channelization, the Caño Ajolí flowed through the same section; the referred area was still a part of the marsh. The Ajolí Bridge is placed at this section, with the deck 2 m far from the streambed when constructed. After the channelization, the sandy sediments load produced the streambed aggradation, becoming nearer to the deck of the bridge, which was blown away several times by water and sand flows. Due to socio-cultural reasons this bridge has been rebuilt as many times as needed, but in 2000 a ford was built upstream next to the bridge ensuring the smooth flow of the traffic and protecting the existing bridge. This paper refers to this area as Ford–Ajolí Bridge section.

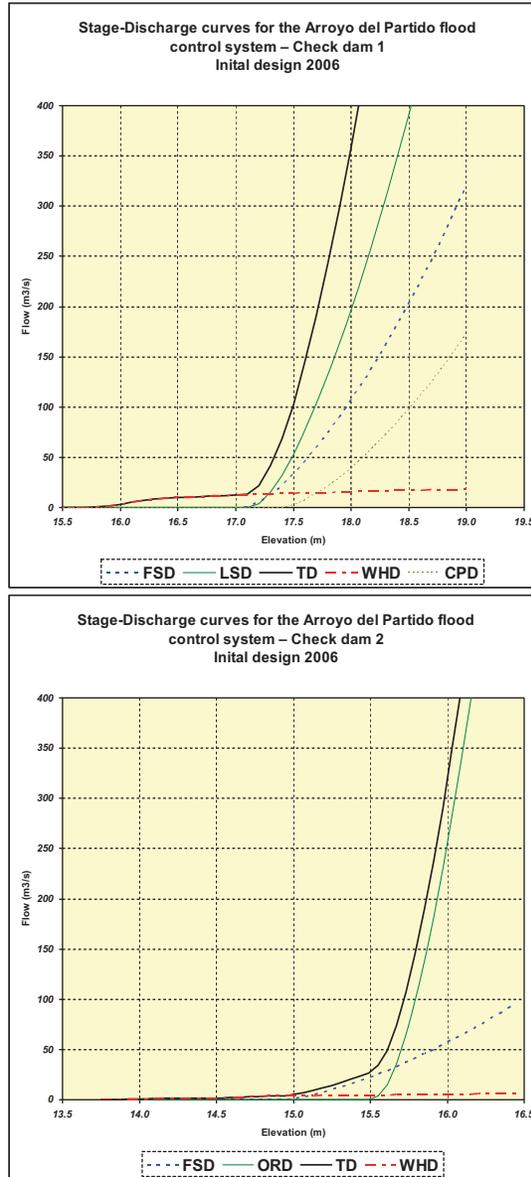
Figure 7: Top: Flow allocation ($\text{m}^3 \cdot \text{s}^{-1}$) at the CD1 among the different discharge sections with the initial design (2006). Bottom: The same allocation for the CD2. Frontal spillway discharge (FSD), lateral spillway discharge (LSD), total discharge (TD), weep holes discharge (WHD), Cañada del Pinar discharge (CPD), over road connecting El Rocío and Villamanrique discharge (ORD).

Stage discharge curves were estimated at the CD1 and CD2, which determine the operation system of the FCS, and the flow allocation through the different spill elements, as originally designed in the project and as executed in the summer of 2006 (Fig. 7). Stage discharge

curves were established using the broad-crested weir and orifice equations, as typically used for hydraulic engineering works.

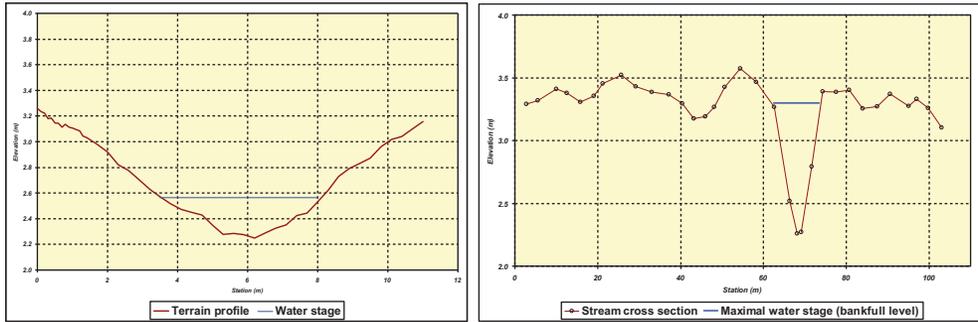
Figure 8: Left: Arroyo del Partido cross-section, on the last reach prior to the marsh inflow, gauged on 17 October 2008. Right: The same cross-section assuming a $4 \text{ m}^3\cdot\text{s}^{-1}$ flow (bankfull level).

As a first approach, it was estimated that this flow corresponded to the bank-full stage of the channel, i.e. the evacuation capacity related to the dominant channel forming flow, linked with its compensation slope [12]. The last flow rate determined by means of direct field survey was $0.0016 \text{ m}\cdot\text{m}^{-1}$. Accordingly, it was considered that for flow rates under $4 \text{ m}^3\cdot\text{s}^{-1}$, the sediment supply to the marsh remains beneath a moderated limit, since the flood remains into the drainage channel, and the sediment transport is essentially restricted to wash load. Above this value, the best option is to allow the flood expansion across both overbanks. For this purpose it is necessary to ensure enough space, moving away any protective embankment or levee to the outer limits of the predictable flood expansion. In this way, the shear stress is insufficient to erode the banks and sweep away sediments into the marsh.

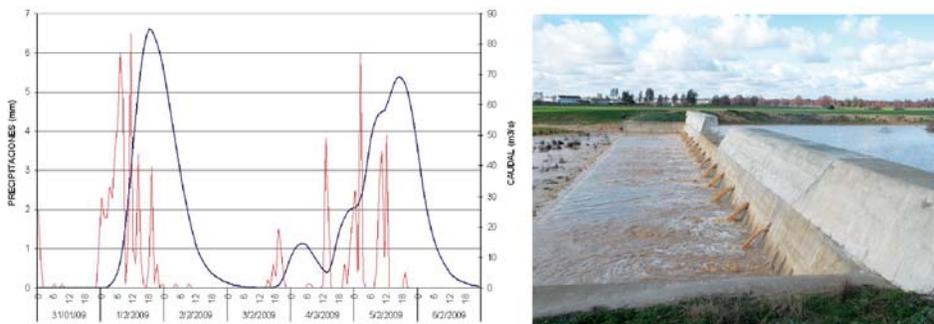
Figure 9: Left: Rain rate at the Bollullos meteorological station (placed approximately at the center of the Arroyo del Partido watershed) between 31 January and 5 February 2009 (red line). Peak flow estimated at the CD1 upstream face on 1 and 5 February 2009 (blue line). Right: Photograph of the CD1 at 13:00 h on 2 February 2009, after the flood of the previous evening.

After the corrections were undertaken in the CD1 design, two major flood events occurred in El Partido stream: one on 1 February 2009 and the second on 5 February 2009 (Fig. 9, left plot).

The applied adjustments had an unexpected result. The flow pressure dragged the gravel blocking the weep holes through them, becoming last operative again, as shown in the photograph in Fig. 9, corresponding to 13:00 h (local time) on 2 February 2009. At that time, the flow hydrograph pointed out a flow rate of 15 m³·s⁻¹, which corresponded to a FCS flood flow passing through the CD1 weep holes, when fully operational (Table 1), as shown in the photograph in Fig. 9.

the flood hydrograph was $65 \text{ m}^3 \cdot \text{s}^{-1}$ (Fig. 9, left image). In this case, $20 \text{ m}^3 \cdot \text{s}^{-1}$ are discharged downstream directly to El Partido channel ($15 \text{ m}^3 \cdot \text{s}^{-1}$ through the weep holes and $5 \text{ m}^3 \cdot \text{s}^{-1}$ through the frontal spillway) and the remaining $45 \text{ m}^3 \cdot \text{s}^{-1}$ are diverged toward the flood–lamination–sedimentation plain through the lateral spillway, to flow downstream the plain as shown in the right photograph in Fig. 10.

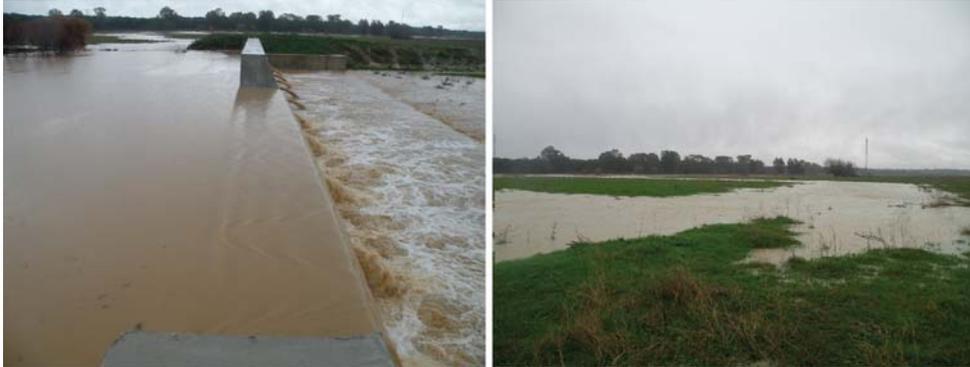
Figure 10: Flood in the Arroyo del Partido stream at 13:10 h local time on 5 February 2009. Left: Flow distribution at the CD1. Right: The flood flows downstream over the flood–lamination–sedimentation plain.

Regarding the flood on 5 February 2009, the photograph on the left side in Fig. 10 shows the discharge through the CD1 at 13:10 h (local time). At that time, the estimated flow rate in

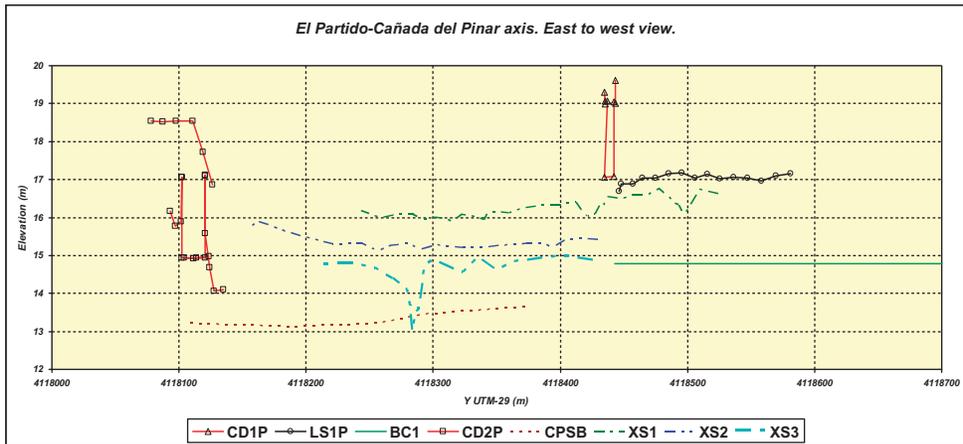
Figure 11: Elevation view (from east to west) of elements composing the FCS, and flood response on 1 and 5 February 2009. From left to right: CD2 profile (CD2P); Cañada del Pinar streambed profile (CPSB); cross-sections defined by floods in the flood–lamination–sedimentation area, surveyed on 6 June 2009 (XS1, XS2, XS3); CD1 profile (CD1P); CD1 lateral spillway profile (LS1P); CD1 backwater curve (BC1).

The evaluation of the effects of these two flood events on the flood–lamination–sedimentation plain surface was more accurate. In addition to the photographs of the flood discharge (e.g. Fig. 10, right image), a topographical survey was carried out on 6 June 2009 to detail the geometry of several terrain profiles, because of their lower levels. Figure 11 shows three of these profiles, along with an outline of the FCS.

This survey verified that the flood flow was adapted to the micro-topography of the plain, defined by ancient flood drainage channels. Surveying operations were limited to the northern

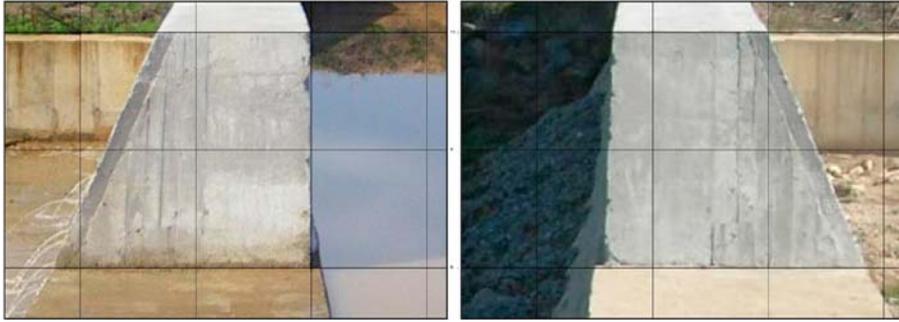
Figure 12: Photographs showing the inner walls of the frontal spillway of CD1, viewed from the left bank to the right bank (left) and seen from the right bank to left bank (right). Two squares fitted from the spill threshold to the crest can be seen. Each square side is 1 m long and over them is measured the water stage immediately upstream of the frontal spillway threshold.

From 20 December 2009 to 4 February 2010 six major flood events took place in El Partido stream that are summarized in Table 2. Before the first flood occurred all the weep holes in CD1 and CD2 were clogged up with concrete, except for the bottom drains. In this way, situations such as that occurred on 1 February 2009 were prevented. To estimate the flood hydrographs the same hydrological model previously exposed was adopted. However, for these events there were available accurate but non-continuous instant gauging data, which allowed for a first calibration of the model. Thereby the physical meaning of the results was improved. Table 3 shows the flow distribution through the different discharge elements at the CD1 during the period under review, obtained by the gauging of the water stages. These values were obtained in two different ways: a) by direct measurement of the water stage immediately upstream of the frontal spillway threshold of the CD1 (Direct) and b) measuring the same parameter calibrating sequential photographs (Photo) as shown in Fig. 12

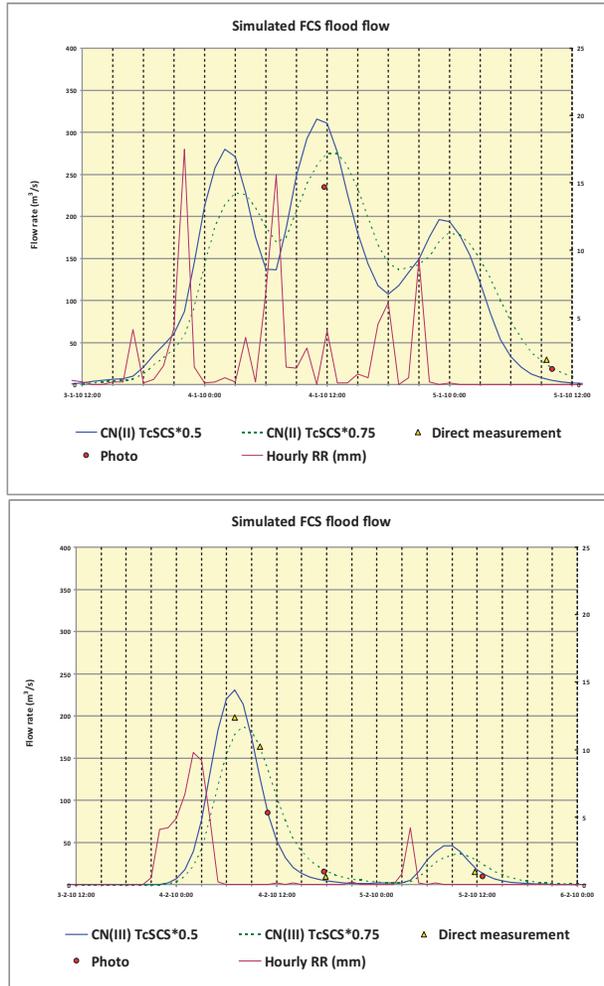
Figure 13: Rainfall rate (mm) measured in Bollullós station (maroon). Top: Flow rate ($\text{m}^3 \text{s}^{-1}$) simulated by flood on 4 January 2010 with CN in condition II and $0.50 t_c$ (blue continue) or $0.75 t_c$ (green in dots). Bottom: Flow rate ($\text{m}^3 \text{s}^{-1}$) simulated by flood on 4 February 2010 with CN in condition III and $0.50 t_c$ (blue continue) or $0.75 t_c$ (green in dots). Flow rate estimated by direct measurement (yellow triangles) and by calibrated photographs (red dots).

We explain below the operations for HMS calibration for two flood events on 4 January 2010 and 4 February 2010. We present here only these two events (from the six analyzed), since they were the ones having a greater available dataset for calibration (Table 3). Figure 13 shows

(in maroon) the rain rates recorded in Bollullos station and two simulations run with HEC-HMS model of the FCS flood flow (blue and green). The first simulation (blue) was performed using a reduction factor of 0.5 for the time of concentration t_c (obtained with the USDA-SCS eqn (1)), while for the second simulation (green) a reduction factor of 0.75 was applied (simulations were performed under a set of different conditions, but were discarded because of a poor performance in calibration process, having no specific approach to available gauging data).

Figure 13 shows, along with the simulated flow rates, the measured instant flow rates (the measurements made on calibrated photographs with red dots and the *in situ* direct measurements with yellow triangles). In this way the CN and t_c were calibrated. The simulated peak flows displayed in Table 2 can credibly explain the effects caused by water and sediments flows at the different reaches of El Partido stream. Figure 14 displays photographically the behavior and the effects linked with the flood event on 4 January 2010 passing through the lateral spillway of the CD1 and the flood–lamination–sedimentation area. Figure 15 shows the situation at the CD1 as well, on 5 February 2010 after the flood event of the previous day.

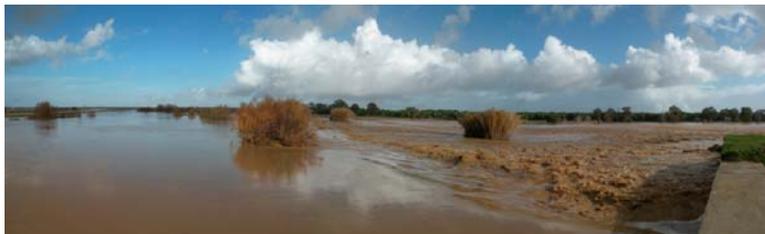
Figure 14: Discharge of the flood flow at 12:47 h (local time) on 4 January 2010 through the lateral spillway of CD1.

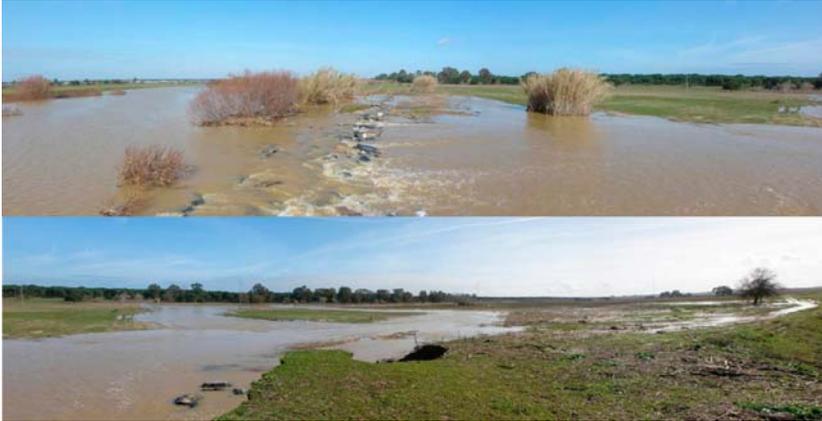
Figure 15: Upper image: Flood discharge at 13:41 h (local time) on 5 February 2010 (the day after the flood event) through the lateral spillway of CD1. Lower image: Effect of the flooding in the flood–lamination–sedimentation plain at 12:49 h (local time) on 5 February 2010.

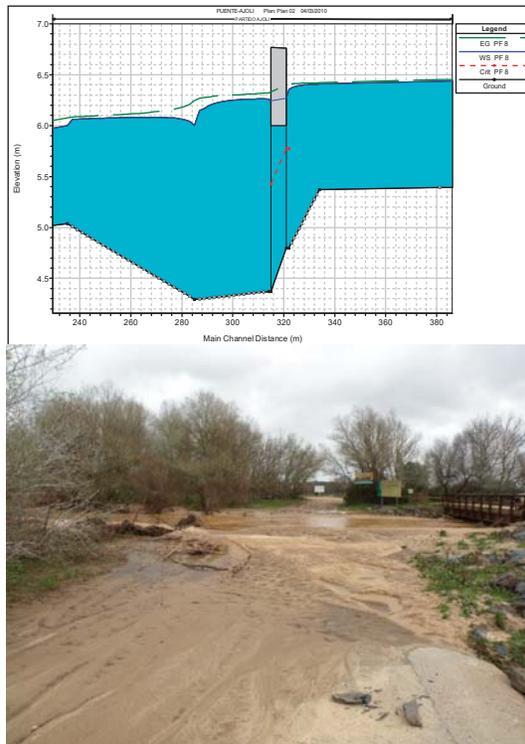
Figure 16: Upper image: Profile section plot output, resulted from HEC-RAS simulation, showing the streamflow through the reach between the Ford and the Ajolí Bridge sections for a flow rate of $20 \text{ m}^3 \text{ s}^{-1}$, from which a part of the streamflow is diverted to the Cañada Real, following the local slope gradient. Lower image: View of the Ajolí Ford, in the center of the image, on 22 February 2010, on the right side the Ajolí Bridge; in the foreground the spot from where a part of flood flow is diverted to the Cañada Real.

The flow distribution between El Partido channel and the Cañada Real at the Ford–Ajolí Bridge section was found in five of the six studied flood events. In these five cases the FCS flood flow exceeded $150 \text{ m}^3 \cdot \text{s}^{-1}$, which implies a flow rate exceeding $20 \text{ m}^3 \cdot \text{s}^{-1}$ running through El Partido channel downstream the CD1. Figure 16 shows the water stage, in a

profile section plot, resulted from simulation with HEC-RAS model at the Ford–Ajolí Bridge section and a photograph of the section where the flood coming from El Partido is diverged to the Cañada Real road when the flow rate exceeds $20 \text{ m}^3 \cdot \text{s}^{-1}$.

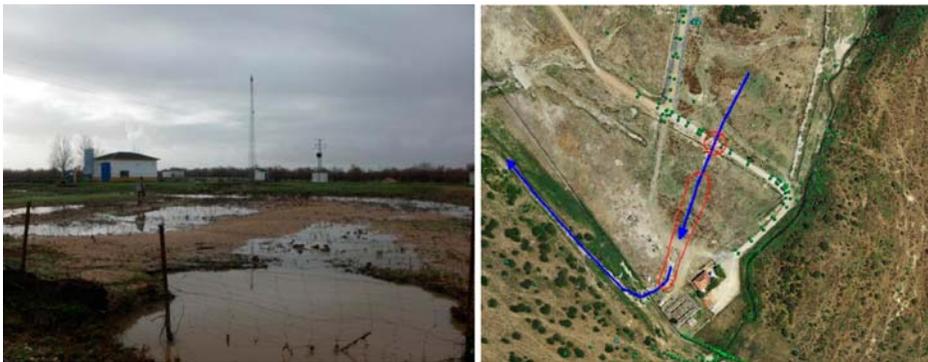
Figure 17: Left: New drain formed near the pumping station of El Rocío on 5 February 2010. Right: An aerial photograph taken in 2008 showing the routing (blue arrows) of the new drain formed on 5 February 2010.

- d. The flood lasted over a month, but with varying degrees of intensity. The stored water was being concentrated at the lower elevation areas, according to the micro-topography of the study site producing a new drainage channel for this area. Figure 17 shows, in left image, a new drain formed on the plain at the eastern side of the protective embankment of El Rocío village, viewed from north to south, from the road connecting the pumping station of El Rocío; and in the right image the erosive effects caused by the new drain (solid red line) on an aerial photograph taken in 2008. The blue arrow points out the routing of the water toward the marsh. In this image, the road leading to the pumping station of El Rocío can be seen (with green dots).

- e. The advance of this new drainage of the flooded area was stopped by the road (which also acted as a small levee) connecting the pumping station of El Rocío (Fig. 17). A cause of warning is the fact that if this drainage is able to trigger retrogressive erosion processes linking this area with the current channel of El Partido, the stream channel (which is the axis of the sedimentation fan) would direct the main flow westward to the plain aside El Rocío and the new drainage. This fact may cause the activation of the alluvial fan, producing a new problem because the entire flow volume would be directed to the urbanized area of El Rocío, raising the flood level and creating difficulties for the drainage of this area close to the village. To avoid this problem, we recommended maintaining a sufficient and uniform elevation for the main levees that are arranged in the area (the levee that protects the main area of El Rocío, the extension of this levee toward the marsh, and the levee-road that joints the latter with the pumping station of El Rocío), though without creating further obstacles to the flood movement, because the more the water spreads out, the less it is able to transport the streambed sands.

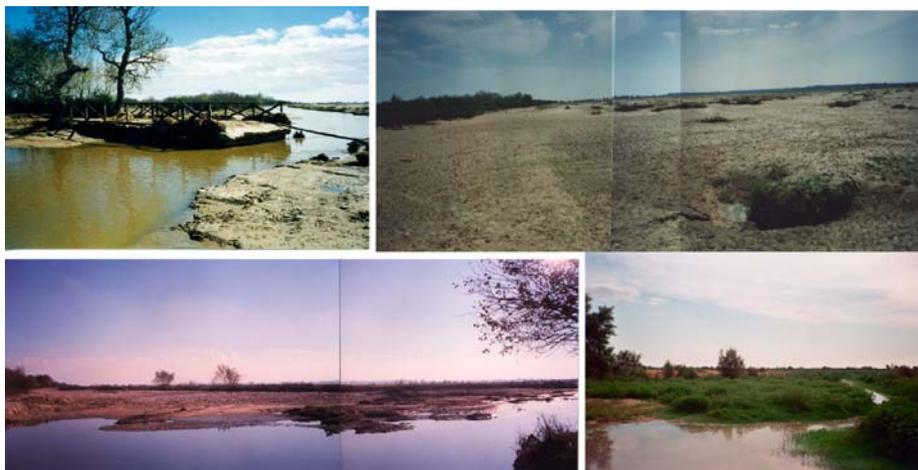
Figure 18: Evolution stages of the channel of El Partido stream and the new alluvial fan immediately downstream the Ajolí Bridge, between 1996 and 2008. Upper images: left: 29 January 1996; right: completely silted on 21 March 1997. Lower images: left: November 2002; right: July 2008.

We conclude this section with four images of El Partido stream downstream the Ajolí Bridge. Figure 18 shows four sequential stages in the evolution of the El Partido stream and the new alluvial fan formed at area, between 1996 and 2008. Upper images on the left show the former channel of El Partido stream after several flood events during the previous days (29 January 1996). The upper images on the right show the channel of El Partido stream completely silted after several major flood events during the previous months (21 March 1997). The lower images on the left show El Partido channel downstream the Ajolí Bridge in November 2002; this image is divided in two parts: on the left is the former channel and on the right is the current operating channel. The lower image on the right shows the evolution of a caño-type morphology of the new operating channel of the El Partido stream in July 2008.

- a. The first one, taken on 29 January 1996, shows the Ajolí Bridge after several major flood events, which dragged and deposited a great amount of sand to this place, and thus raising the streambed elevation and causing the fall of the bridge. In the image El Partido stream still flows through its primitive channel.

- b. The second one, taken on 21 March 1997, shows the former streambed which completely disappeared by aggradation, after the major flood events occurred in the previous months. From this date the stream opened its new channel downstream the Ajolí Bridge section, following the local slope, which conditioned the westward direction (toward El Rocío village).
