DYNAMIC CHARACTERISTICS OF A BRIDGE ESTIMATED WITH NEW BOLT-TYPE SENSOR, AMBIENT VIBRATION MEASUREMENTS AND FINITE ELEMENT ANALYSIS

C. CUADRA¹, N. SHIMO¹ & M. SAIJO²

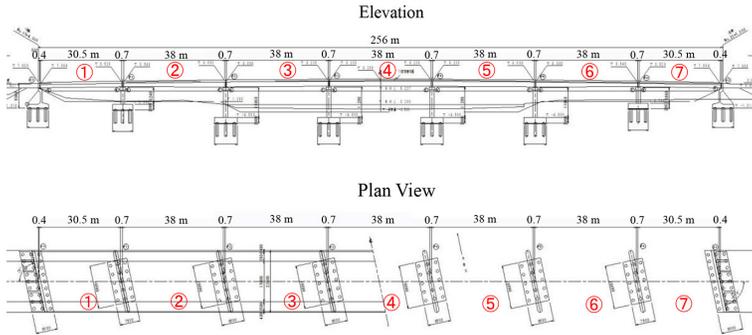
Figure 1: Elevation and plan view schemes of Asuka Ohashi bridge.

The bridge is 256-m length and connects the south and north-east part of Akita prefecture as a part of the route 105. It must be noted that the routes of Japan are numbered according to their year of construction, where lower numbers correspond to oldest routes. Elevation scheme and plan view can be appreciated in Fig. 1. Spans are labeled with encircled numbers from ① to ⑦. A general photograph is shown in Fig. 2. The deck is 22.8-m wide and consisted of cast in place reinforced concrete slab supported by longitudinal steel girders. The structure consists of seven spans where spans at both ends have 30.5 m of nominal length and other central spans have 38-m nominal length. Spans are connected by expansion joints and span can be considered as single-supported structure. Details of girders and a view of road carpet are shown in Fig. 3.

Two series of ambient vibration measurements were carried out, using seven simultaneous recording data loggers with three channels per data logger. That is, 21 channels were measured in total. Sensors were located on the pedestrian deck and distributed as is shown by encircled numbers in Figs 1 and 2. Three components of vibration were measured at each point of observation. All sensors were located on the central portion of each span. Six hundred seconds were measured using a sampling ratio of 100 Hz to provide good wave-form definition. Figure 4 shows some details of the equipment for micro vibration measurements. First, all equipment is calibrated and chronometers are synchronized using GPS information obtained from satellites. Sensors for two horizontal directions and for vertical direction are set up at each selected point of measurement. Sensor in horizontal directions corresponds to longitudinal and transversal directions of the bridge. Sensor in vertical direction permits to obtain the larger vertical vibration of each span of the bridge. Measurements were performed in a morning with normal traffic condition and therefore vehicles passing the bridge excite the vertical vibration of the bridge. Data loggers were set up to start measurements simultaneously, and data were stored in memory cards for its posterior analysis. Data logger is

As was mentioned previously, the largest response of the vibration was observed for the vertical component. It was detected that each span has its own predominant frequency. Spans for points ①–⑥, which are presented in Fig. 1, are of the same length; however, dimensions of steel beams and support condition are different. Spans for points ① and ②, which are spans near abutments, have same length; however, this length is shorter than the length for other spans. Therefore, to observe the difference between different types of span, responses at points ①–④ were chosen and their correspondent Fourier spectrum is shown in Fig. 5. The

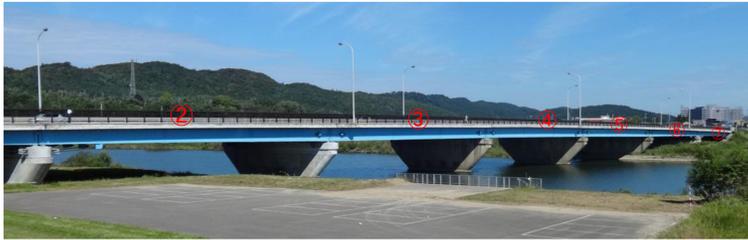
Figure 2: General photograph of Asuka Ohashi bridge.

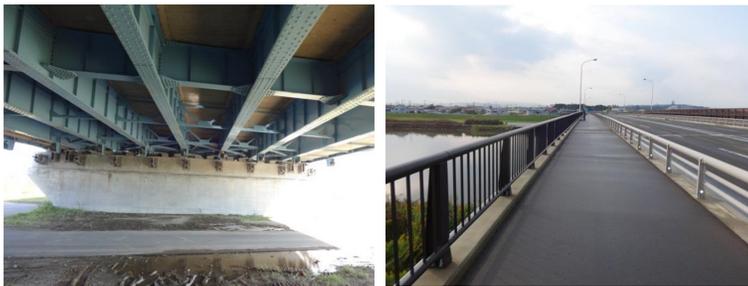
Figure 3: Details of girders and view of bridge deck.

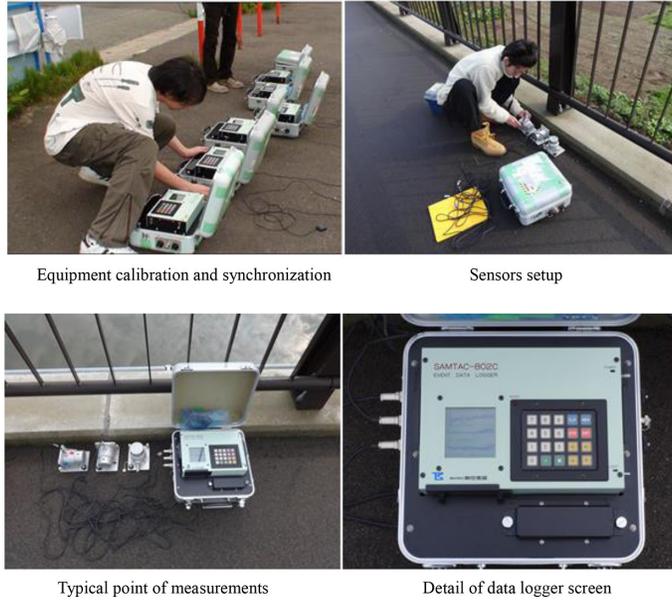
Figure 4: Details of measurements and equipment.

SAMTAC-802C made by Tokyo Sokushin Co. Ltd, and sensors were magnetic-coil type with a range of measurement from 0.2 to 50 Hz.

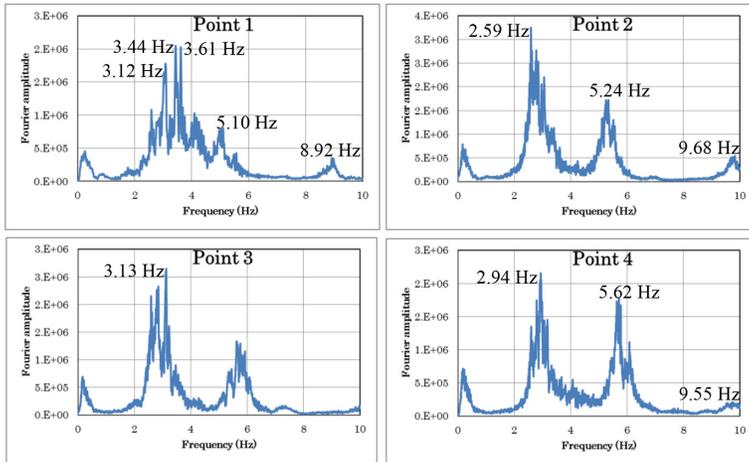
Figure 5: Fourier spectrum responses for different spans of the target bridge.

Responses show that natural frequency for span ② presents the lowest value of frequency at 2.59 Hz, since beams have variable depth to permit a smooth transition between span ① (smaller depth) and span ③ (larger depth), resulting in lower vertical stiffness and therefore lower frequency. It was expected that Spans ① and ④ could have the same predominant frequency; however, different frequencies were obtained probably due to different support conditions. Span ① has shorter length and it is reasonable that its predominant frequency is

different and three peaks are observed in this case (3.12, 3.44 and 3.61 Hz). However, 3.44 Hz can be considered as predominant frequency. Span ① was selected for measurements using new piezoelectric bolt sensor. This span presents also peaks at 5.10 and 8.92 Hz, and in the next section detailed analysis is presented to explain and verify the characteristics of vibration of this span and vibration of whole bridge.

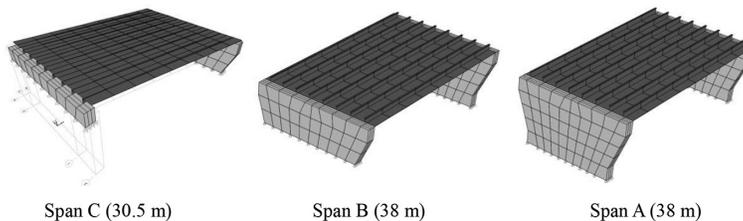
Figure 7: Modeling of typical spans for the target bridge.

A three-dimensional finite element model of the bridge was created using the commercially available SAP2000 computer program. Figure 6 shows the general model of the target bridge indicating types of spans in relation with points of ambient vibration measurements. Span C is the shortest span with 30.5 m of length, while spans B and A have 38 m of length. Span A has large girder depth of 1400 mm in average. Span C has girder depth of 1100 mm in average. Span B has girders of variable depth since they are transition from span C of 1100 mm of girder depth to span A of 1400 mm of girder depth. The bridge consists of seven spans; however, only representative typical spans (A, B, C) were modeled since each span is separated by an expansion joint and therefore each span can be analyzed as single supported bridge. Then the three types of span models that were considered for analysis of vibration characteristics of the target bridge are shown in Fig. 7.

For each span, supports were modeled using solid elements, and girders of variable cross-section were considered according to bridge design draws. Concrete slab that includes the asphalt carpet were considered for the deck and basically contributes to the mass of structure. It is considered that changes in vertical vibration properties are influenced mainly by stiffness from girders and with a small contribution of the concrete slab.

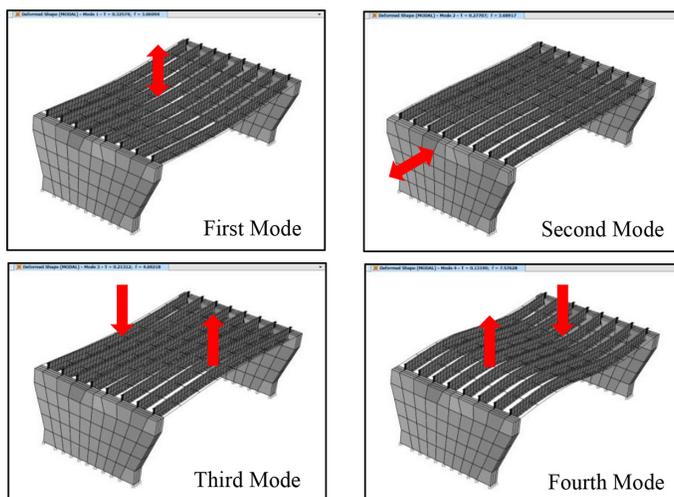
Figure 8: Modes of vibration for span A.

Modes of vibration for span A are shown in Fig. 8. The first mode of vibration corresponds to the simplest vertical vibration with a predominant frequency of 3.07 Hz. The second mode corresponds to lateral vibration of supports in this case in the longitudinal direction of the bridge, with 3.61 Hz of predominant frequency. The third mode is transversal vertical vibration with 5.39 Hz as the predominant frequency. The fourth mode

corresponds to the second longitudinal mode of vibration with 7.58 Hz as the predominant frequency. From measurements at point ④, vertical modes (first, third and fourth modes of analysis) were detected as peaks at 2.94, 5.62 and 9.55 Hz, respectively. For span B, similar modes were obtained with frequencies of 2.89, 3.57, 4.59 and 6.86, Hz respectively.

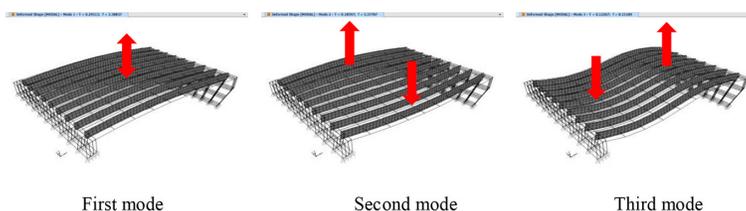
Figure 9: Modes of vibration for span C.

Modes of vibration for the shortest span C are shown in Fig. 9. The first mode of vibration corresponds to the simplest vertical vibration with a predominant frequency of 3.39 Hz. The second mode is transversal vertical vibration with 5.39 Hz as the predominant frequency. The third mode corresponds to the second longitudinal mode of vibration with 8.15 Hz as the predominant frequency. These modes of vibration were also detected during measurements at point ① as peak at 3.44, 5.10 and 8.92 Hz, respectively.

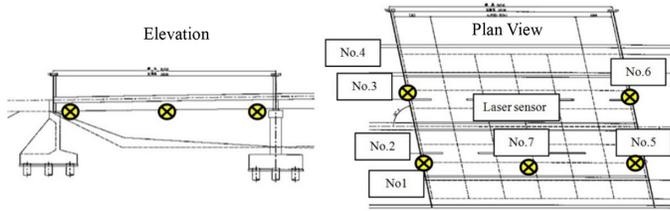
Figure 10: General setup of points of measurements.

Piezoelectric bolt sensor was set up at span C near left abutment of the bridge. This span corresponds to point ① for ambient vibration measurements. For a detailed measurement of span C using piezoelectric sensor, seven points were selected as shown in Fig. 10. For comparison, accelerometers were also set up at same points of measurements. In addition, at middle of span a laser displacement transducer was set up near point 7.

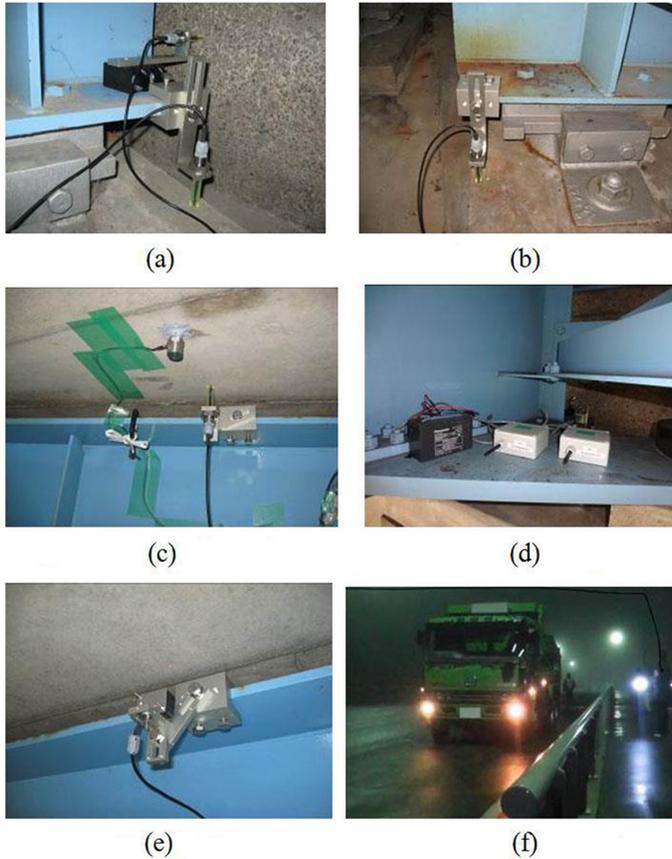
Figure 11: Details of sensor setup and measurements. (a) Sensor nos 1, 3, and 2, 4, (b) sensor nos 5 and 6, (c) sensor no. 7 and accelerometer, (d) radio unit, (e) laser sensor, and (f) the 19 t heavy duty truck.

Figure 11 shows some details of sensors setup. Basically, relative displacements between girders and support structure were measured at each point. For this purpose, sensors were fixed firmly to girder flange with its end in contact with support surface. Sensors 1–6 were setup in this way as can be observed in Figs 11a and b. Figure 11c shows the details of accelerometer and sensor setup at point 7, which is the centre of span. Figure 11d shows the wireless transmission unit (radio unit) and corresponding battery. This unit receives signal from sensor and sent it to the computer for data acquisition. Figure 11e shows the setup of laser displacement transducer. Also, vibration due to moving loads was measured and in Fig. 11f, the truck of 19 t that was used for this test is shown.

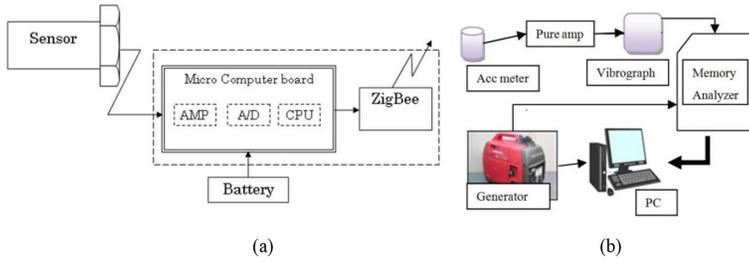
Figure 12: Scheme of measurement systems. (a) Proposed system and (b) former systems.

Basic scheme of measurement systems are shown in Fig. 12. Fig. 12a shows the proposed system where signals from piezoelectric bolt sensors are transmitted to computer by means of a wireless module, which contains a microcomputer board. As can be observed, the proposed system is simple and it is easy to install in situ. Former measurement systems require more equipment such as energy generator, signal amplifiers, etc., as can be observed in Fig. 12b for the case of measurements using accelerometers.

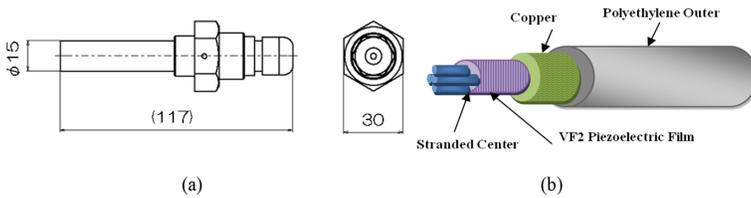
Figure 13: Proposed piezoelectric bolt sensor. (a) Bolt sensor and (b) details of piezoelectric cable.

The piezoelectric bolt sensor is shown in Fig. 13a. Basically, it consists of a piezoelectric cable located in its inner core and external cover of urethane resin resulting in a nominal diameter of 15 mm. The structure of piezoelectric cable is shown in Fig. 13b. The piezoelec-

tric film that acts as electric condenser emits voltage when the cable is subjected to an external action that produces deformation on the cable, especially in the case of dynamic action or vibration.

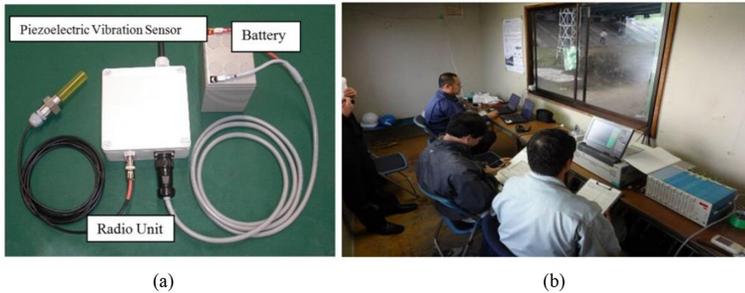
Figure 14: Sensor signal transmission and general layout of control room. (a) Sensor unit and (b) control room.

As is shown in Fig. 14a, the sensor is connected to a radio unit, which sends a wireless signal to a controller connected to a computer. The sensor itself does not need input energy to emit its response; however, radio unit requires a source of energy. Signals from sensor can

be monitored from a control room as shown in Fig. 14b. In this research, a prefabricated portable room was installed near target bridge to perform measurements.

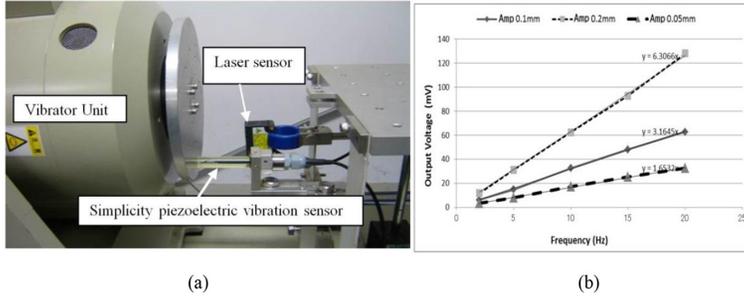
Figure 15: Vibration test using piezoelectric bolt sensors. (a) Vibration test setup and (b) frequency and output voltage relationship.

Figure 15a shows the general layout of a vibration test of bolt sensor using a small vibration machine that were carried out to verify sensor response to dynamic actions. These tests were performed at fixed amplitudes and therefore it is supposed that the sensors behave under a fixed harmonic force. For comparison, displacement of the vibration machine was measured by means of a laser displacement transducer. Vibration test was performed for 0.05, 0.1 and 0.2 mm of amplitude, respectively. For each amplitude value, the frequency was set up from 2 to 20 Hz. The curves that relate the frequency, amplitude and the maximum output voltage of the sensor are shown in Fig. 15b.

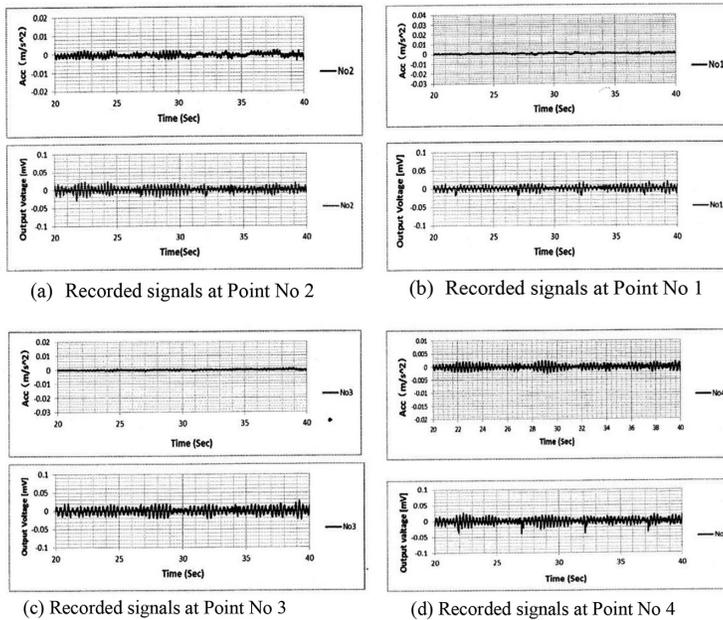
Figure 16: Measurement signals from accelerometers and from bolt sensors. Recorded signals at point nos. (a) 2, (b) 1, (c) 3 and (d) 4.

As illustrative examples of measurement results, responses at measurement points 1–4 are shown in Fig. 16. Upperwave that is shown for each point corresponds to acceleration obtained by means of accelerometers (m/s^2). Bottom wave for each point represents the voltage output from the piezoelectric bolt sensors (mV).

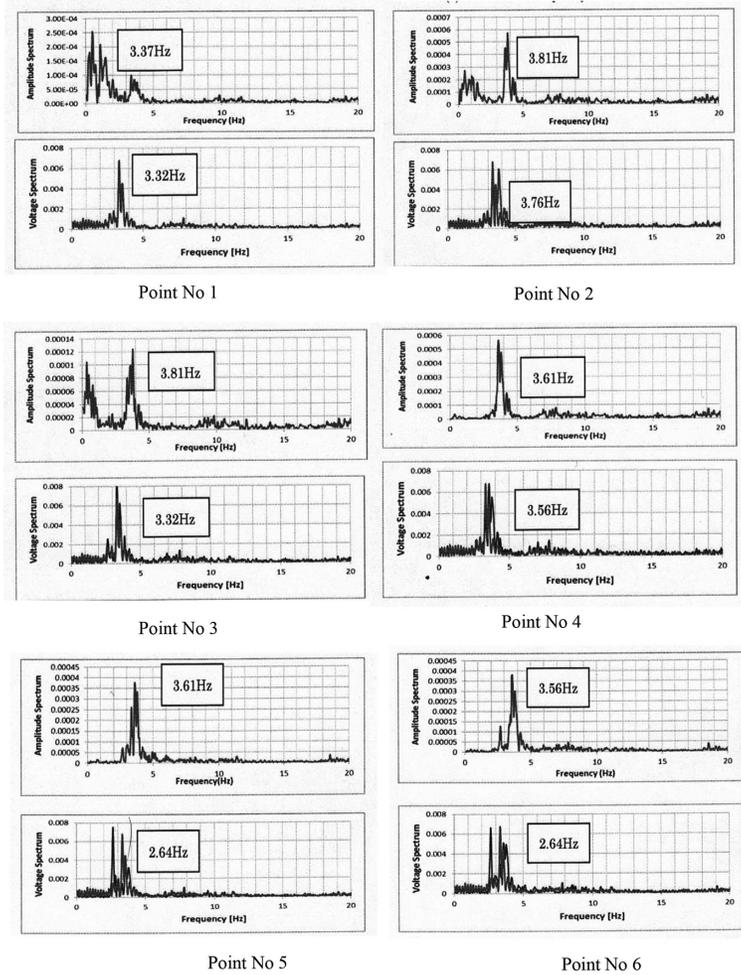
Figure 17: Predominant frequencies from Fourier analysis.

From recorded signals, predominant frequencies were obtained by Fourier analysis. In Fig. 17, Fourier spectrum for signals from point nos. 1 to 6 is shown. Upper part of each figure corresponds to accelerometer results and bottom part corresponds to proposed sen-

sor results. Results for point nos. 1, 2 and 4 show good agreement between accelerometer results and proposed sensor results. The difference of results at point nos. 5 and 6 is believed due to that proposed sensors and accelerometers are not set up at same location. However, in the Fourier spectrum for proposed sensor a second peak near 3.6 Hz is observed, which is comparable with the predominant frequencies obtained from accelerometers.

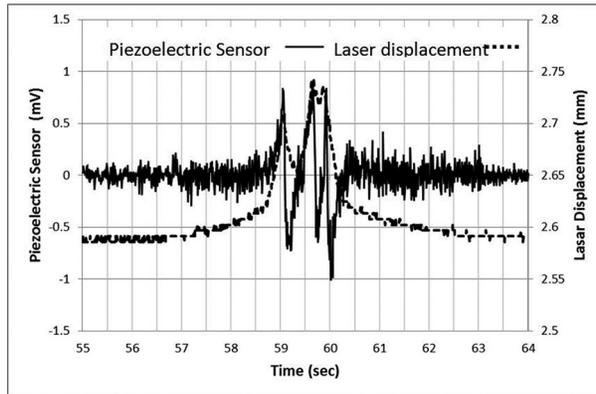
Figure 18: Comparison of sensor response and laser transducer response.

Figure 18 shows a comparison of proposed sensor response and laser displacement transducer response when the truck of 19 t runs on a target span at a velocity of 20 km/h. Although this measurement corresponds to relative displacement between girder and slab and therefore only small displacement can be detected, external action (in this case, load from truck) was clearly captured by both sensors as can be observed in the disturbance at the central part of the figure.
