SAND DRIFT AND GROWTH OF SAND DUNES ON THE JÆREN COAST, SOUTHWESTERN NORWAY

ALF TØRUM¹ & OVE TOBIAS GUDMESTAD²

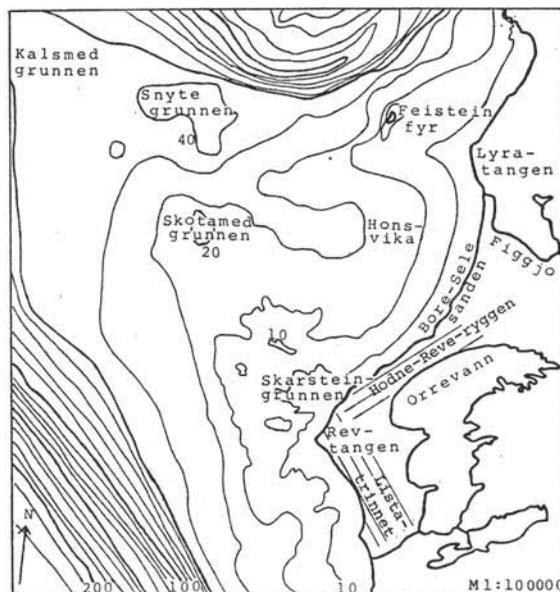
Figure 2: The area at Revtangen – Bore-Sele sanden. The Hodne-Reve ryggen (ridge approximately 7–12 m high) is a drumlin. “Listatrinnet” is the Lista-stage end moraine, which at Revtangen continues northwards into the sea. Note that the bottom slope is mild close to the coast but very steep into the South Norwegian Deep Channel.

The South Norwegian Deep Channel, Fig. 1, that runs along the south coast of Norway is some 300 m deep and has been “carved” out by glaciers. The Lista-stage end moraine running along the coast is an end moraine left by glaciers. Figure 2 shows a more detailed map of the area at Revtangen, while Fig. 3 shows the beaches at Orre, south of Revtangen. The beaches and dunes consist of fine sand, gravel and even in some cases cobbles.

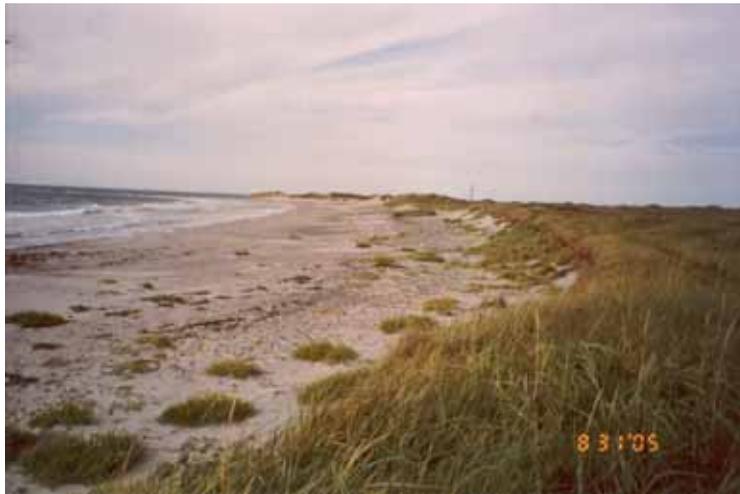
Figure 3: The beach and dunes at Orre, somewhat south of Revtangen in 2005.

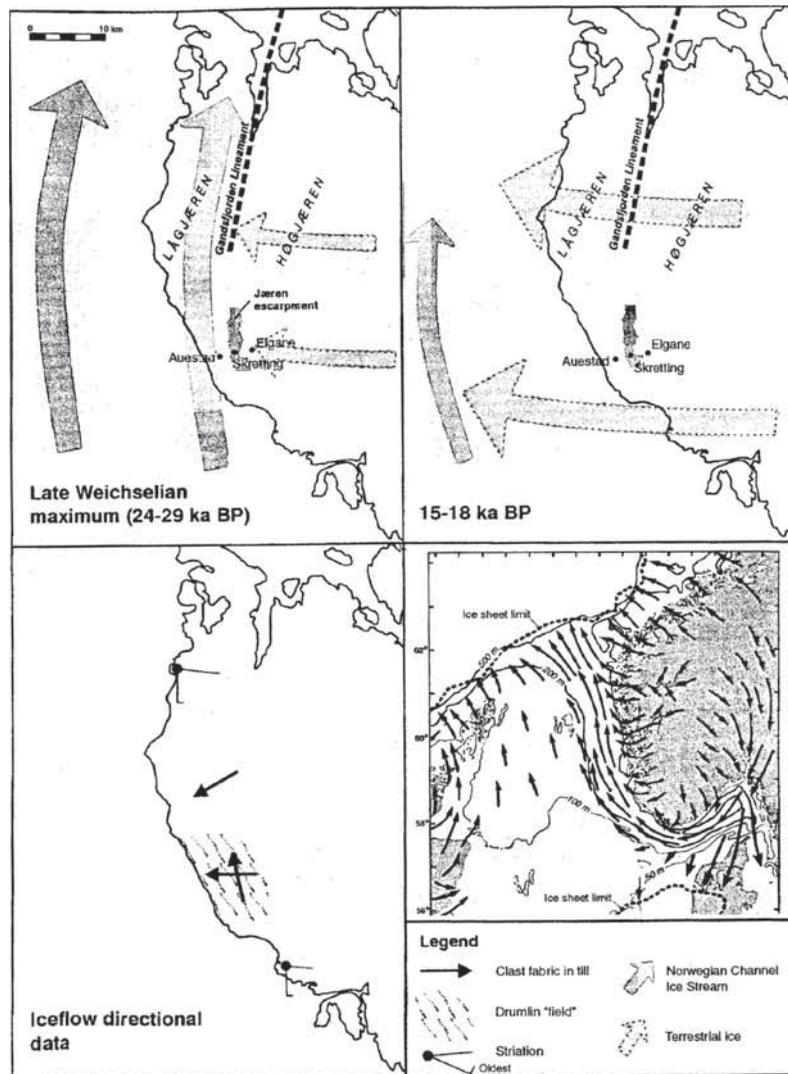
Figure 4: Interaction between the Norwegian Channel Ice Stream across Jæren at the Last Glacial Maximum followed by a glacier advance across the coastline by terrestrial-based ice about 18,000–15,000 years ago as the ice stream calved back into the Norwegian Channel. Some ice flow directional data from areas below the Jæren escarpment are also shown. The small map shows a more regional picture during maximum glaciations, modified from Sejrup *et al.* [26]. From Larsen *et al.* [2].

There are no big rivers entering the sea at Jæren. The sand, gravel and boulders on the sea bottom, on the beaches and on the land have been brought there by glaciers. Figure 4 shows how it is envisaged that the glaciers moved in this area during the last glaciations, for example, in the time period 29,000–15,000 years ago.

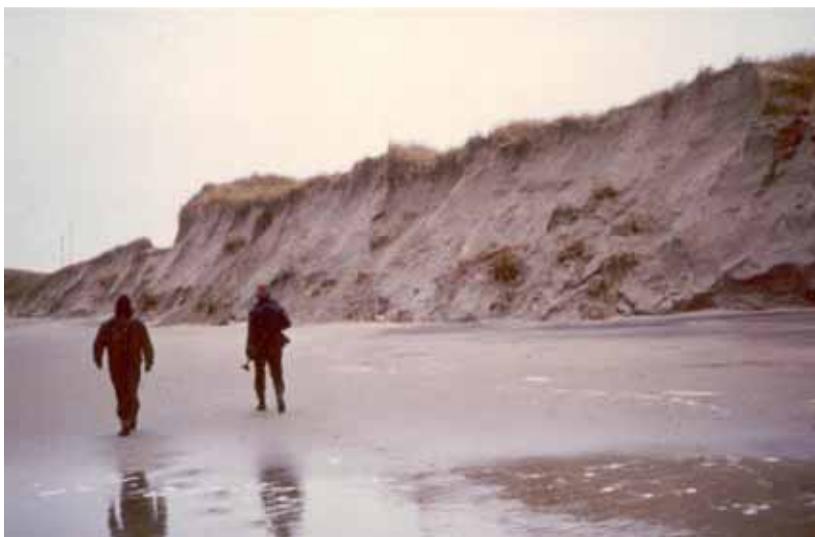
Figure 5: The sand dunes at Bore-Sele, Fig. 2, seen 2 days after a heavy storm in November 1981. In this case there has been considerable erosion of the beach and the dunes. The dune height is estimated to be 6–8 m [27].

The beaches along the Jæren coast are relatively stable; however, there are setbacks during heavy storms, Fig. 5. This setback is apparently temporary as the dunes grow again, as will be discussed later.

Beach erosion has not been of much concern on the Jæren coast, even though the situation after large storms has appeared dramatic, Fig. 5. Following the beach erosion incidents, the dunes have built up again. It is a fact that the sand dunes at Bore-Sele, Reve and Brusanden have been growing during the past 50–100 years. The planting of marram grass has contributed significantly to this fact.

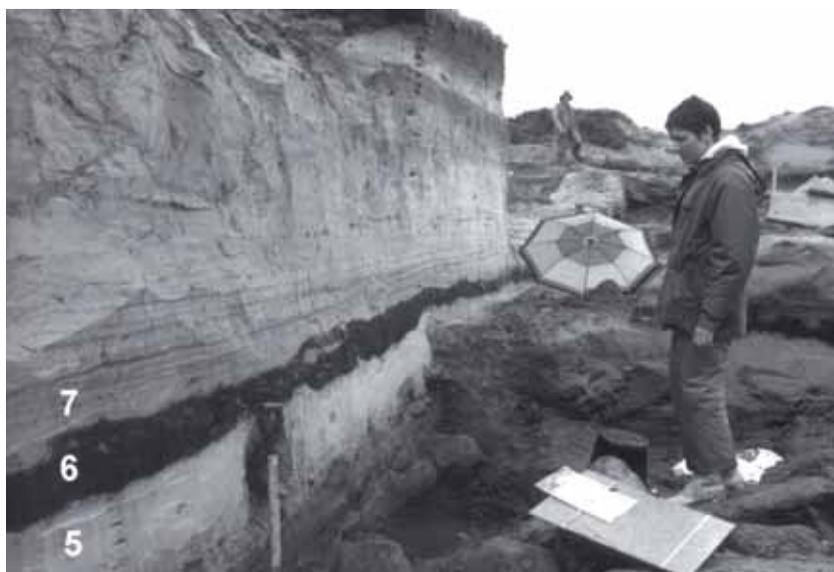
Figure 6: Soil section from the excavations at Sola, Jæren [3].

We will, however, first give an account of the Aeolian sand drift in the Jæren area, a drift that has been a nuisance to the farmers in the area, but which is now brought under control, mainly by planting marram grass (*Ammophila arenaria*). Figure 6 shows a soil section from excavations at Stavanger airport, Sola [3]. The layer marked “6” is a peat layer. The thickness of the peat layer varies, reaching up to 80 cm. The bottom of the peat layer is C^{14} dated to 4540 ± 90 years before present (BP), while the upper part of layer “6” is dated to 2540 ± 80 years BP. Layer “7” is Aeolian sand (wind driven sand). While removing some of the peat layer, “6”, a series of tilled grooves were observed. They penetrated the peat layer and were interpreted as plough marks, reflecting cultivation dating to the time interval 2550–2200 years BP [3]. Pollen analysis from seven places in layer “6” also indicates that the land has been cultivated.

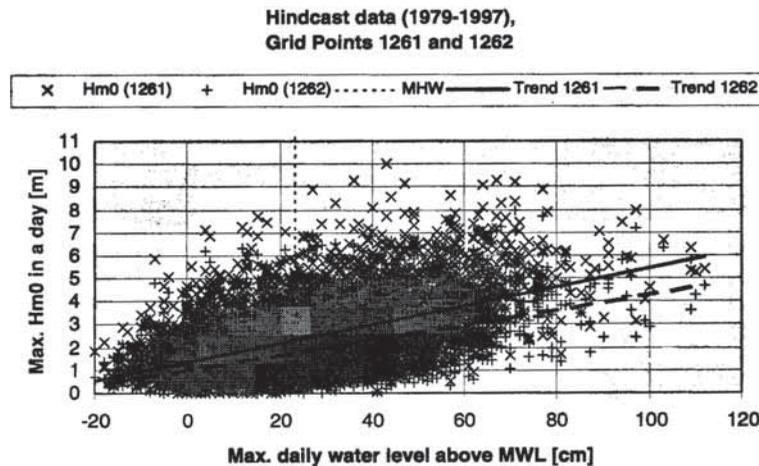
Figure 7: Correlation of water levels in Stavanger and wave heights along the Jæren coast [5].

are the standard grid points for which the Norwegian Meteorological Institute makes forecasts and hindcasts of waves on a routine basis. Figure 7 shows the results of the investigation by Løvås [5]. There is a scatter in the results, but the trend is, as expected, that there are high water levels when there are high waves.

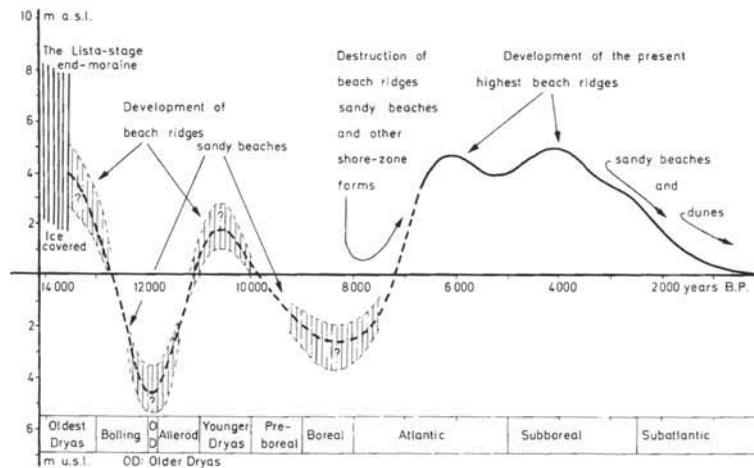
Figure 8: Probable sea-level displacement curve for the Brusand area, Fig. 1, based on geomorphological features from different sources [12].

The Scandinavian Peninsula was covered with an ice sheet of about 3–4000 m thickness during the last ice age. The land was pressed down and the relative water level was much higher than it is today. Prøsch-Danielsen [3] deals with sea levels along the southwestern coast of Norway during the latest 10,000–15,000 years. She shows diagrams for the sea-level variation at several locations. Figure 8 shows a probable sea-level displacement curve for the Brusand area, Fig. 1.

Bird and Klemsdal (1986) also describe what they think is the reason for the growth of the sand dunes at Brusand. They refer to the varying water levels, Fig. 8, confirming that it is reasonable to assume that there is a large transport of sand from the sea to the beach and the dunes.

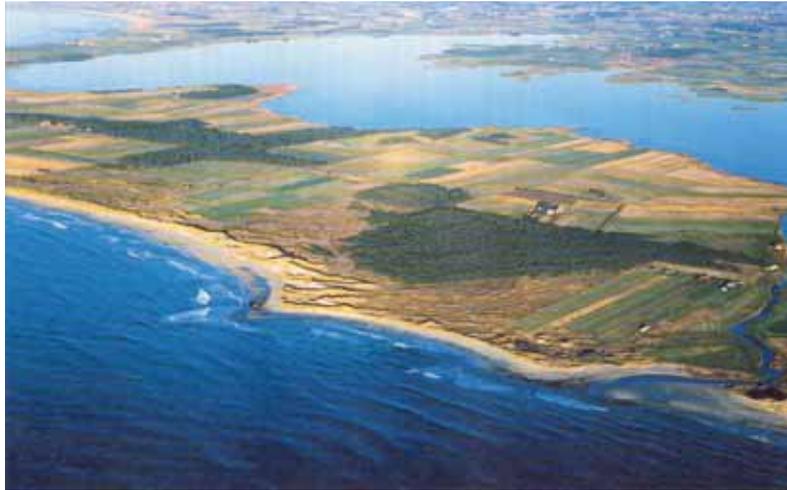
Figure 9: Orre in Klepp commune slightly south of Revtangen. Courtesy Norsk Fly and Flyfoto A/S. Picture taken 1995. (With permission from Fylkesmannen i Rogaland, Rogaland County Governor).

Today the Jæren area is among the best farmland in Norway, Fig. 9. However, in the past the area was much hampered by sand drift during heavy storms. Sand drifts forced the farmers to abandon their farms. A map from 1806 [6] of the same area as that illustrated in Fig. 9 shows that the farms were located among sand ridges/dunes.

Later on, when Arne Garborg visited the Nærland farm in the 1890s, he reported, again in “Letters of Knudahei”, that where there had been sand dunes and sand drifts, there were now fertile farm fields and even fruit and berry gardens. The most important tool in the battle against the sand drifts was the planting of marram grass, organized by Torger Nærland. In addition some pine was also planted. So gradually the sand-ridden land was made fertile, as can be seen in Fig. 9.

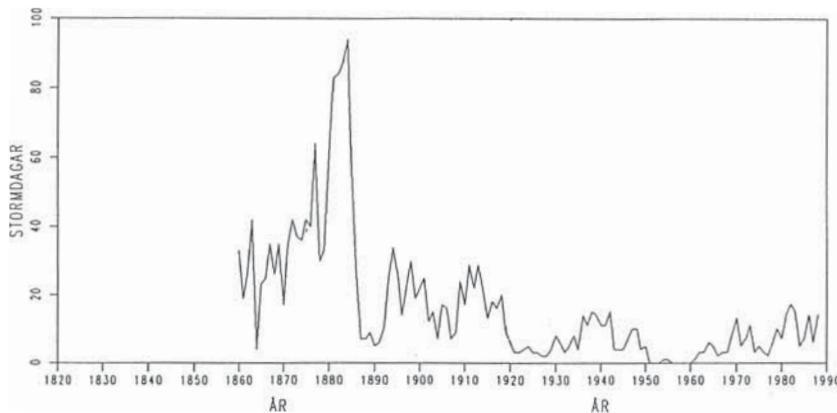
Figure 10: Number of storm days at Utsira lighthouse in the time period 1860–1988 [11].

In a school essay in 1924 about her grandfather Torger Nærland, Klara Gudmestad reports that heavy northern storms occurred in the late 1860s [10]. This is also verified by the information given in Fig. 10, showing the number of storm days at Utsira during the time period 1860–1988 [11]. Utsira is an island some 65 km northwest of the city of Stavanger, Fig. 1. When wind observations started

in the 1860s the wind speed was judged visually. Different scales have been used for measuring wind speed. In 1867 a scale from 1 to 6 was used, with scale 5 indicating a storm. The Beaufort scale was introduced in 1919. This scale, from 1–12, can also be used for visually judged wind velocities. When wind velocity measurements in meters per second are used, “storm” is reported when there is 10-minute mean velocity of 20.8–28.4 m/s. Although the wind observations, which are the background for Fig. 10, are not fully consistent due to the different scales used, the figure supports what Klara Gudmestad [10] wrote: “Towards the end of the 1860s heavy northern storms occurred”.

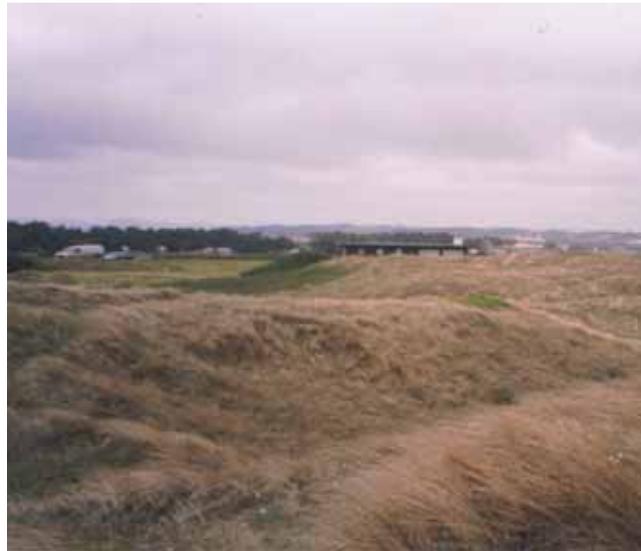
Figure 11: From the Bore-Sele beach in 2006. The photograph is taken landwards from the dunes' outer edge. May 2006.

Figure 11 shows a part of the beach at Bore-Sele. According to the landowner, the cabin in the background was built almost at the outer edge of the dune around 1965. Since then the dune has progressed some 100–150 m toward the sea. This is due to the marram grass, which covers the dunes. The marram grass requires new sand to be brought in from the sea since it is dependent on nutritious elements being brought in along with the sand from the sea. The diameter of the sand brought in by the wind is approximately $d_{50} = 0.20$ mm.

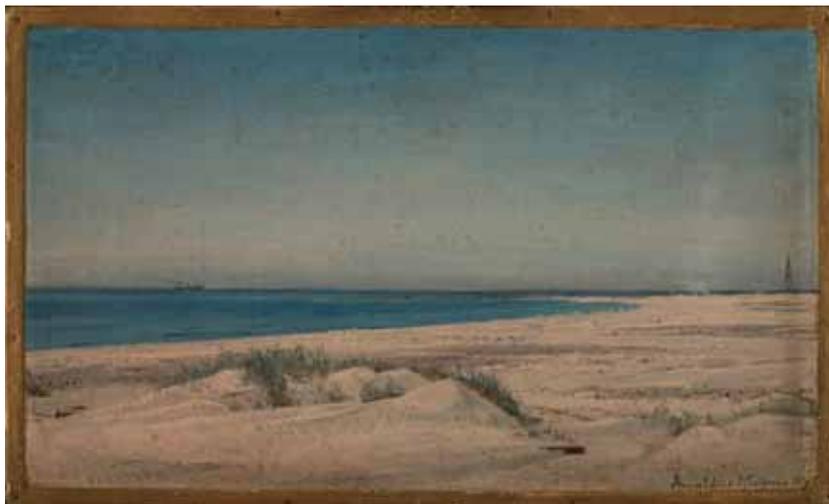
Figure 12: “Revet, Jæren”, painting by Amaldus Nielsen, 1893. Courtesy: Stenersenmuséet, Oslo.
Foto: Richard Jeffries© Stenersenmuséet.

In about 1870 a sailing mark was erected at Reve to help ships with their navigation during day time (“Day-time marker”, no lights). Figure 12 shows an older painting from the Reve area where the “Day-time marker” is visible. Many ships went aground on the Jæren coast, and whenever this happened there was an auction of the ship wrecks. The painting shows that the area at Revtangen at the end of the 19th century was rather flat.

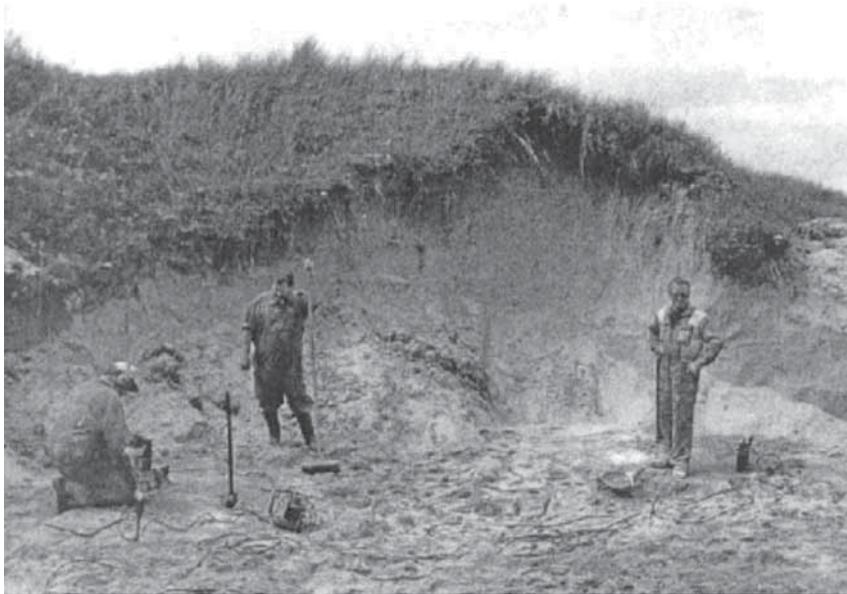
Figure 13: Uncovering of the old concrete foundations for the “Day – time marker” at Reve in 2004. The photograph and the information on the “Day – time marker” were provided by Thore Refve, Reve Jæren.

The “Day-time marker” was abandoned when new modern navigation became available in the beginning of the 20th century. It was, however, decided in 2004 to restore the “Day-time marker” as a piece of cultural heritage. The old concrete foundations were unburied to be used for the new “Day-time marker”. Figure 13 is a photograph from the exhumation of the old foundations. The sand dunes are several meters high. The highest dunes today at Reve are approximately 7.5 m above sea level.

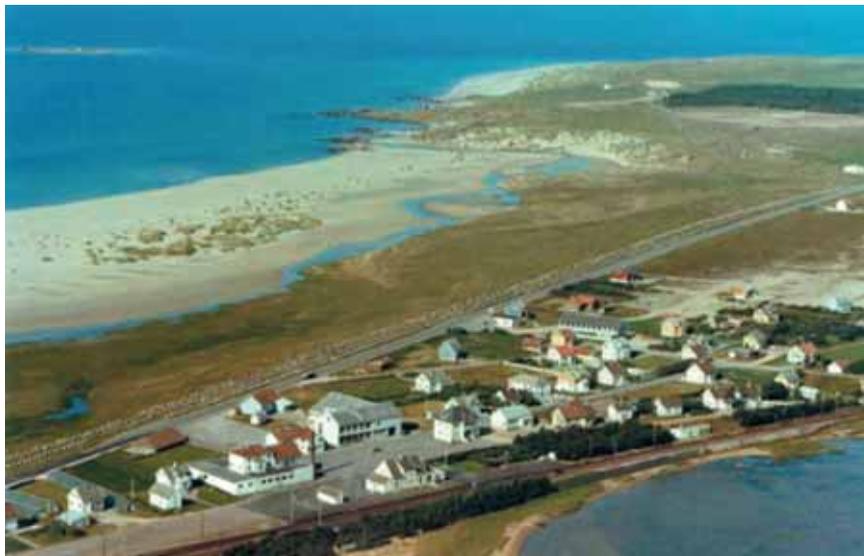
Figure 14: Brusand 1963. Foto: FjellangerWiderø A/S. Lake Waulen to the right.

Brusanden is located at the southern end of Jæren, Fig. 1. Figure 14 shows a photograph of the area in 1963, revealing that there is hardly any vegetation between the small creek and the ocean.

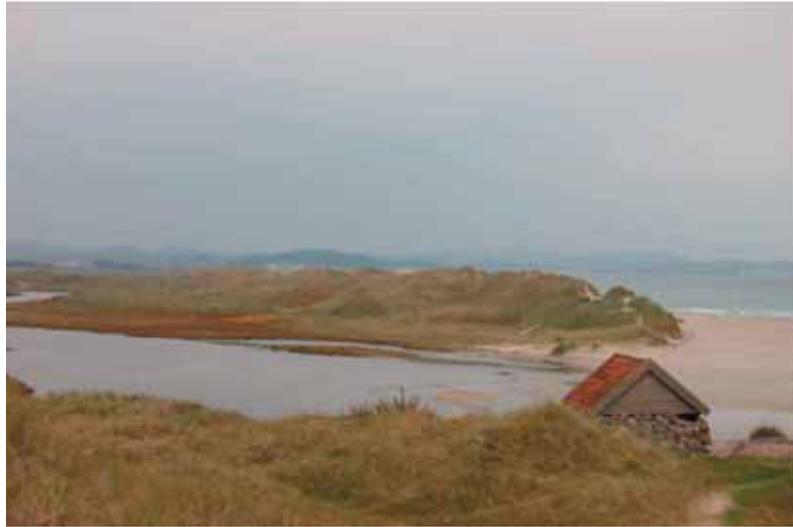
Figure 15: The northern end of Brusanden in 2007 with the outlet of the small river and Lake Waulen in the foreground.

Figure 15 shows the northern end of Brusanden in 2007. Although Marram grass was planted on Brusanden in 1894, it was not successful. Later, marram grass was planted on Kvalbeinsanden slightly north of Brusanden. This planting was successful. By natural spreading, the marram grass has also settled on Brusanden, whose dunes have grown considerably during the past 40–50 years.

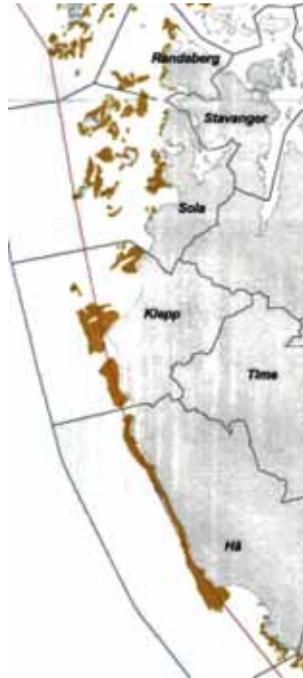
Figure 16: Location of kelp fields along the Jæren Coast (dark areas) [15].

Kelp (*Laminaria hyperborean*) grows in many places along the Jæren coast. Figure 16 indicates the location of the kelp fields. The kelp grows on stones or rocks at a depth from 2 down to a water depth of approximately 20 m, depending on the visibility in the water.

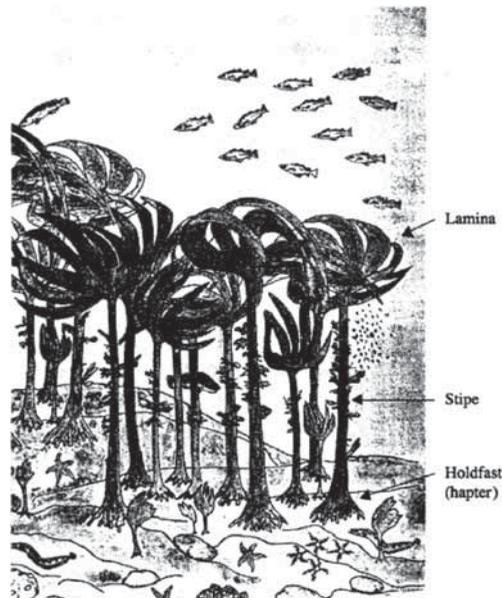
Figure 17: Kelp, *Laminaria hyperborean*, is split into three parts: the lamina, the stipe and the holdfast organ. The holdfast organ and the stipe are perennial, while the lamina changes every year. The new lamina moves the older one outward on the stipe until the old lamina leaves the stipe in spring time.

Figure 17 shows kelp plants, *Laminaria hyperborean*. When fully grown, these grow at a rate of approximately 10 plants per m² and to a height of 1.5–2.0 m. The lamina is approximately the same length. It takes about 5 years for a kelp plant to become fully grown.

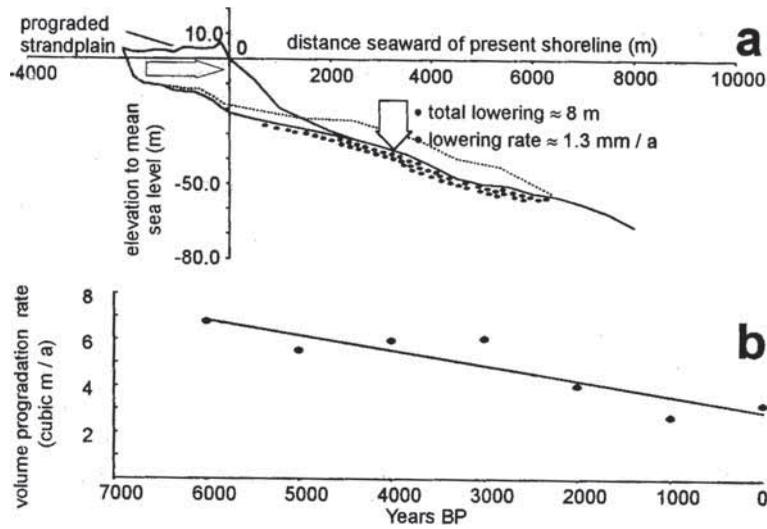
Figure 19: Moruya Beach [23]. The cross section is an interpretation of the lowering of the sea bed. The dotted line is the bottom level 6000 years ago. The lower diagram shows the rate of propagation of sand volume into the beach.

Cowell *et al.* [23] describe the development of the Moruya Beach in Australia, which has grown significantly during the last 6000 years. The sand in the sea was deposited during a glacial period. The Moruya Beach is a pocket beach and no sand has been transported into the area either from rivers or along the beach. The water level has not varied significantly during the last 6000 years. Figure 18 shows the location of the Moruya Beach and marks a cross section through it. Figure 19 shows the cross section as marked on Fig. 18.

It is interesting to note that for the Moruya Bay, Fig. 19, the sand has been brought up from approximately 50 m water depth. Thus the findings at Moruya Beach give further evidence of growing sand beaches, similar to the situation for the beaches at Jæren.

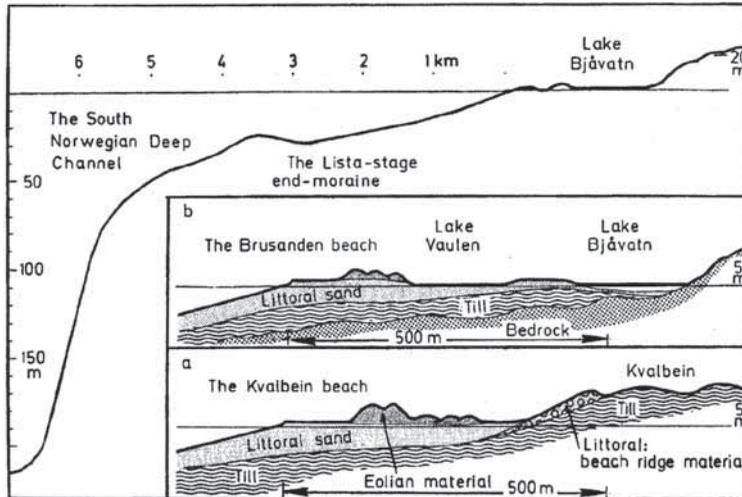
Figure 20: Profiles at Brusand and Kvalbein [12]. The indicated thicknesses of sand, etc., are assumptions and not based on borings (personal communication between Klemsdal and Tørum).
