## Priority Areas for Mangrove Conservation to Support Disaster Mitigation Efforts in Pacitan Bay

Mangrove ecosystems at the estuary of Teleng River, Pacitan Bay, call for preservation, protection, and development as a natural vegetative defense against tsunami impacts. Limited availability of potential land for mangrove growth poses a challenge to sustainable mangrove management. To anticipate land acquisition for another use, it is necessary to study land suitability for mangrove and mangrove conservation priorities in the Pacitan Bay. The land suitability parameters consisted of landform, slope, soil texture, and tidal fluctuation, while the mangrove conservation priority was determined based on several aspects: mangrove land cover reduction, mangrove damage level, beach ridge and riparian zone, and land suitability. The results indicate that lands with high potential for mangroves are distributed along Teleng and Grindulu Rivers but not precisely at the estuary. Based on the suitability results, highly potential and potential lands are proposed for mangrove planting, while existing mangroves are for protection and preservation zones, especially on the sides where relatively yo

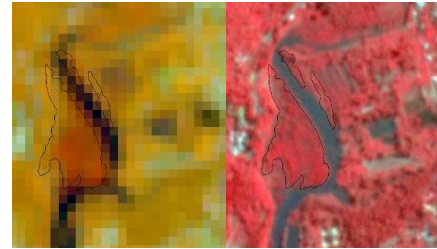
QuickBird and PlanetScope imagery used in mangrove identification has been geometrically corrected. Mangrove appearances in the PlanetScope image were delineated with the help of Sentinel-2A imagery, namely by applying the 8A114 composite that spectrally sharpens and makes a suspected mangrove object appear dark orange and easy to distinguish from other vegetation objects. Then, mangrove digitization on the 2006 QuickBird image and the PlanetScope image in 2017-2020 followed the mangrove boundaries derived in the previous delineation (Figure 2). This process adopted several provisions: the mangrove digitization started with the 2006 QuickBird image, then the resulting mangrove boundaries were reused with adjustments to mangrove conditions from 2017 to 2020. Thus, the derived mangrove changes occurring between these years are not caused by the digitization and geometric differences between the images.

**Figure 2.** Dark orange mangroves on Sentinel-2a 8A114 composite image (left) and mangrove digitization results on 2020 PlanetScope image (right)

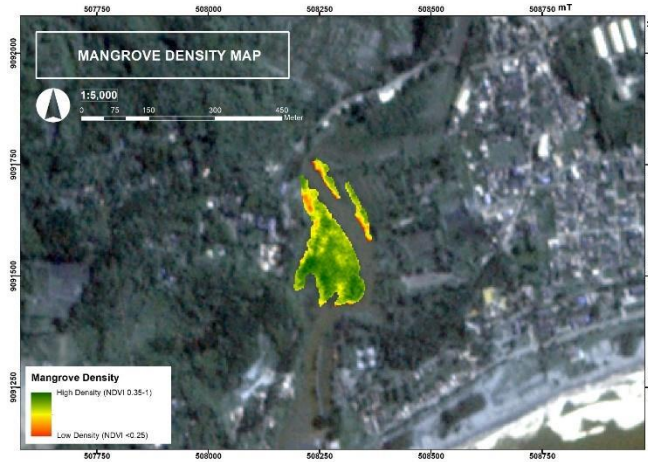
**Figure 5.** Mangrove density map in 2017-2020

Mangrove canopy density data were obtained by classifying the results of PlanetScope image transformation, NDVI (Normalized Difference Vegetation Index). In the pre-processing stage, the PlanetScope image pixels were first converted from integer data into float data by dividing the value of each pixel by 10,000. The NDVI values were then classified according to the Regulation of the Minister of Forestry No. 12/2012 with adjustments (Table 10). The derived mangrove canopy density is presented in Figure 5.

Table 11 shows that a large share of the mangrove area was densely covered, whereas only a small part had medium density. The southern (west of the river) and southwestern parts (east of the river) had a lower canopy density than other parts. This can be attributed to the young mangroves in the two locations whose leaves are not as thick as those of mature mangroves. Young mangrove trees are at higher risk of damage by events or activities in their surrounding environments. Therefore, mangroves with a low canopy density had a smaller score, which, in this case, is moderate density (score = 2 out of 3).

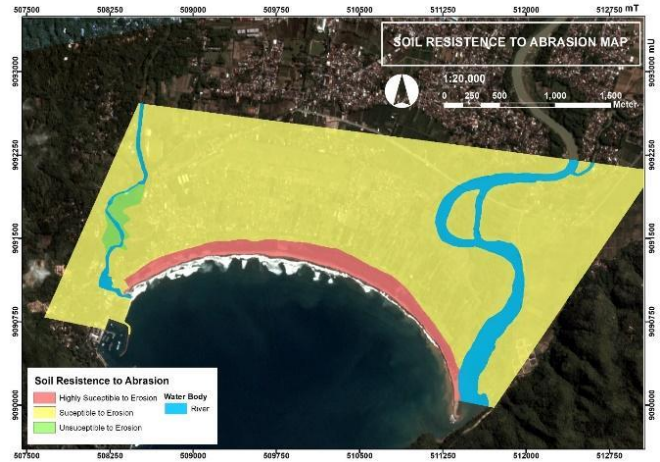
**Figure 6.** Map of soil resistance to abrasion

not susceptible to abrasion have the texture of clay. On the contrary, soils with mixed texture and sand texture are, respectively, susceptible and very susceptible to abrasion. The classification results of soil resistance to abrasion and extents are presented in Figure 6 and Table 12 respectively.

Soils that are prone to abrasion contain dynamic materials that can easily change positions. Therefore, mangroves planted on these soils can have unstable rooting and are prone to damage, especially in young mangroves. For this reason, land consisting of these soils is not suitable for mangrove growth. Soils with high susceptibility to abrasion were identified along the coast, whereas most soils sensitive to abrasion were found in almost all the study area. Soils unsusceptible to abrasion were located west of the bay and directly adjacent to the river, covering an area of 9,758 ha. This type of soil was scored 3 out of 3, meaning that the mangroves grown on it tend to have a low potential for damage.

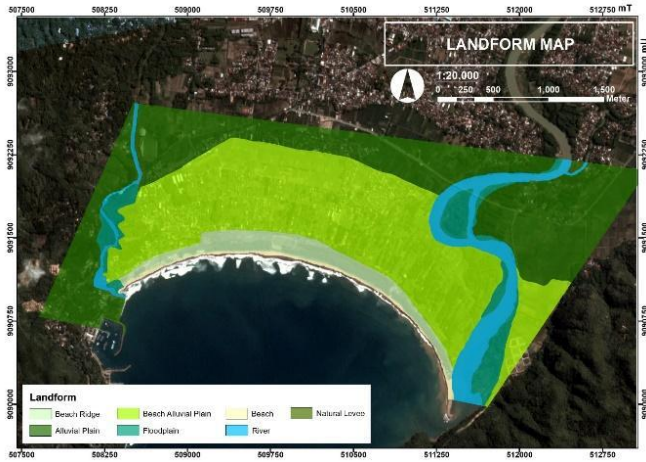
Figure 7. Landform map

The landforms, as presented in Figure 7, were delineated through visual interpretation by considering geology, slope, and genesis. Pacitan Bay is a shaky beach flanked by two large rivers. Its landforms, influenced by fluvio-marine processes, consist of pocket hides, shoals, alluvial plains, coastal alluvial plains, floodplains, and natural embankments. The landform type and area are described in Table 13.

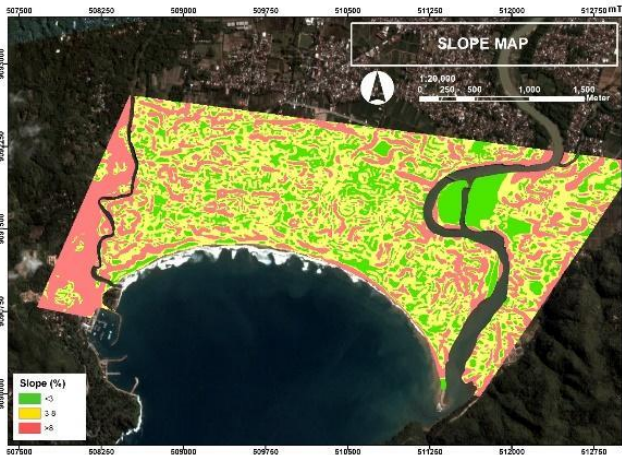
Figure 8. Slope map

Slope data were obtained from DEMNAS BIG in the form of DSM, which requires conversion into DTM. In this process, the slope value of the terrain filter in the PCI Geomatica program was set at 2 degrees. The slope classification results and extents are presented in Figure 8 and Table 14 respectively. It shows that the study area mainly had <3% slopes scattered along the bay, while the >8% slopes were found in karst hills abutting the western side of Pacitan Bay. These hills were also randomly scattered along the bay.

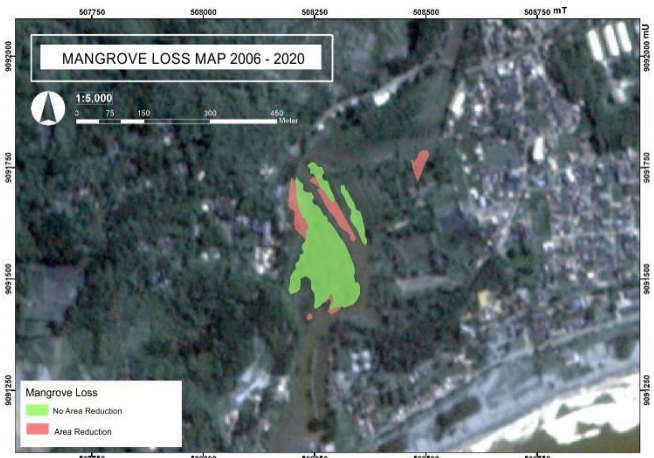
Mangrove land cover reduction was determined by overlaying the 2006 (oldest) and 2020 (most recent) mangrove land cover maps. Any detected addition to the mangrove area was categorized into the no-reduction class. Changes in mangrove land cover are presented in Figure 12. A decrease in mangrove covers was scattered in the north and south, and the total area of reduction is shown in Table 17. These mangrove cover dynamics can be related to Cempaka Tropical Cyclone on November 22, 2017, and a flash flood on November 28, 2017, that hit Pacitan Bay, changing the river and land morphology at the bay.

Figure 12. Mangrove degradation map in 2006–2020

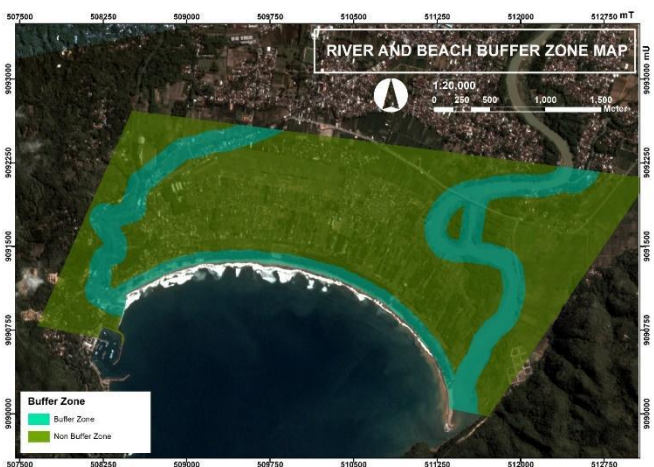
Figure 14. Map of river and beach buffer zones

Data on the beach and river buffers (beach ridge and riparian zone), as presented in Figure 14 and Table 19, were obtained through visual interpretation of the 2020 PlanetScope imagery. In spatial planning, these buffers are part of the local protected areas; therefore, the permitted uses are only those related to the provision of green open space.

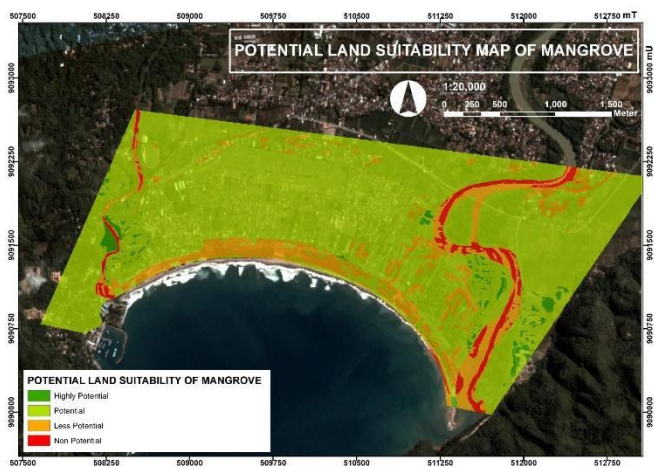
The land suitability model for mangroves was generated by overlaying several parameters: landform, slope, soil texture, tides, and land use. The lands with potential for mangrove growth and development based on the suitability model are presented in Figure 15. Their respective areas are presented in Table 20.

**Figure 15.** Distribution of land potentials for mangroves based on the suitability results

In this research, the mangrove land suitability shows that the lands suitable and, thus, potential for mangroves are evenly distributed throughout the study area. The closer the land to the river and the beach, the lower the land suitability for mangroves. The mangrove-suitable land is spread unevenly along the river in coastal alluvial plains, alluvial plains, and flood plains. The existence of mangroves in some part of the study area adds to the land suitability because the established habitat or condition indicates and allows for mangrove development. Further, a developed mangrove ecosystem was found west of the river, and this area can be designated for conservation activities, including mangrove planting and development.

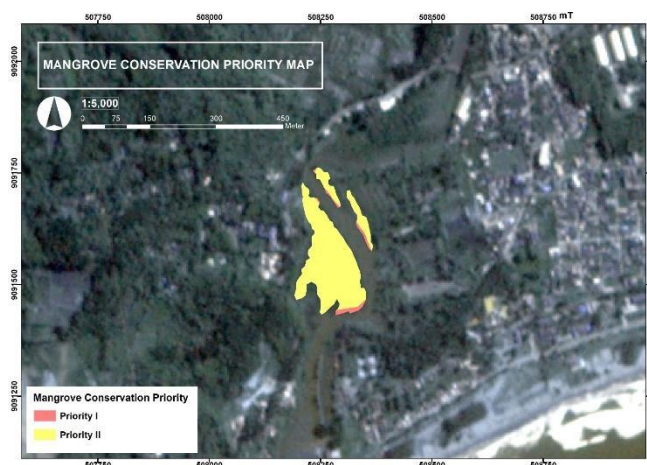
**Figure 16.** Mangrove conservation priority map

Mangrove conservation priority was based on the model that overlaid mangrove damage level, parameters contributing to mangrove land cover reduction, beach and river boundaries, and land potential for mangroves. The derived mangrove conservation priorities are presented in Figure 16. Most of the existing mangroves in the Teleng River are designated for conservation with Priority 2 (Table 21), which highlights controlled mangrove use or the combination of mangrove and non-mangrove spatial use where the latter is conducted at a lower intensity than the former. Priority 1 includes mangroves in the outermost part, which are relatively young and have less stable roots, whereas Priority 2 is for relatively more mature mangroves.
