Technical Closure of the Humberto Molina Astudillo Hospital and Its Implications for Sustainability, Zaruma-Ecuador

Zaruma, a heritage city of Ecuador with a rich geological mining history, it suffers from technical problems of stability. The Humberto Molina Hospital and its surroundings have been affected by different geodynamic events, causing damage to buildings. The aim of this study is to analyze the technical components that led to the Hospital's closure through engineering considerations of studies carried out and a matrix that includes the implications of the inhabitants' perception of the closure for the proposal of remediation measures. The methodology considers: a) Surveys and analysis of citizen perception; b) Analysis of the technical studies and its components; and c) Remediation proposal for the rehabilitation and sustainability of the Hospital. Citizen perception is aware of the imperative need for a hospital for a city recognized as a "magic town" (2019) by the Ecuadorian Ministry of Tourism. The stability analysis shows that the steep slopes decrease the safety factor. The study area has low susceptibility to landslide, also are present extreme precipitation cond

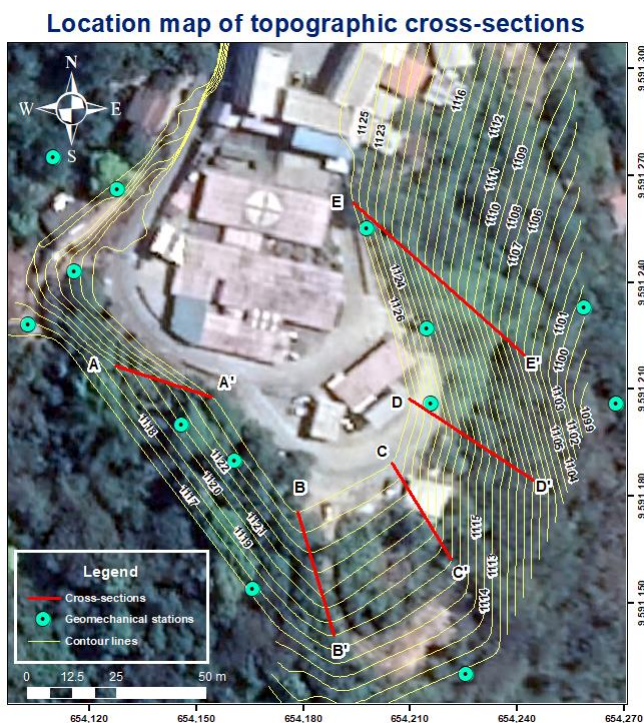
Figure 3. Location map of the topographic cross-sections in the study area and geomechanical stations

Several executions were carried out in the slope analysis software, using the five proposed cross-sections to calculate the safety factor (Figure 3). Each cross-section was analyzed under static and pseudo-static conditions (static including seismic action), applying the Spencer method and circular failure surface. The safety factors in the static analysis vary between 1.36 to 3.47 (Table 4 and Figure 12). On the other hand, the pseudo-static analysis varies between 0.95-1.81 (Table 4 and Figure 13). According to NEC-15, for a slope to be considered stable, the minimum safety factor in the static analysis is 1.50. Whereas for the pseudo-static analysis, it is 1.05.

- (7) There must be joints and separations in the contacts between old and new buildings to avoid knocking and forming cracks such as those currently observed.
- (8) Construction of berms with drainage channels in cross-section AA' and EE' (see Figure 3) to reduce the slope angle and infiltrate water.

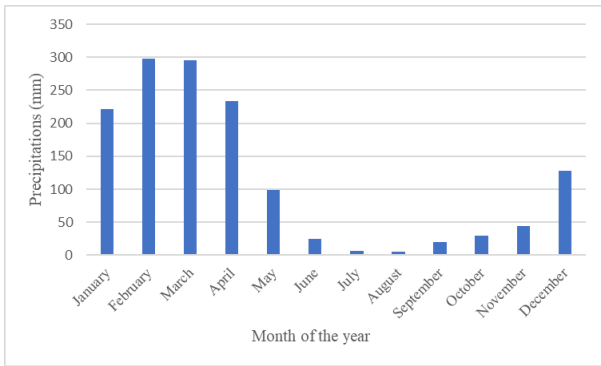
Figure 8. Multiannual average by monthly precipitation (1964-2020)

Climatic aspects were analyzed such as annual average maximum temperature with a value of 29.3°C, average annual minimum temperature of 17.2°C, multiannual average solar radiation with a value of 17.96 (MJ/m²/día), the average annual temperature of the point dew in the micro-basin of 19.24°C and the value of the multiannual average wind speed of 1.98 m/s. All these variables are directly related to precipitation. The multiannual average precipitation within the 1964-2010 period (Figure 8) for the study area was 1,403 mm. Being the months of February (297.90 mm) and March (294.90 mm) are the ones with the highest rainfall, and the months of July (6.39 mm) and August (5.06 mm) with the least rainfall.

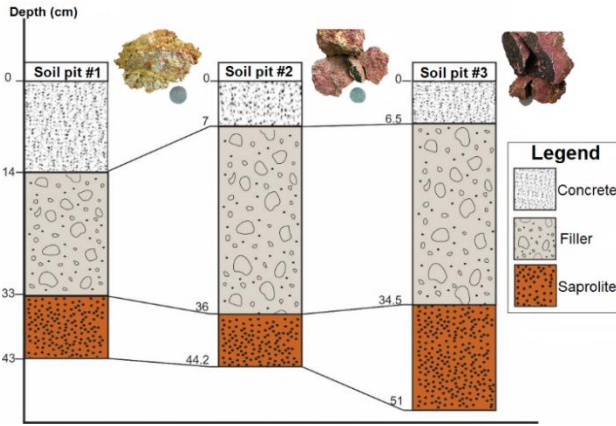
Figure 11. Cross-section of pits in the study area

Based on the areas of interest located in the geoelectric tomographies, two drillings PZ7 and PZ8 of 10 and 15 meters, respectively (see Figure 9), were made to directly determine the lithology below the study area. Three pits were made (Figure 9 and Figure 11) inside the Hospital, determining the presence of a concrete layer, followed by a very thick filling layer and finally a layer of saprolite that varies from orange to reddish, with a granulometry fine to medium (Figure 11).

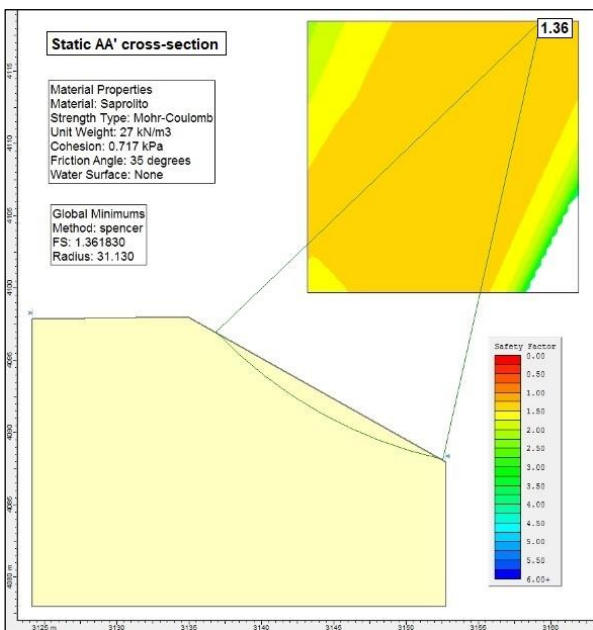
Figure 12. Minimum safety factor by static analysis

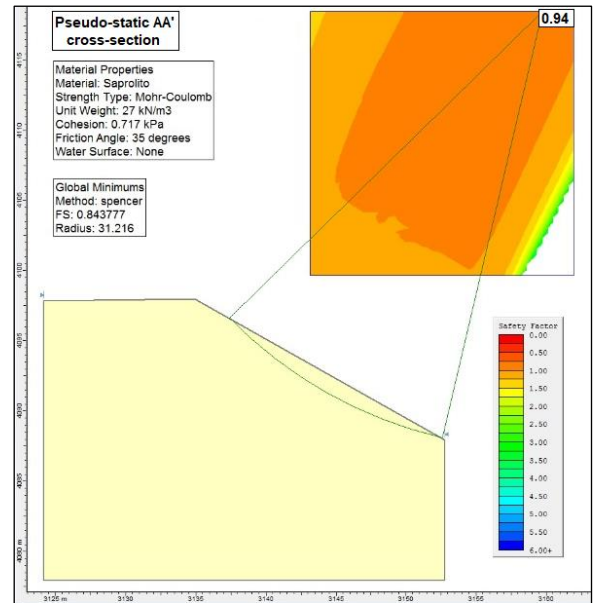
Figure 13. Minimum safety factor of the pseudo-static analysis

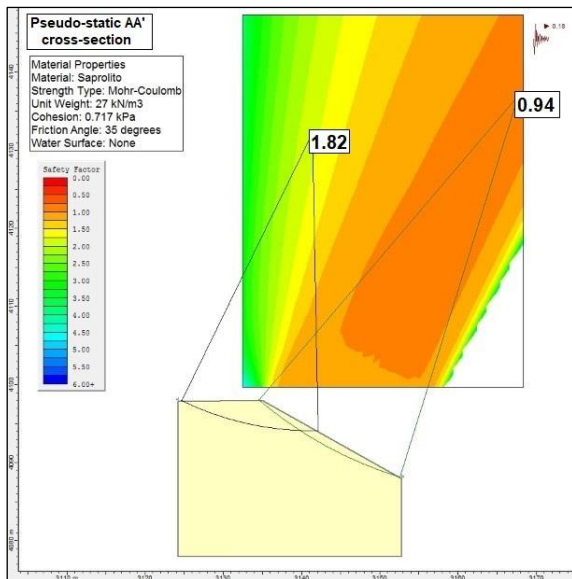
Figure 17. Calculation of the safety factor in the pseudo-static analysis, analyzing the land on which the Humberto Molina Hospital sits and the AA' cross-section
