Application of zirconia thermal barrier coating on the surface of pulling-straightening roller

Feng Zhang¹, Dengyue Sun^{1*}, Jiuming Xie², Shimin Xu¹, Huagui Huang¹, Jun Li¹, Haitao Hou¹, Jin Wu²

¹National Engineering Research Center for Equipment and Technology of Cold Strip Rolling, Yanshan University, Qinhuangdao 066004, China

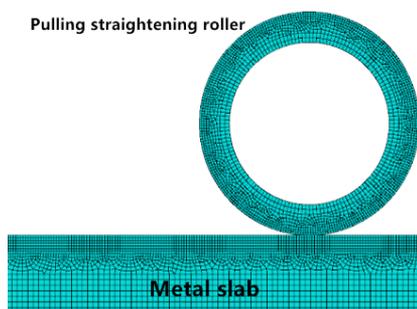
Figure 1. Geometric model

(a) Geometric model

(b) Local amplification

This section probes into the effect of TBCs on the surface temperature of pulling-straightening roller. For computing efficiency, the 2D model was employed without sacrificing the calculation accuracy [12]. The geometric model and the mesh division are shown in Figure 1(a). The roller was treated as a deformable body and divided into 4-node quadrilateral temperature/displacement elements. Specifically, the outer grid cells of the roller and the top grid cells of the metal slab are 2mm in size. The coating and the top surface of the roller share the same grid but differ in mesh type. Hence, the outer ring of the coated roller appears as a bright layer (Figure 1(b)). The ceramic layer was made of zirconia, whose thermal physical parameters are presented in Table 1 [13]. The thermal physical properties of the matrix material H13 are listed in Table 2.

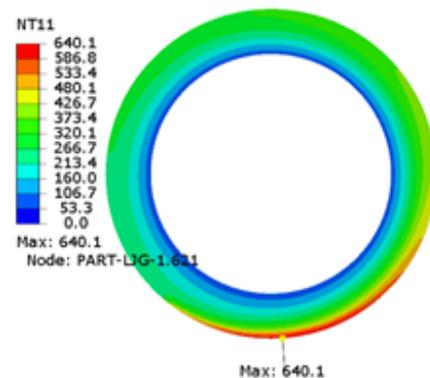
Figure 2. Temperature distribution of uncoated roller

based on the node temperature and temperature graph. According to temperature distribution of uncoated roller in Figure 2, the surface temperature dropped by 390°C from the peak value of 640°C to the valley value of 250°C. According to the temperature distribution of coated roller in Figure 3, the surface temperature dropped by 265°C from the peak value of 445°C to the valley value of 180°C. It is clear that the coated roller lagged behind the uncoated one in the peak surface temperature and the temperature drop. The peak temperature of roller surface was synthesized and recorded in Figure 4.

The FEM results show that: in the uncoated scenario, the roller surface temperature rose rapidly in the deformed area, and then declined fast under air convection and water cooling. The heat shock is very obvious. The dramatic temperature change on roller surface resulted in a great heat stress, a catalyst of thermal fatigue cracking. Under the joint action of heat stress and other factors, the cracks continued to propagate and eventually developed into macro cracks, leading to surface exfoliation. With the application of 8YSZ TBCs, the roller surface temperature and heat stress dropped noticeably. The decline curbed the thermal cracking and increased the service life of the roller.

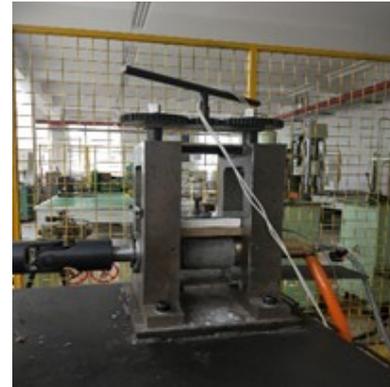
Figure 5. Two-high rolling mill

The temperature measurement was carried out on a two-high rolling mill (Figure 5). The effect of TBCs on roller surface temperature was tested to verify the correctness of the FEM results. The roll surface coating of the 100mm-long test roller was plasma sprayed using a plasma spraying unit (Sulzer

Metco). The cylindrical surface diameter of the roller was 90mm. The roller surface temperature was measured by a LaserSight infrared thermometer (Optris). A cast copper heating plate was employed to heat up the roller surface to 500°C. The HS-G type bidirectional inner tube fixed rotary joint was adopted to pour the cooling water into the roller and water cool the inner wall of the test roller.

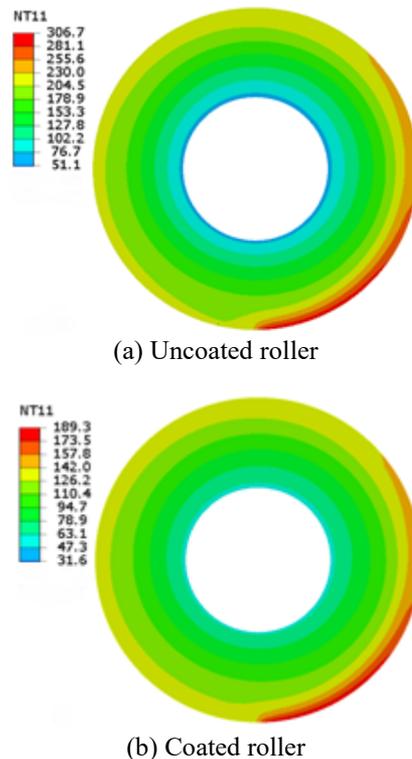
Figure 6. FEM under the test conditions

As shown to Figure 6, under the test conditions, the surface temperature of the uncoated roller was maximized at about 306°C, and minimized at about 204°C. After the roller surface was coated with 8YSZ, the maximum surface temperature dropped by 117°C to about 189°C, and the minimum surface

temperature dropped by 78°C to about 126°C.

The FEM of the test roller was performed on ABAQUS according to the test conditions. The boundary conditions and mesh generation method were the same with the previous FEM, other than the heating method. The FEM results are illustrated in Figure 6.

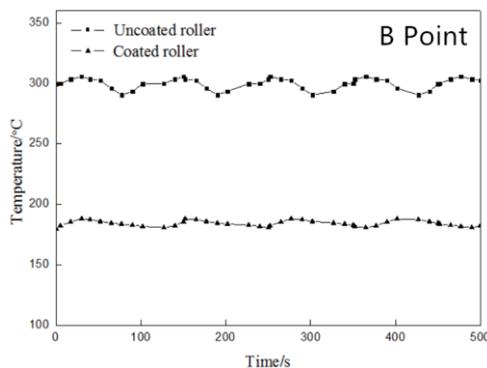
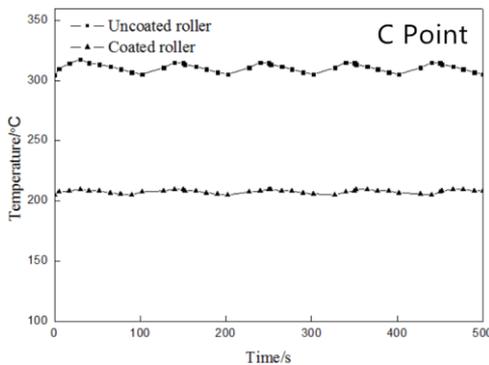
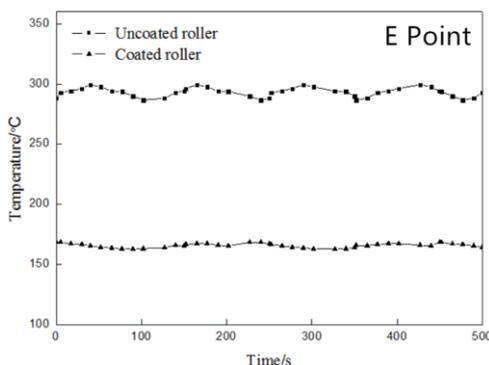
Figure 8. Steady-state temperature curves of three test points

(a) Point B temperature

(b) Point C temperature

(c) Point E temperature

On the roller surface, there was a symmetrical relationship between points A and E, and between points B and D. Hence, each pair of points shared a basically consistent trend of temperature. In view of the symmetry, points B, C and E were taken to measure the steady-state temperature variation curves of coated and uncoated test rollers. The measured temperature is shown in Figures 8 (a), (b) and (c).

From Figure 8, it can be seen that the average temperature of points B, C and E on the uncoated roller surface was about 300°C and that on the coated roller surface was about 180°C. The measured temperatures on the roller surface coincide with those obtained by ABAQUS simulation, which verifies the reliability of the ABAQUS simulation in determining the surface temperature distribution of pulling-straightening roller.

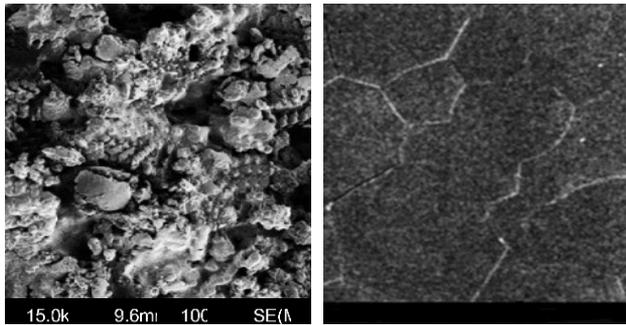
Figure 9. Coating surface morphology

According to the surface morphology of plasma-sprayed coating in Figure 9 (a), the YSZ coating exhibited a typical structure of plasma-sprayed ceramic powders, and visible particles not fully melted on the coating surface. The heavy presence of unmelt particles is attributable to the incomplete melting of 8YSZ powders. With a high melting point and a low thermal conductivity, 8YSZ powders are unlikely to melt thoroughly in the heating, deformation and cooling processes of plasma spraying. The unmelt particles led to a rough and uneven surface structure.

Figure 9 (b) is the surface morphology of the laser-remelted coating. It can be seen that the coating surface was relatively smooth, and the unmelt particles disappeared. This is because

the unmelt ceramic powders were sufficiently melted thanks to the rapid rise in coating surface temperature during laser remelting. When the laser beam moved away, the powders solidified and recrystallized quickly, resulting in fine grains, a uniform microstructure and a smooth surface.

(a) Plasma-sprayed coating (b) Laser-remelted coating

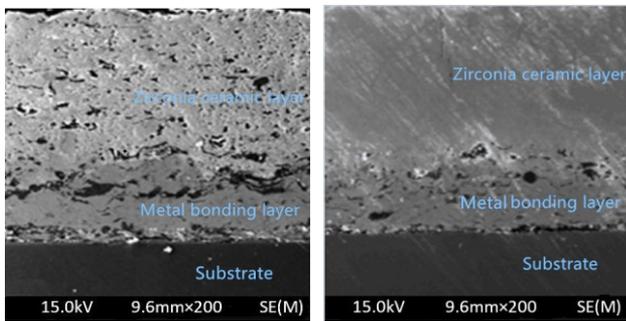
Figure 10. Fractured cross-section morphology

Figures 10 (a) and (b) shows the fractured cross-section morphology of plasma-sprayed 8YSZ coating and laser-remelted coating, respectively. From bottom to top, the cross-section consists of the substrate, the metal bonding layer, and the ceramic top layer.

(a) Plasma-sprayed coating (b) Laser-remelted coating

As shown in Figure 10 (a), clear boundaries were observed between different layers, and the layers were combined loosely via physical and mechanical bonds. The cross-section of plasma-sprayed coating contained lots of pores and cracks. It can be seen from Figure 10 (b) that the number of pores and cracks reduced dramatically after laser remelting, and the inter-layer boundaries were blurred. The microstructure comparison of the two coatings shows that the coating quality was remarkably improved through laser remelting.

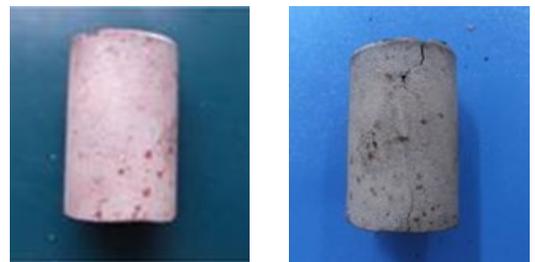
Figure 11. Post-thermal shock morphology of plasma-sprayed samples

Figure 11 shows the macroscopic morphology of plasma-sprayed coatings after thermal shock tests. Macroscopic cracks appeared at the end of the cylindrical sample after 14 thermal cycles. With the increase in the number of cycles, the quenching-induced heat was released from the cracks, leading to a high thermal stress. Under the joint action of thermal oxide layer and thermal stress, the coating peeled off across a large area. The exfoliation continued to worsen until the coating failed at the 32nd thermal cycle.

(a) Before thermal shock (b) 14th thermal cycle

(c) 32nd thermal cycle

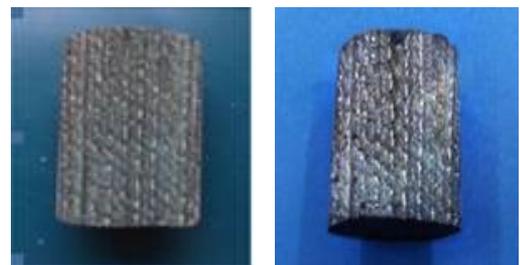
Figure 12. Morphology of laser-remelted samples after thermal shock

(a) Before thermal shock (b) 43rd thermal cycle

(c) 94th thermal cycle

Figure 12 shows the macroscopic morphology of laser-remelted coatings after thermal shock tests. Unlike the plasma-spraying coatings, the laser-remelted coatings suffered from no obvious macroscopic cracks during the tests. The thermal shock failure of laser-remelted TBCs was dominated by local exfoliation. After 43 thermal cycles, small pieces of the coating started to flake away from the top of the cylindrical sample. With the increase in the number of thermal cycles, more and more places underwent exfoliation, creating an ever-increasing area of spalling. The top ceramic coating peeled off in large areas at the 94th thermal cycle. Compared with plasma-sprayed coatings, the laser-remelted coatings had a much greater resistance to thermal shock.

The coating damages are mainly caused by the following factors: the thermal stress produced in the TBC under thermal shock, the thermally grown oxide (TGO) generated at the interface between the top ceramic layer and the bond layer, and the phase transformation stress [19, 20]. The plasma-sprayed coatings had a laminated structure with many horizontal cracks, especially at the interface, while the laser-remelted coatings had a columnar structure in the ceramic layer. The columnar structure boasts a better resistance to thermal shock in thermal cycles than the laminated structure. In addition, the vertical cracks in the remelted coating can release part of the stress accumulated in thermal cycles, which further improves the thermal shock resistance of the coatings [21].

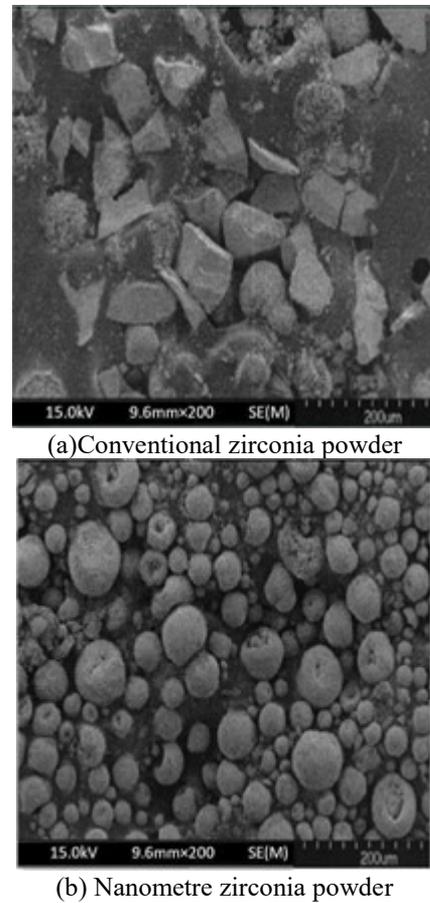
Figure 13. SEM images of zirconia powders

Figures 13(a) and 13(b) display the SEM images of the conventional zirconia powder and the nanometre zirconia powder, respectively. It is clear that the conventional powder was polyhedral and irregular in shape, while the nanometre powder was nearly spherical or ellipsoidal. The morphology of nanometre powder is featured by good flowability and high density, making the powder suitable for plasma spraying.

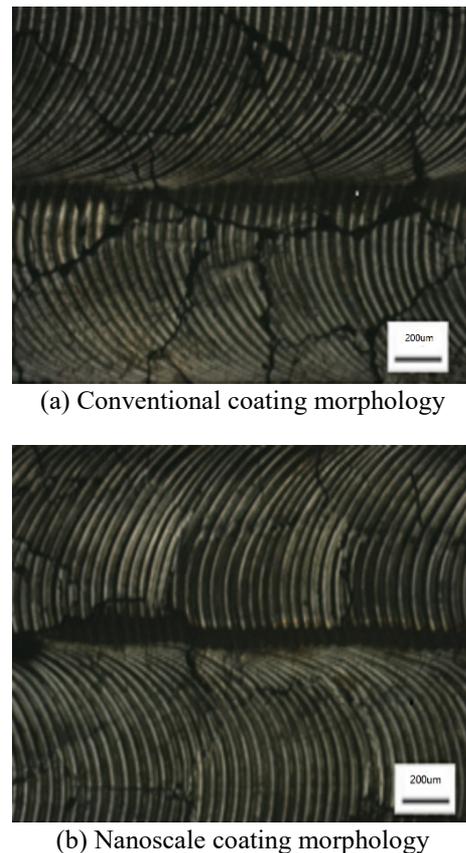
Figure 14. Surface morphology of remelted coatings

The two types of zirconia powders were adopted to prepare remelted coatings (hereinafter referred to as the conventional coating and the nanoscale coating). The surface morphologies of the two coatings were observed by an OLS 3100 confocal laser scanning microscope. As can be seen from Figures 14(a) and 14(b), both of the two coatings had retiform micro-cracks and corrugated bulges after laser remelting. The surface morphologies are resulted from the low fracture toughness of the ceramic material [22]. The material was easily cracked in the heating and cooling cycles during the laser remelting process. In addition, the high viscosity of the melting ceramic during the heating process also contribute to the crack formation. The viscous melting ceramic trapped the gases produced by expansion, adding to the possibility of cracking. Comparatively speaking, the coating prepared from nanoscale powders had much less reticulated cracked than the conventional coating. This may be related to the high toughness of nanoscale zirconia coatings.

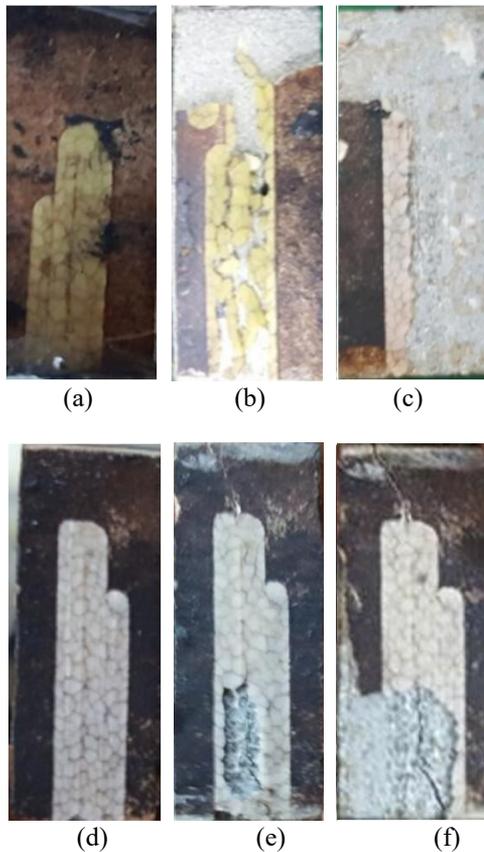
Figure 15. Macroscopic diagrams of conventional and nanoscale coatings

By the same method as before, a thermal shock test was conducted on the two types of coatings. Figure 15 show the macroscopic diagrams of the conventional and nanoscale coating samples at the 60th, 90th, and 150th thermal cycles. The thermal shock test results are summed up in Table 5. After 60 thermal cycles, neither the conventional nor the nanoscale TBCs produced microcracks or exfoliation. After 90 thermal cycles, both types of coatings suffered from different degrees of exfoliation, microcracking and bulging. For the nanoscale coating, only about 5% of it experienced exfoliation, much smaller than that (18%) of the conventional coating.

- (a) Conventional coating at 60th thermal cycle
 (b) Conventional coating at 90th thermal cycle
 (c) Conventional coating at 150th thermal cycle
 (d) Nanoscale coating at 60th thermal cycle
 (e) Nanoscale coating at 90th thermal cycle
 (f) Nanoscale coating at 150th thermal cycle

After 150 thermal cycles, the conventional coating was mostly fallen off with no cracks on the matrix, while about 20% of the nanoscale coating fell off with a noticeable crack on the matrix. Both specimens suffered from serious deformations. The failure of the conventional sample was initiated by the spalling of the ceramic coating, while the failure of the nanoscale sample was induced by the high inner heat stress from the mismatch of thermal expansion coefficient between ceramic top and metal matrix. Under the breaking tension produced by the matrix crack, the ceramic layer was stretched all the way towards TBC cracking.

Through the comparison, it is clear that the nanoscale coating outperformed the conventional one in thermal shock resistance. The edge in performance is related to the coating toughness and porosity. With a relatively high toughness and low porosity, the nanoscale coating inhibits the crack propagation, and has only a few microcracks. Hence, the nanoscale zirconia powders can greatly enhance the thermal shock resistance of coatings.
