Experimental Investigation on Improving Lifetime of Peripheral Pump Impeller under Cavitation Using Different Techniques

Aveen T. Mohsin^{1,2}, Banipal N. Yaqob^{2*}

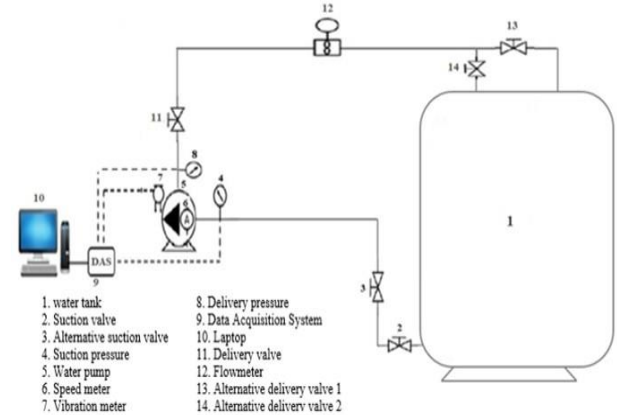
Figure 1. Schematic diagram of experimental setup

valve). Figure 1 shows the schematic diagram of the pump's flow loop system. The measurement range and accuracy of various sensors used are given in Table 1.

A peripheral pump AP220, a 3-phase motor, 2.2 kW, 4.6 Ampere, (380 to 415) Volts, with a capacity range of (0.3-5.5) m³/h, 2900 rpm, 25.4 mm inlet and outlet diameters respectively, and a maximum head of 100 m, with a brass impeller of 36 blades was utilized in this study, which is widely available in the market. An AC-Drive system is used for controlling and changing the rotational speed of pump motor. The built-up re-circulatory flow loop system consists of a pump, plastic water tank, PVC pipes, connectors, and fitting components. The working process of this built-up recirculation flow loop system is to provide water from the tank to the system and recirculated to the tank again, in order to allows better control over the water temperature and keeping the same level of water in the tank. In the meantime, the pump rotational speed is set at 2900 rpm, and the flow rate, suction and delivery pressure, and impeller weight will be measured before and after each test and each operation time interval while the pump is operating under cavitation conditions. To measure the water flow a turbine flow meter was connected to the pump delivery side, and two pressure transducers were used to measure pump inlet and outlet pressure. Temperature, voltage, and electrical current are among the other physical factors detected, monitored, and measured by various sensors and devices. These measurement sensors and devices helped to directly controlling the variables through holding them constant throughout the study (e.g., the rotational speed of the pump controlled by using AC drive system, the water temperature, and tank water level controlled by thermometers and using re-circulatory flow loop system, and by-pass line used for controlling the opening degree of the

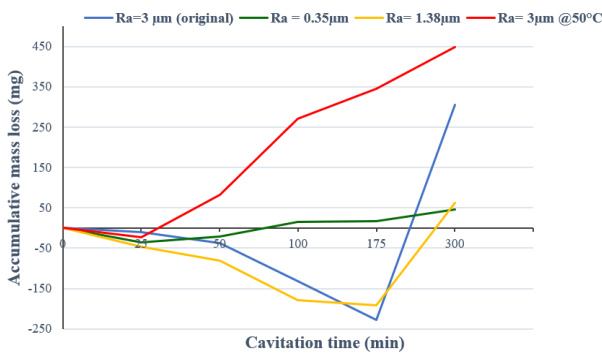
Figure 2. Mass loss for different surface roughness as a function of cavitation time

Statistical measures, such as arithmetic surface roughness (Ra), are commonly used to assess surface roughness. The control of erosion and material removal is known to be influenced by surface roughness [20]. For optimizing the impeller lifetime, three impellers with different surface roughness (Ra) (0.35, 1.38, and 3) μm and the original one with (3 μm), were operated under cavitation conditions for (300) minutes at a pump rated speed of 2900 rpm. The cavitation test was stopped at various points, and the impellers were weighed with a sensitive balance. The original impeller with the other two impellers with Ra of (0.35 and 1.38) μm were operated under cavitation conditions at a normal water temperature of (15.5-17.5) $^\circ\text{C}$, while the fourth impeller with Ra of 3 μm , which has the same Ra of original impeller, was operated under the same cavitation condition but with a water temperature of 50 $^\circ\text{C}$. The result of accumulated mass loss of the four impellers as a function of cavitation time is presented in Figure 2. This figure reports that at normal water temperature, after 300 minutes operating under cavitation condition, the original impeller with Ra of 3 μm has the greatest mass loss of 304.6 mg, and the impeller with smallest Ra of 0.35 μm has the lowest mass loss of 46.1 mg, which is 84.86% less than the original one, followed by the impeller with Ra of 1.38 μm by mass loss of 62.1 mg which is 79.6% less. This means that cavitation erosion can be decreased by

improving impeller surface quality, thus extending the impeller lifetime with better performance. In other words, cavitation erosion increases by increasing surface roughness. Because surface roughness creates stress inhomogeneities, which promote cavitation, this result was also observed by other researchers [23].

Also, the figure presented that, the temperature of the working fluid has a direct effect on the impeller mass loss, where the impeller with the Ra of $3\mu\text{m}$ (same as the original one) under water flow temperature of 50°C has the highest mass loss of 448.8 mg compared to the mass loss of the original impeller with the same Ra but under normal water temperature of $(15.5\text{-}17.5)^\circ\text{C}$, which is 304.6 mg. This is due to the fact that the cavitation erosion increased by raising the fluid temperature because of the formation of more bubbles and their collapse [24, 25].

Moreover, it can be noticed from the figure that all of the impellers had an incubation stage followed by an accelerated erosion stage. The watershed between the incubation stage and the accelerated erosion stage can be determined depending on factors including surface roughness and grain size, and this

conclusion was also found by others researchers [26, 27]. The original impeller, with a high Ra of $(3\mu\text{m})$ at normal and high-water temperature, was subjected to corrosion and then surface erosion. This because, when an oxidized film scale forms on the impeller surface, it acts as a corrosion barrier [25, 28, 29]. Also, water is one of the worst performers in terms of impeller damage under cavitation conditions, for two main reasons: relatively high density, and phase change behavior. Table 3 shows the effect of cavitation erosion on impellers. In conclusion the impeller lifetime under cavitation can be improved by improving the impeller surface roughness, better finishing surface, longer impeller operation time.

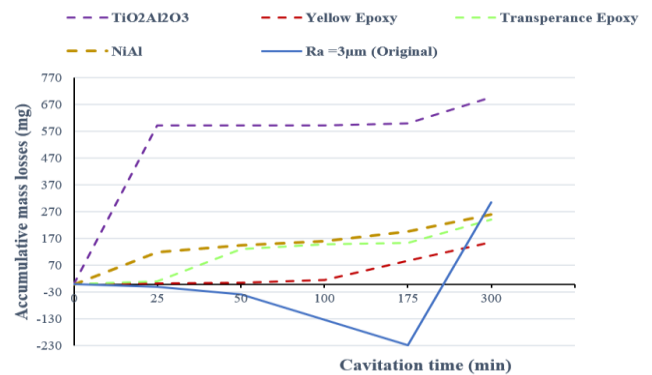
Figure 3. Mass loss for different surface coating as a function of cavitation time

Four impellers with four different erosion resistance composite materials ($\text{TiO}_2\text{Al}_2\text{O}_3$, NiAl, Transparent epoxy, and yellow epoxy) were coated and prepared by the method of thermal spray coatings in order to test their resistance to cavitation erosion in this study, and compare the result with the uncoated original impeller. The test was carried out to see if coatings were a viable alternative for extending the life of pump impellers. Each impeller was run for 300 minutes at a rated pump speed of 2900 rpm in normal water temperature under cavitation conditions. Figure 3 shows that $\text{TiO}_2\text{Al}_2\text{O}_3$ coated impeller has the highest mass loss value of 697.1 mg, then followed by (259.5, 240, and 156.8) mg for NiAl, transparent epoxy, and yellow epoxy, respectively. Considering these results with the original impeller result, we figured out that only the $\text{TiO}_2\text{Al}_2\text{O}_3$ coated impeller has a mass loss value greater than the original uncoated impeller. Otherwise, all of the others have lower values. The mass loss percentages for NiAl, Yellow Epoxy, and Transparent Epoxy as compared to the original impeller are lower by 14.77%, 48.50%, and 21.20%, respectively. These results show that thermally sprayed coatings are an effective technique to improve the cavitation erosion resistance of components, and extending pump impeller lifespan under cavitation condition. Because no substantial changes to the microstructure of substrates and excessive deformation are promoted during the deposition process [30]. The cavitation erosion resistance of $\text{TiO}_2\text{Al}_2\text{O}_3$ was lower than that of an uncoated original impeller because the nature of the procedure and the processing parameters influence the quality of the coatings produced by thermal spray techniques. Table 4 presents the photos of coated impellers before and after submitting to cavitation.

(2) For coating process tests under cavitation conditions, it was discovered that only the $\text{TiO}_2\text{Al}_2\text{O}_3$ coated impeller has a mass loss value greater than the original impeller; otherwise, all of the others have lower values. This is because the quality of the coatings generated by thermal spray techniques is influenced by the nature of the operation and the processing conditions. These findings suggest that thermally sprayed coatings are an excellent method for increasing the impeller's cavitation erosion resistance and thereby extending its lifespan.

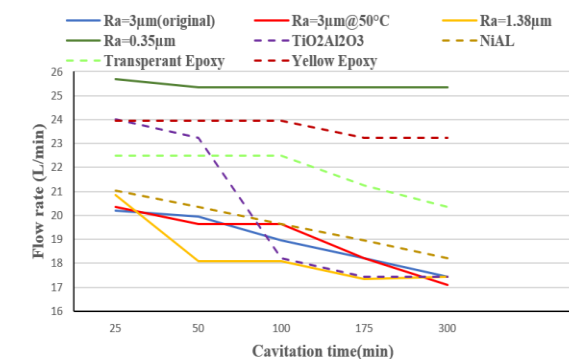
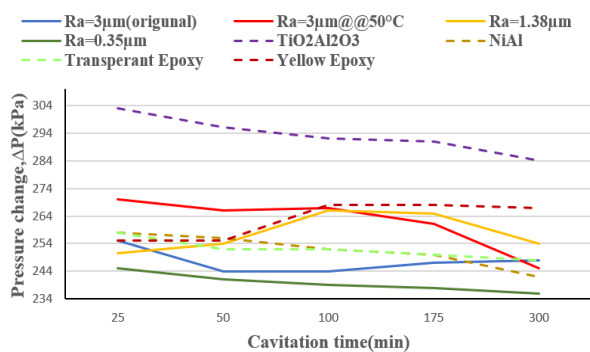
Figure 4. Performance reduction of the pump with the eight impellers during submitting to cavitation

performance curve and pump efficiency curve for the eight impellers, including the original one, was made before the pump impeller was exposed to cavitation, after exposing to cavitation and during cavitation for 300 minutes at high rotational speed of 2900 rpm. In Figure 4(a), it is clear that the flowrate of the pump decreased when the pump with eight impellers is subjected to cavitation, this due to the bubbles formed during the cavitation [31]. Also Figure 4(b) shows change in pressure between suction and delivery sides will generally decrease when the pump with eight impellers is exposed to cavitation except for the yellow epoxy coated impellers, which results in a drop in pump performance. Figure 5 presents the pump head versus flowrate (H-Q) and efficiency curves for the eight impellers before and after submitting to cavitation. It can be seen from this figure that the head and efficiency curves of the pump for all the impellers after being exposed to cavitation conditions are degraded except for the yellow epoxy surface coated impeller. This is because the pump was operated with low net positive suction head available, and caused cavitation occurrence especially when the pumping liquid is water. The collapsing cavitation bubbles damaged the impeller surface, and the hollow areas partially clogged the impeller passageways. As a result, reduced pump performance. The performance of the yellow epoxy surface coating has been improved because of a decrease in surface roughness after exposure to cavitation conditions.

(a) Flowrate versus cavitation time

(b) Pressure change versus cavitation time

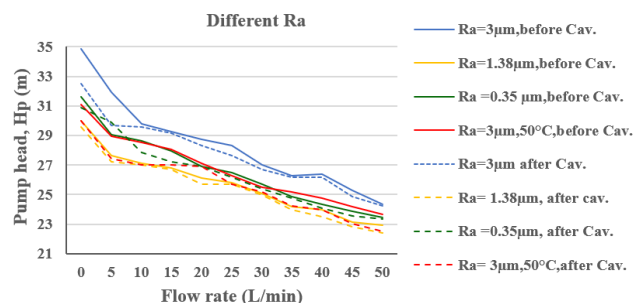
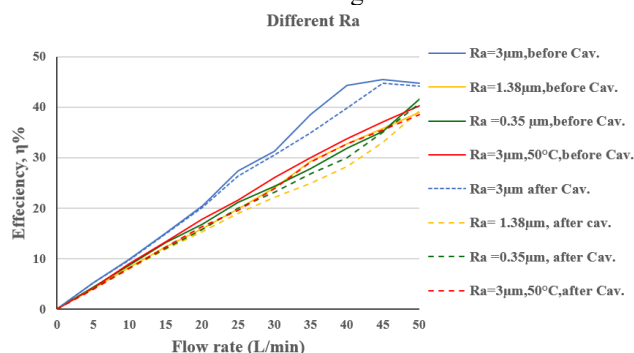
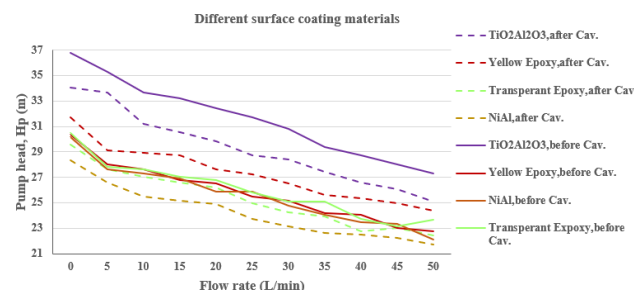
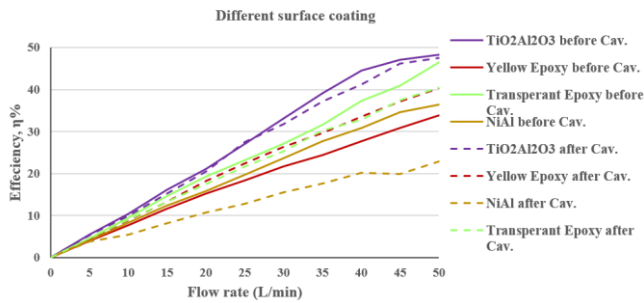
Figure 5. Performance curves for the eight impellers before and after submitting to cavitation

(a) Head versus flowrate curve for impellers with varying surface roughness

(b) Efficiency curve for impellers with varying surface roughness

(c) Head versus flowrate curve for impellers with varying surface coatings

(d) Efficiency curve for impellers with varying surface coatings

Cavitation is a phenomenon that can arise in any pump and significantly decline the pump's performance [29]. For studying the impact of cavitation on pump performance, after monitoring and gathering extensive data on the pump's performance experimentally, a comparison between the pump

(3) The performance of the pump with the seven different surfaces finished and coated impellers after submitting to cavitation had decreased, except for the yellow epoxy surface coated impeller. The performance of the yellow epoxy surface coated has been improved because of a decrease in surface roughness after exposure to cavitation conditions.
