A LABORATORY INVESTIGATION AND AN APPRAISAL OF THE VIABILITY OF EXPANDED POLYSTYRENE DWELLINGS

BONKE MNCWANGO & DHIREN ALLOPI
Durban University of Technology.

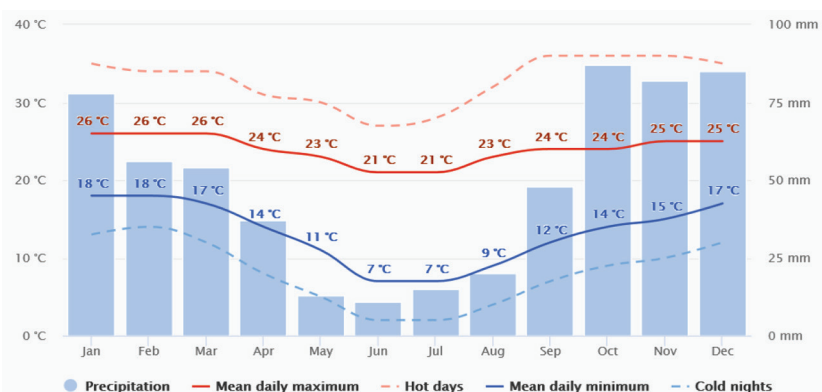
Figure 1: General climate of Pietermaritzburg, KwaZulu-Natal [4].

There are numerous threats which exist to any dwelling, these threats include, but are not limited to fire, wind, rain, storms, lightning and earthquakes. Since some of these threats cannot immediately be experienced by the constructed EPS model; it was necessary to conduct laboratory tests to test the compressive strength, thermal stability and flexural strength of EPS. The location of the placement of the model is Pietermaritzburg, South Africa. A resemblance of Pietermaritzburg’s low and high points of temperature is depicted in Fig. 1 by Meteoblue [4].

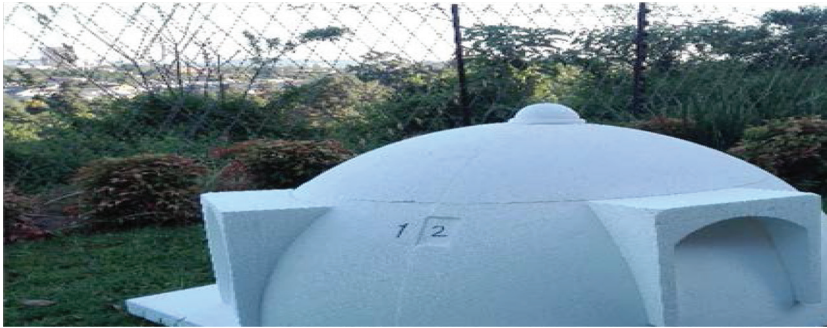
Figure 2: EPS Dome model first placed in February 2018.

The dimensions of the model are 1200 mm diameter \times 600 mm carved dome of 15 kg/m^3 density. The shape of the dome was carved through a hot wiring process. The EPS dome house model was placed and exposed to the elements from the 1st of February 2018 to the 30th of April 2018 (three months) as shown in Fig. 2.

The highest recorded temperature during the 3-month observation was 36° on the 2nd of February 2018. Highest rainfall day was the 16th of March 2018 at 28 mm. Highest wind speeds were experienced on the 2nd of February 2018 at 39 km/h. Observations made on the model on the 3rd of February 2018 indicate that the high temperature from the previous day did not alter the structural composure of the model in any way. Observations made on the 17th of March 2018 also indicate that no noticeable water penetration could be noted. Figure 3 taken on the 11th of March 2018 indicates that the surface texture remained unaltered. The non-penetration of water by the model is partly due to the material properties of EPS, but also

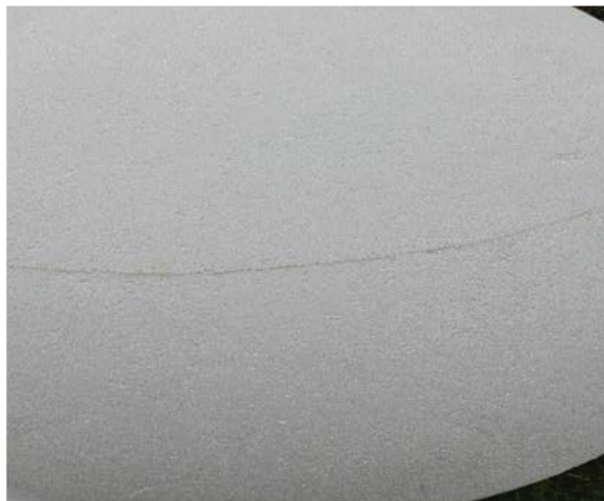
Figure 3: EPS Dome model captured from a different angle in March 2018.

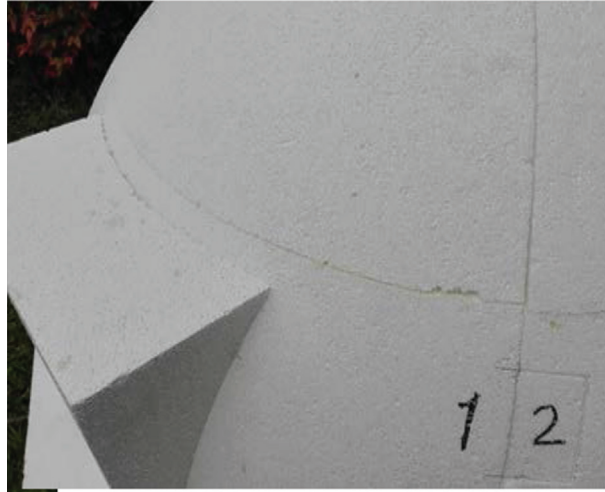
Figure 4: EPS Dome model at close range.

largely due to the shape of the model. Surface water run-off is maximized with a dome shape rather than with a conventional box shape. The model pieces were only inter-locked to each other as shown in Fig. 4, but wind speeds observed on the 2nd of February 2018 did not collapse the model. This was due to wind gusts flowing easily through the curvatures of the model. The lack of any sufficiently large enough surface area for the wind to force itself against, causes it to flow through the model and to continue on its path.

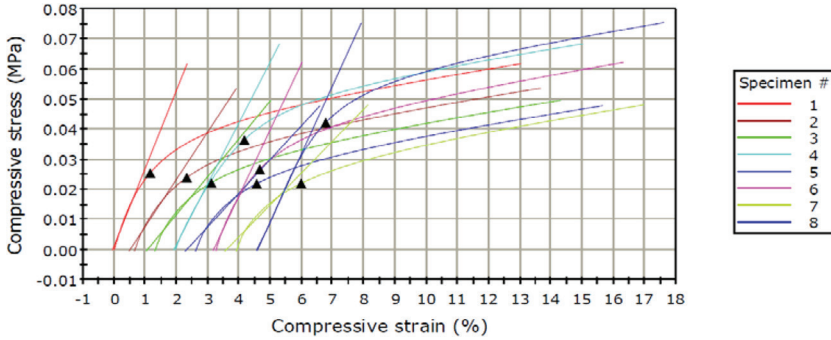
Figure 5: Compressive stress vs compressive strain graph for 15 kg/m³ samples.

The mean and standard deviation for each different type of density have been detailed in Figs. 5 to 7 and in Tables 1 to 3.

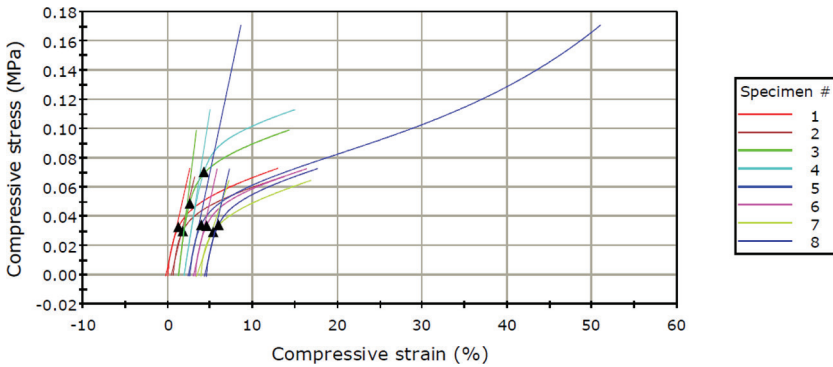
Figure 6: Compressive stress vs compressive strain graph for 20 kg/m³ samples.

From the eight specimens for each different density, the three most comparable results from each were considered and are detailed in Table 4. Specimen number 5 in Fig. 6 is an outlier as it deviates significantly from the general pattern of all the other 20 kg/m³ specimens. One of the most likely causes for this variance is that of material contamination. Material contamination can cause a materials' performance to lie outside of the 'normal' range of performance. Such a specimen indicates that caution should be exercised in the handling of EPS since any contamination may alter its material characteristics and possibly compromise its intended function.

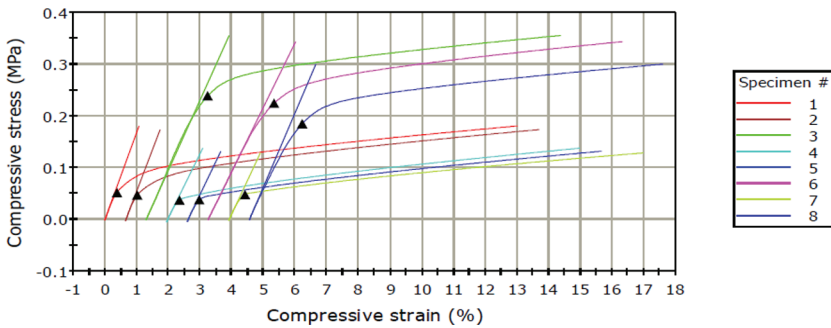
Figure 7: Compressive stress vs compressive strain graph for 30 kg/m³ samples.

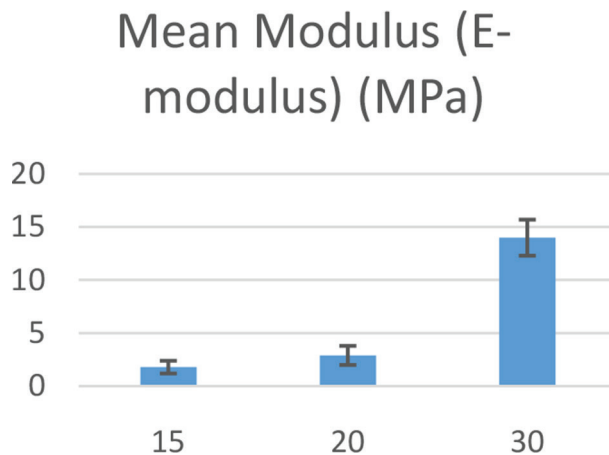
Figure 8: Compressive strength mean modulus graph showing error bars using standard deviation.

In terms of material variability and also as shown in Fig. 8, the error bar for 30 kg/m³ density samples indicates that the difference between 30 kg/m³ and lower densities such as 15 and 20 kg/m³ differs significantly. Standard deviation error bars for 15 and 20 kg/m³ show that the difference is statistically not significant and this further means that the characteristics of both densities of 15 and 20 kg/m³ only differ by a minor degree. Shodhganga [5] states that the modulus of elasticity for three clay brick samples considered during an investigation of compressive strength for clay bricks was 600.6, 559.2 and 574.2 MPa. This shows that the modulus of conventional materials such as clay bricks is significantly higher than the modulus of EPS. However, Japan Dome House Co. Ltd. has shown that EPS can be manipulated during manufacture to yield a much higher density in order to achieve a greater compressive

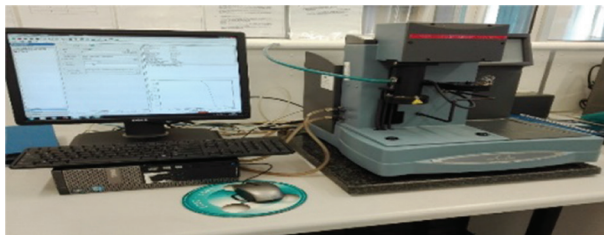
Figure 9: Thermo-gravitational analysis Q500.

The equipment used for the investigation is the thermo-gravitational analysis (TGA) Q500. A sample of the material to be examined was placed in an inert container and then heated at a controlled rate under a controlled atmosphere. The sample mass was recorded continuously as a function of time and temperature. When the sample underwent a reaction or thermal decomposition involving a mass change that change was indicated by a departure from the initially established baseline of the mass record. The onset temperature and mass changes were determined and recorded.

The TGA analyser shown in Figs. 9 and 10, plotted three line graphs of the performance of all three densities which are presented in Figs. 11 and 12. These line graphs were used to identify the tolerance levels of the varying densities and to further identify the point at which each material begins to degrade.

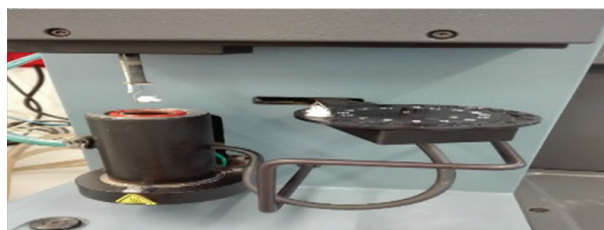
Figure 10: Samples being loaded in a furnace.

The empty specimen container was weighed. The specimen and container were placed into the TGA at ambient temperature. Heat was applied to the specimen at a constant rate of $10^{\circ}\text{C min}^{-1}$ and the thermogravimetric curve was recorded. Heating continued until a constant mass was obtained or until the temperature was well above the useful temperature range of the material tested.

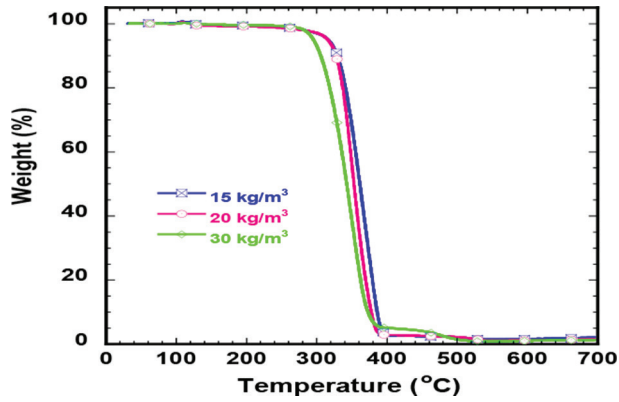
Figure 11: Weight vs temperature graph of EPS samples.

As the density of EPS increases, the maximum degradation temperature decreases, this is contrary to what would naturally be expected. A natural assumption would be that the higher the density, the lower the susceptibility to being consumed by fire. Fires range up to values in excess of 1000°C [8]. The above degradation values indicate that the natural face of EPS would need to be reinforced with a clad layer on top in order to increase its resistance to heat, and also to off-set its degradation value to a greater value.

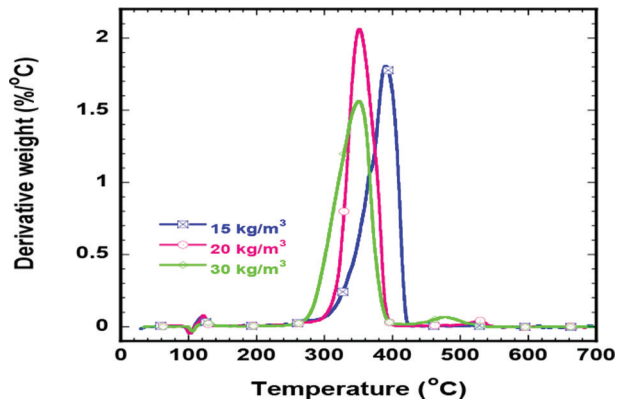
Figure 12: Derivative weight vs temperature graph of EPS samples.

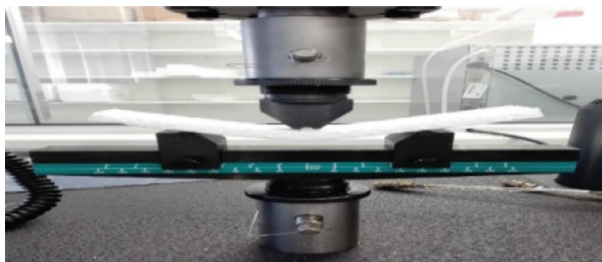
Figure 13: EPS sample being subjected to flexure during the flexural strength test.

Each specimen's width and depth were measured to the nearest 0.3 mm at the centre of the support span as shown in Fig. 13. The dimensions of the test specimen were 100 × 40 × 10 mm.

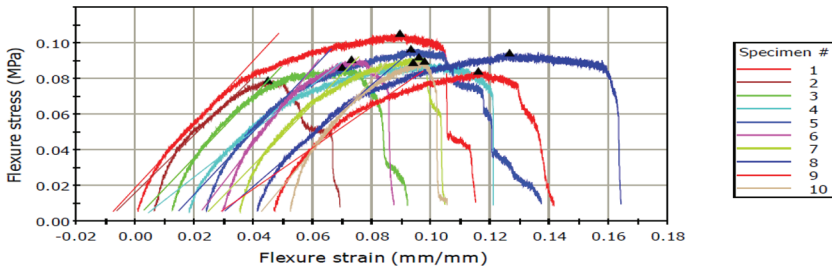
Figure 14: Flexural stress vs flexural strain graph of 15 kg/m³ samples.

Instron 5966- k8883 display unit plotted the relevant line graph for each of the samples with varying densities. The performance of each sample with regards to stress and strain is demonstrated in Figs. 14 to 16.

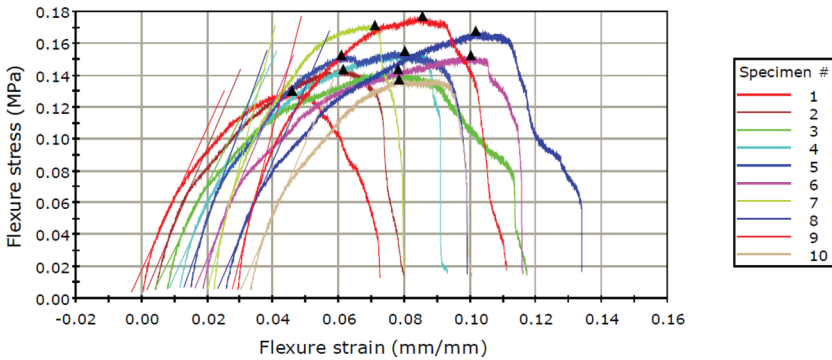
Figure 15: Flexural stress vs flexural strain graph of 20 kg/m³ samples.

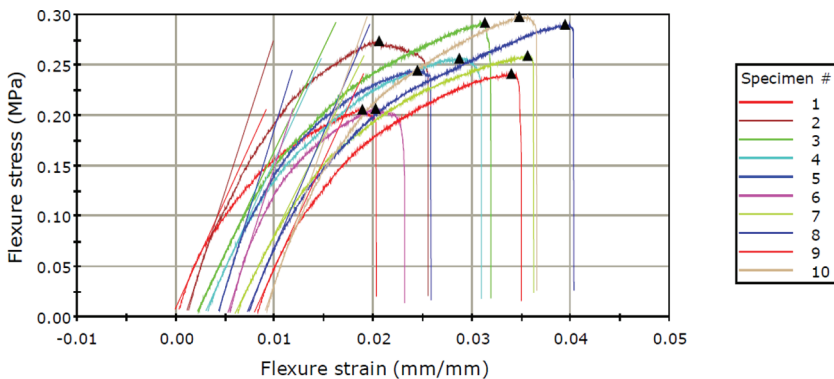
Figure 16: Flexural stress vs flexural strain graph of 30 kg/m³ samples.
