## **Landslide Mechanism of a Slope in Nanhuan Road, Funxin, Northeast China**

Huiming Liu\*, Changming Wang, Suoyu Zhang, Bing Wang

### **Abstract**

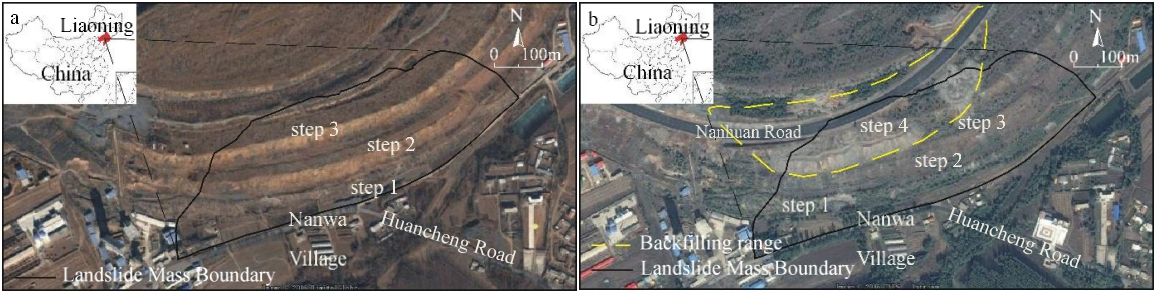
The study area and the location of the slope are shown in Fig.1. The clear steps on the slope reflect the stages of backfilling by the surrounding mines. A three steps slope was formed at the end of backfilling in 2004 (Fig.1.a). The slope was originally stable and free from deformation. However, the stability was undermined by the construction of Nanhuan Road from March to September 2012. The road crossed the top of the original slope at Step 3 from northeast to southwest. A largescale backfilling was carried out to meet the road design requirements. The backfill formed a new step (Step 4) atop the original slope (Fig.1.b). After the construction, the slope can be divided into four steps, each of which consists of a 25~35° slope and a relatively flat platform. From bottom to top, Step 1, Step 2 and Step 3 are all 20m tall, and Step 4 is about 15m in height (Fig.1.b).

Fig.1. Location of the Study Area (a. Before backfilling b. After backfilling)

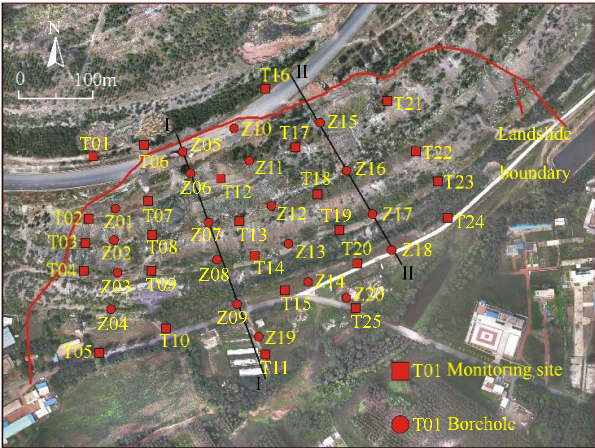
Fig.4. Location of Monitoring Points, Boreholes and Section Lines

A site survey was conducted to ascertain the distribution of the sliding features on the slope surface and evaluate the slope stability and development trend of landslide. Fig.4. shows the location of monitoring points, boreholes and section lines, and illustrates the distribution of slope

After the site survey of the landslide, 24 surface displacement monitoring points (T01-T24) were set up on the surface of the slide mass and in the surrounding area, aiming to capture the sliding trend in different areas (Fig.4).

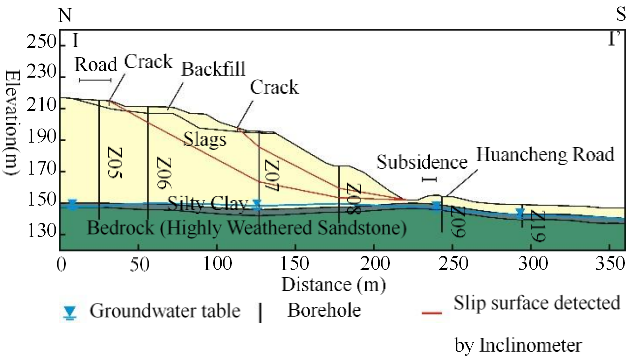
Fig.5. Cross-section I-I' of the Slope

deformation features. Fig.5. details a typical longitudinal section I-I' extracted from Fig.4. and displays the stratigraphic information obtained from the boreholes. As shown in the figure, the slope is formed with the slags produced by surrounding mines. The upper part of the gangues is a 4.2~64.4m thick layer of sandstone, mudstone and sub-clay, while the lower part of the gangue is a 1.2~12.0m thick layer of silty clay. The lower part used to be the surface soil layer before the accumulation of slags. The bedrock is composed of weathered sandstone. The ground water table was measured based on the monitoring results of drilling. The relevant engineering geological parameters of the slope were tested according to the relevant requirements of the Code for Investigation of Geotechnical Engineering (GB50021-2009). The test results are summarized in Table 1.

In light of the surface displacement monitoring data, the section with the most significant displacement along the sliding direction, i.e. section I-I', was selected as the typical section for slope stability analysis. The Morgenstern-Price (M-P) method was introduced to compute the slope stability, as it was assumed that the slip surface is not a circular sliding surface. Table 1 lists the calculation parameters obtained from the pre-survey test. Three types of conditions were configured for the slope stability analysis in different phases. In condition 1, the subgrade backfill was not performed and the slope was in the natural state. In condition 2, the subgrade backfill had been finished but the slope was not affected by rainfall infiltration. In condition 3, the slope had been affected by rainfall infiltration.
