## Assessing and Mitigating Seismic Risk for a Hospital Structure in Zaruma, Ecuador: A Structural and Regulatory Evaluation

This research, conducted in Zaruma, southern Ecuador, seeks to evaluate the seismic vulnerability and performance level of the Humberto Molina Hospital's reinforced concrete buildings. The study employs an examination of national and international seismic codes for rehabilitation, along with the implementation of recommended techniques. Structural characteristics of the buildings were identified through auscultation, surveys of reinforcing steel, and the extraction of concrete cores. The amassed data, coupled with a seismic hazard analysis of the site, facilitated a structural assessment of the blocks, conducted in accordance with national (MIDUVI) and international (ASCE/SEI) codes. The Federal Emergency Management Agency (FEMA) subsequently proposed rehabilitation alternatives for each block. Due to the importance of the hospital's functions, data collection was limited to blocks B3 and B4. The structural system, composed of moment-resisting concrete frames, exhibits potential vulnerabilities due to knocking (collision) and torsion, attributed to its irreg

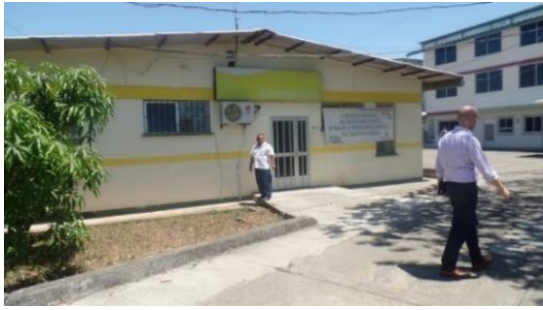
(a) B4 front view

Block B4 is comprised of moment-resistant concrete frames. The building has an irregular shape without joints between the sub-blocks. B4 had no horizontal structural system because it was directly over the portico. Among the damages found inside B4, the following can be observed: a) Cutting cracks along the masonry surface; b) Joint formation at the floor level, damaging non-structural elements such as tiles; and c) Vertical cracks in the masonry and beams.

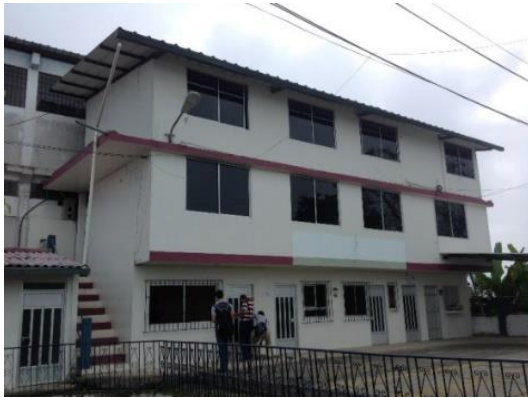
(b) B3 front facade

B3 is made of reinforced concrete in the first two mezzanines, whereas the last mezzanine is made of a metallic structure. According to auscultations, the structural system consists of moment-resisting concrete frames, with a ribbed slab-type horizontal system in one direction with band beams. Among the damage found were cut and vertical cracks in the masonry. Knocking between the administrative building (B3) and the San Juan Bosco school is possible.

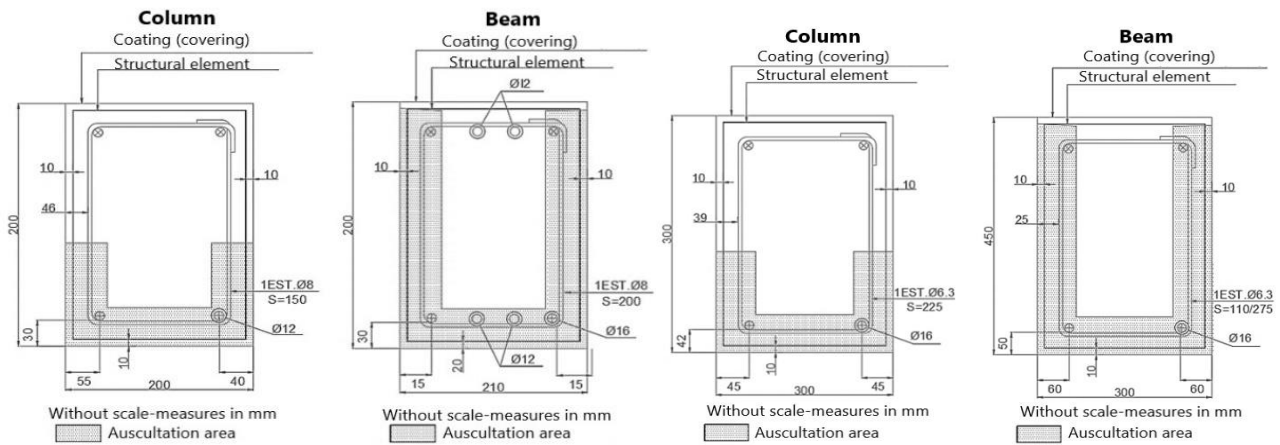
(a) Typical column and beam of B3

(b) Typical column and beam of B4

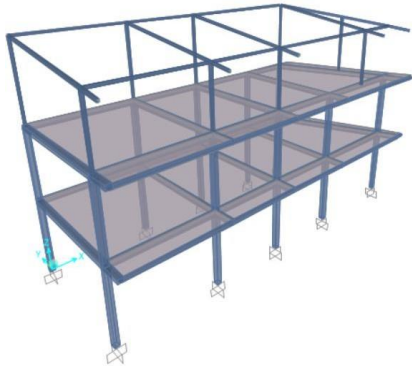
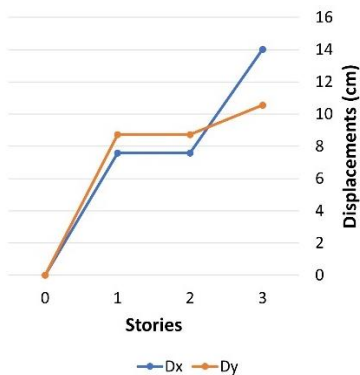
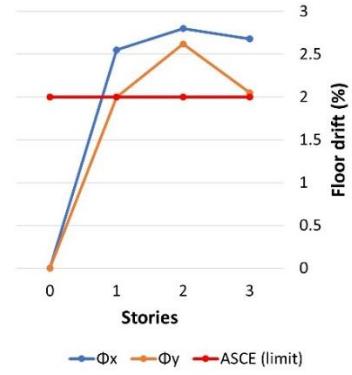
(a) 3D view of block B3

(c) Displacements in B3

(d) Floor drift (%) in B3

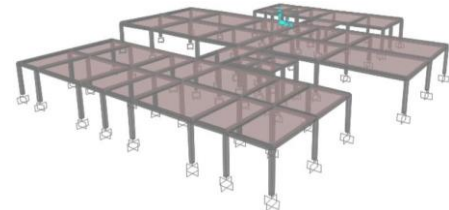
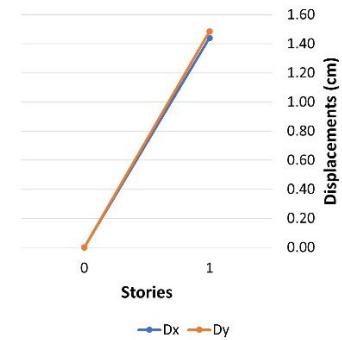
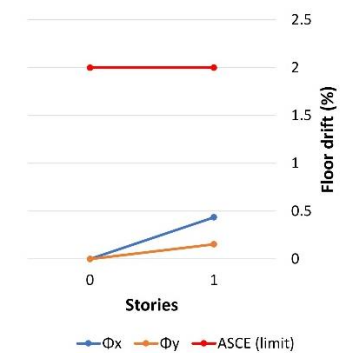
**Figure 11.** Spectral modal analysis of B4

(a) 3D view of block B4

(c) Displacements in B4

(d) Floor drift (%) in B4
