HANDS-ON-EXPERIENCE ON SEISMIC RETROFIT IN FOUR DIFFERENT COUNTRIES

HAZIM YILMAZ & THOMAS HACHMANN
OBERMEYER Planen + Beraten GmbH, Munich, Germany.

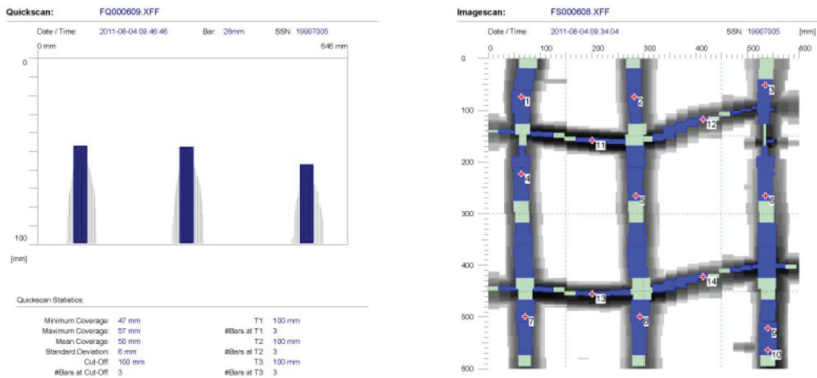
Figure 2: Use of ferroskans.

A reinforcement scanner is a very efficient tool in order to get information about the diameter, spacing, and concrete cover of the in-built reinforcement. Different scan types can be used to verify existing reinforcement. Application examples can be seen in Fig. 2. The left picture shows a 'Quick scan', which IS used to determine the existence, distance, and concrete cover of reinforcement bars. The right picture shows an 'Image scan'. An 'Image scan' shows the distribution of rebars in a section and gives additional information on rebar diameter. If necessary and allowed by the customer, destructive tests on few selective locations are a suitable for validation.

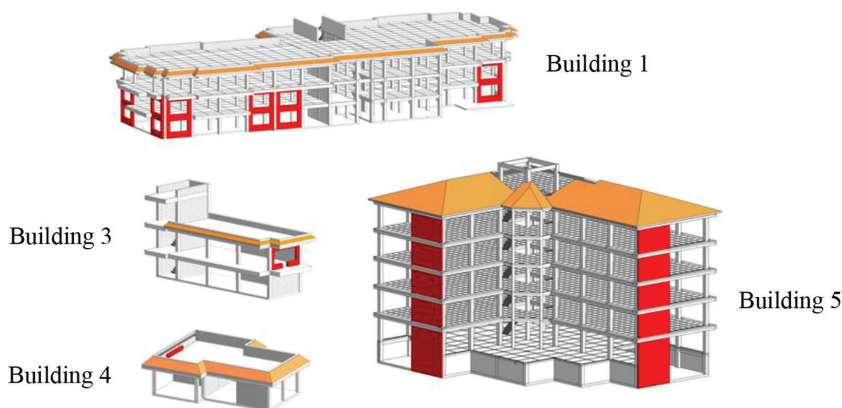
Figure 5: Retrofit design.

Based on the result of the seismic assessment procedure, Obermeyer planned seismic strengthening adding reinforced concrete shear walls. The proposed locations of shear walls can be seen in Fig. 5.

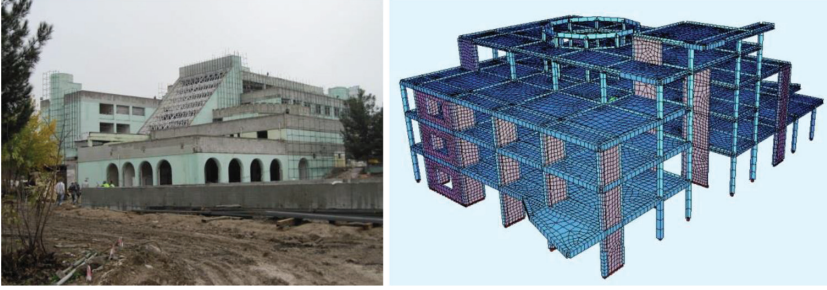
Figure 6: Retrofit design.

Based on the result of the seismic assessment procedure, Obermeyer planned seismic strengthening adding reinforced concrete shear walls. The proposed locations of shear walls can be seen in Fig. 6.

However, the construction company started to use steel bracings without the agreement of Obermeyer, which would definitely not substitute RC shear walls in terms of stiffness and strength properties. Additionally, the use of steel bracings needs a proper workmanship that was not available on site. Quality of welding seams was inappropriate as well as connection to reinforced concrete parts. The only way to react to these circumstances was the addition of supplementary steel bracings.

Obermeyer could fortunately avoid the replacement of reinforced concrete shear walls by steel bracings in the most affected areas in the lower floors.
