Corrosion Behavior of Thermal Seamless Carbon Steel Boiler Pipes

Jamal Nayief Sultan^{1*}, Muna Khethier Abbas², Marwa Abd-al Kareem Ibrahim¹, Emad Toma Karash³, Adel M. Ali³, Hssein A. Ibrhim³

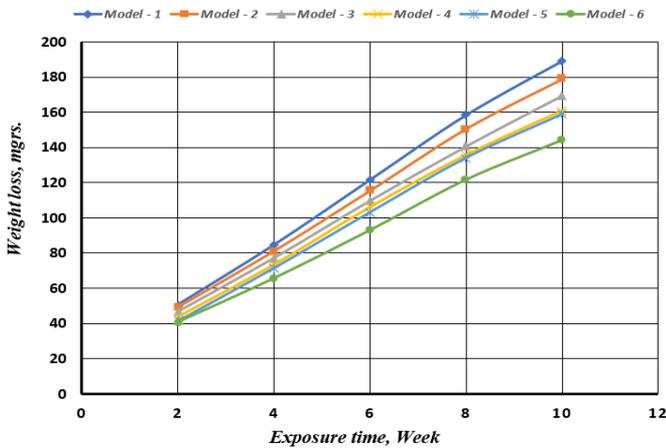
For varied PH values and corrosive hardness (CaCO_3), Figure 13 shows the difference in lost weight in relation to the duration of exposure to corrosion media. With an increase in exposure time to corrosive medium, the figure shows an increase in weight loss.

Figure 13. Depicts the weight loss of carbon steel pipe specimens as a function of exposure time to corrosion fluid at various pH levels

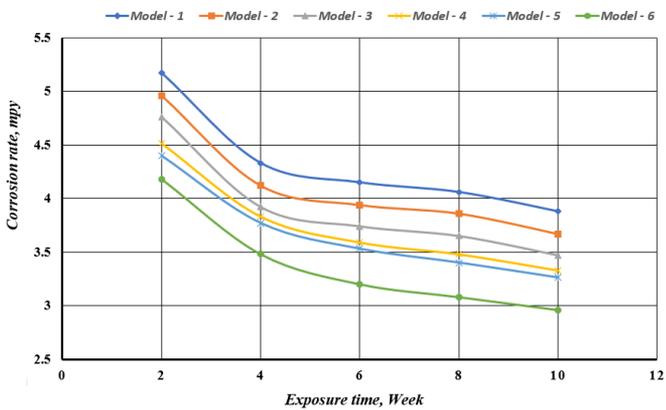
Figure 14. Corrosion rate of carbon steel pipe specimens vs. time exposed to corrosion media at varied pH values

For varied pH and hardness values, Figure 14 depicts the difference in corrosion amount (mpy) as a function of exposure time to corrosive media.

The corrosion of boiler pipe material has been reduced when the pH value has increased from 7.2 to 8.4, as shown in Figure 14 and Figure 15.

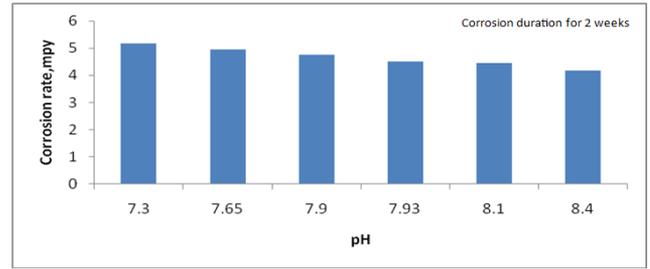
Figure 15. Corrosion rate of steel tube sample in relation to pH value

The corrosive impact of low pH water caused the corrosion rate to decrease. The solubility of calcium carbonate decreased as the pH value increased, making it more likely to precipitate in the form of flakes, while high alkalinity water led to the production of flakes at lower pH values.
