# Experimental analysis of thermal and damage evolutions of DCFC under static and fatigue loading

*ABSTRACT.* Discontinuous carbon fibre composite (DCFC) is a new low-cost material that has already been applied for commercial components, such as window frames of the Boeing 787 Dreamliner. Studying DCFC is very challenging because it does not show the same behaviour than conventional composites or isotropic materials. This work presents an experimental study of DCFC specimens submitted to static and fatigue tensile loading, based on mechanical and thermography non destructive evaluation (NDE) technique. An infra-red (IR) camera is used for real time monitoring of temperature change at the specimen outer surface. Under static loading, thermal response permits to well detect the early appearance of micro defects up to the final failure of DCFC material. Moreover, thermal response gives a good correlation with the damage evolution under fatigue loading. It is also shown that thermography method allows to successfully determine the high cycle fatigue strength (HCFS) of DCFC material.

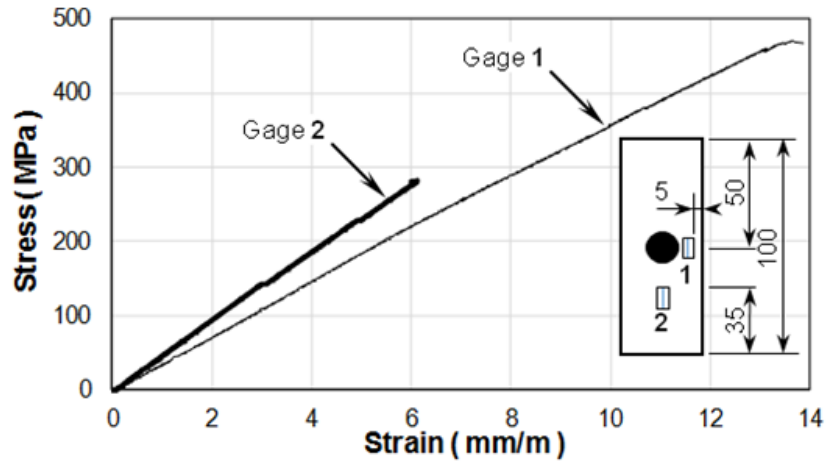
Figure 5. Stress-strain curves for DCFC subjected to a static test

Fig. 5 represents typical stress-strain curves in area with hole (gage 1 and Eq. (1)) and in area without hole (gage 2 and Eq. (2)) under the same tensile loading until failure. The presence of the hole reduces the cross-section and increases the calculated strength. These different stress-strain calculations yield to different LS measurements:  $35290 \text{ MPa}$  for gage 1 and  $46180 \text{ MPa}$  for gage 2.

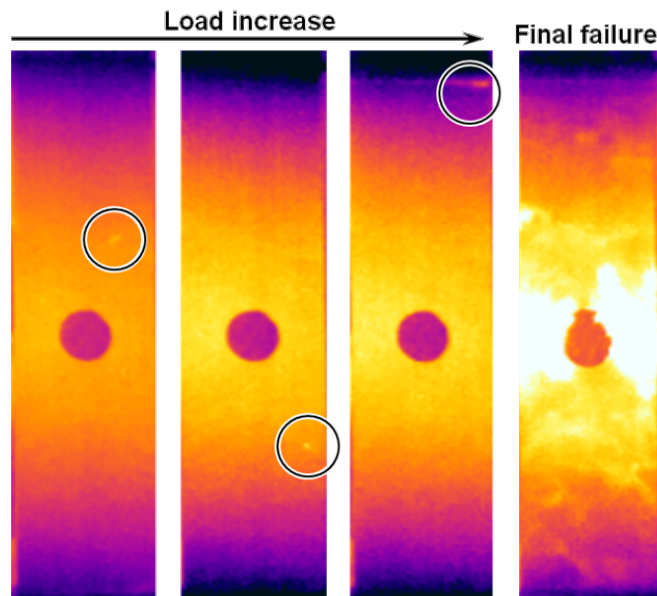
Figure 6. DCFC thermography images obtained during a static test

Thermography images obtained by the IR camera during a tensile test are shown in Fig. 6. Before final failure, images show several very local peaks of  $\Delta T$ , called

hot-spots. These hot-spots, varying in location and intensity, are pointed out by black circles in Fig. 6. The central region of the specimen presents the higher temperature during the whole test, which increases until final failure.

Temperature evolution appears according to two stages. In the first part, a minor increase of  $\Delta T$  is recorded, which is possibly due to micro defect mechanisms appearing during the test. These micro defect mechanisms provoke some hot-spots that are visible by the IR camera only for a few seconds, and could be local debonding of compound tips from matrix. In the second part, a major increase of temperature is observed in a constant and large area where final failure eventually occurs. During this last stage, close to final failure, characteristic breaking sounds can also be heard.

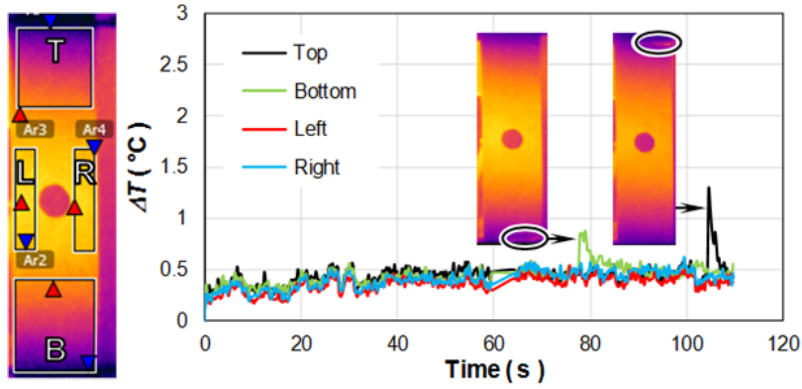
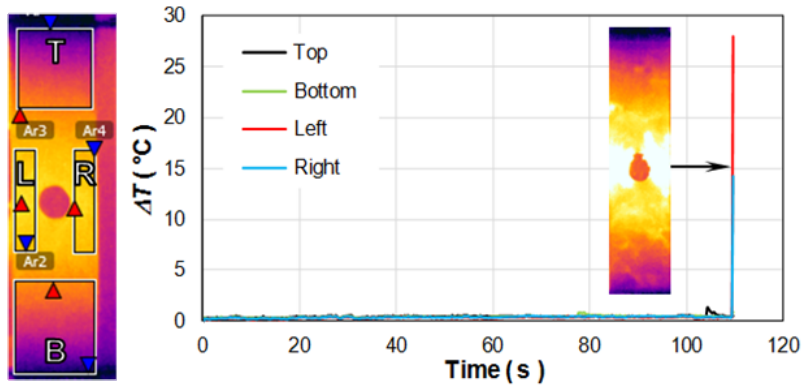
(a) Hot-spots at first stage of minor  $\Delta T$  increases

(b) Fixed heating areas as second stage of major  $\Delta T$  increases

Figure 7. Evolution of the temperature variation  $\Delta T$  during a static test

In order to follow the  $\Delta T$  evolution during the test, four subdomains defined on the specimen are shown in Fig. 7: one at each edge of the hole and the others closed to the clamps. Fig. 7 shows the  $\Delta T$  evolution thereby obtained until final failure. Before final failure, the entire specimen surface presents a  $\Delta T$  varying between  $0.3$  and  $1.4^\circ C$ . A  $\Delta T$  above  $0.7^\circ C$  is clearly shown by several hot-spots located close to the clamps as seen in Fig. 7a. When the final failure occurs,  $\Delta T$  suddenly increases up to around  $28^\circ C$  at the edge of the hole, as shown in Fig. 7b.

Considering the local  $\Delta T$  evolution, it clearly appears that most of hot-spots do not indicate the final failure location. The presence of early hot-spots possibly brings out lower local mechanical properties coming from manufacturing defects or from the non-homogeneous chips nature. As a consequence, these early hot-spots seem to represent only sporadic local damages, which do not grow nor coalesce to form the macro damage. This phenomenon has already been pointed out by a previous study (Feraboli *et al.*, 2010). The final failure occurs at the edge of the hole which demonstrates that the hole diameter used for this study is large enough to produce such a stress concentration that the stresses in region away from the hole can be neglected. Thermography observation also confirms that all the micro defects giving early hot-spots have less effect than the hole triggering the critical damage. It is pointed out that this DCFC thermography behaviour is substantially different from that obtained for continuous fibre composite (CFC) where hot-spots often indicate the crack initiation or at least the location of macro defects. The sudden  $\Delta T$  increase followed by final failure represents the energy which is released just before rupture. In areas with no macro damage,  $\Delta T$  does not show any significant increase. Summarizing, we can conclude that minor  $\Delta T$  increases are due to manufacturing defects while major  $\Delta T$  increases are caused by macro defects related to significant macro damages.

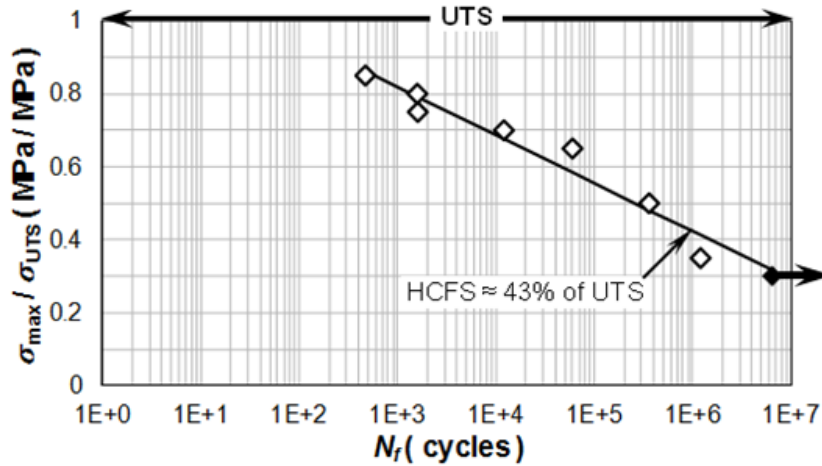
Figure 8. S-N curve obtained for DCFC

The S-N curve shows a gradual decline in fatigue strength when  $N_f$  increases. The trendline predicts a high cycle fatigue strength (HCFS) of about 0.43, that is to say that  $N_f$  reaches  $10^6$  cycles when the maximum stress value is around 43% of UTS. Hence for this DCFC material, a normalized stress level of up to about 0.43 (approximately 200 MPa) can be taken as a safe value for fatigue strength (i.e., the stress corresponding to a life of more than  $10^6$  cycles).

The normalized S-N curve is then represented by Eq. (3) where the 0.05 value is called the fatigue sensitivity coefficient:

$$\frac{\sigma_{max}}{\sigma_{UTS}} = 1.23 - 0.05 \ln N_f \quad (3)$$

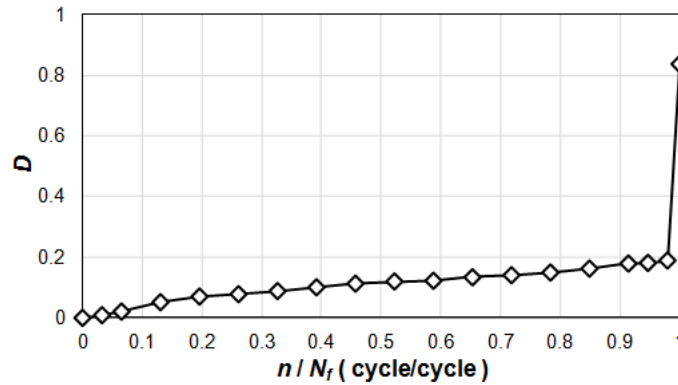
(a) Damage evolution for a load level of 80 % UTS ( $N_f = 1580$  cycles)

(b) Damage evolution for a load level of 85 % UTS ( $N_f = 470$  cycles)

Figure 9. Typical damage evolution for DCFC specimens

Two typical cumulative damage examples are given in Fig. 9. In these curves,  $D$  represents the cumulative damage defined as:

$$D = 1 - \frac{GS}{GS_0} \quad (4)$$

where  $GS$  and  $GS_0$  are the global stiffness at any given loading cycle  $n$  and the initial global stiffness, respectively. In both examples  $D$ -curves show the same behavior: after an initial rapid increase (an average increase of about 10% during the first 20% of fatigue life), damage increases slowly until being close to the final failure; for the last 5% of fatigue life, damage increases suddenly and strongly as a consequence of the final catastrophic failure. In the present study,  $\Delta T$  of the specimen subjected to fatigue loading is evaluated by an IR camera. Fig. 10 reports the average  $\Delta T$  versus  $n$  for specimens loaded at different stress levels, using average value evaluated over the two regions at the hole edge (see Fig. 7) where the final failure takes place.

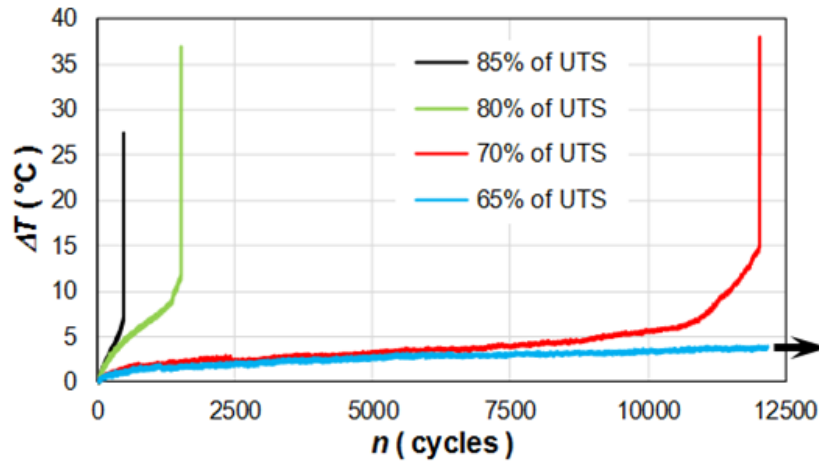
Figure 10. Temperature profile during fatigue test for different load levels

It can be seen that  $\Delta T$  increases during fatigue testing for all the stress levels, but not in the same manner.  $\Delta T$  response of the specimen loaded at 65% of UTS shows an increase during the first  $n = 1000$  cycles. As the testing proceeds, however,  $\Delta T$  remains nearly constant, with a rate of only  $0.0002^\circ C/cycle$  until the end of the testing (12000 cycles).  $\Delta T$  curve of the 70% shows a very similar trend in the initial loading phase as well as a very moderate increase of  $0.005^\circ C/cycle$  until  $n = 10500$  cycles, when an increase up to  $\Delta T = 15^\circ C$  is attained at a rate 10 times larger than in the preceding phase. The total failure is finally reached in only one cycle, and is accompanied by an abrupt increase of  $\Delta T$  up to  $37^\circ C$ . The same 3 phases characterize the  $\Delta T$  response of the 80% and 85% specimens. After a rapid increase of a few degrees at the beginning of the test,  $\Delta T$  changes with a constant rate

(respectively  $0.0066^\circ C/cycle$  and  $0.014^\circ C/cycle$ ) until reaching the final failure, which is accompanied by an abrupt and very strong  $\Delta T$  increase.

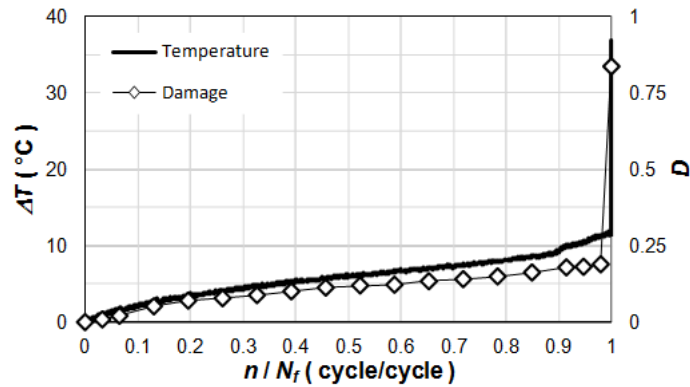
(a) Load level of 80 % UTS

(b) Load level of 85 % UTS

Figure 12. Temperature and damage evolutions during a fatigue test for different load levels

An evaluation of  $\Delta T$  increase and damage evolution in DCFC material is now conducted. The superposition of  $\Delta T$  and damage measurements obtained from global stiffness evolution (see Eq. (4)) are given in Fig. 12a for 80 % and in Fig. 12b for 85 % of UTS. The variation of the temperature  $\Delta T$  with respect to damage  $D$  is presented in Fig. 13, indicating that  $\Delta T$  and  $D$  are well correlated for this heterogeneous material.

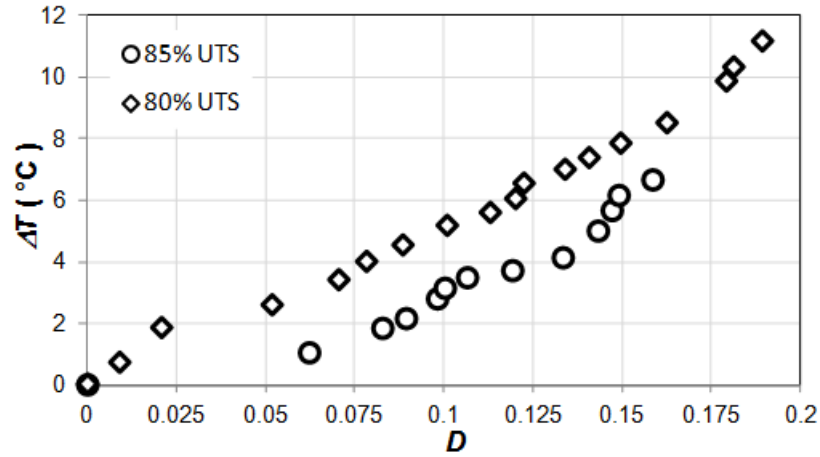
Figure 13.  $\Delta T$  versus  $D$  for the two load levels

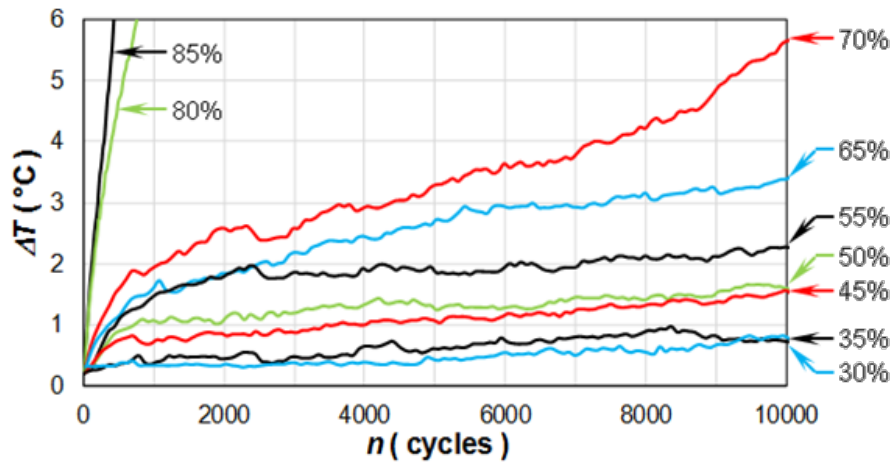
Figure 14.  $\Delta T$  evolution obtained for each load level

The purpose of this section is to assess Risitano method (Curti *et al.*, 1986) for DCFC material, combining thermography measurements and energy dissipation, as proposed in (Montesano *et al.*, 2013). The DCFC fatigue strength is evaluated on the basis of IR camera results and  $\Delta T$  is recovered from the previous fatigue tests over several thousand of cycles which corresponds to approximately  $10^4$  cycles for each load level. The area around the hole is again used to trend the  $\Delta T$  evolution and results are shown in Fig. 14. Using  $\Delta T$  values coming from the stabilized part of the curve ( $n = 6000$  is chosen), HCFS is then determined as the intersection of two

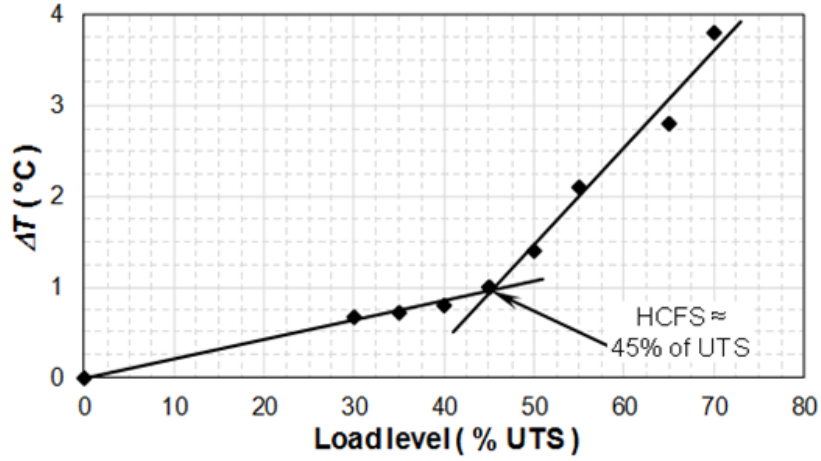
Figure 15. HCFS of DCFC determined by thermography approach

linear regressions that interpolate the  $\Delta T_s$  for low and high load levels. The result of this procedure is shown in Fig. 15.

HCFS values for DCFC are found with three different approaches: traditional Wöhler S-N curve (Fig. 8), direct thermography study (Fig. 15) or energy dissipation analysis (Fig. 17(b)).

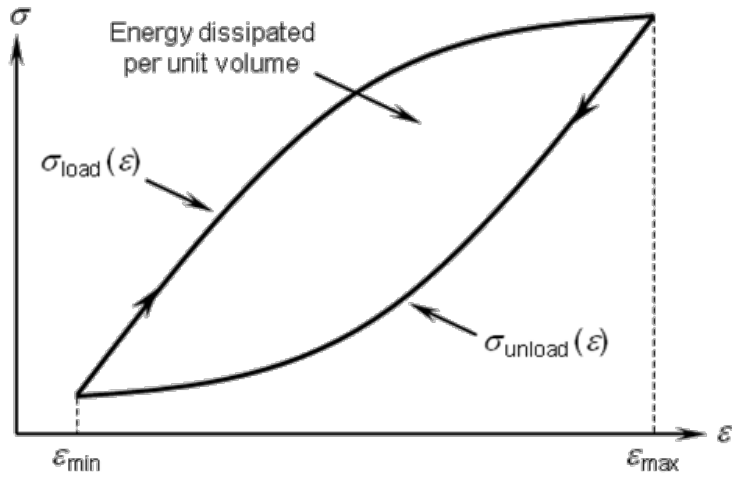
Figure 16. Schematic of quantifying dissipated energy  $E_d$  for any given cycle  $n$

An approach based on dissipated energy is next proposed in order to assess the thermography-base method for estimating HCFS. The energy dissipation per unit volume during one loading cycle is schematically shown in Fig. 16. The dissipated

energy  $E_d$  is thus measured as the area of the hysteresis loop by the following equation:

$$E_d = \int_{\epsilon_{min}}^{\epsilon_{max}} \sigma_{load}(\epsilon) d\epsilon - \int_{\epsilon_{min}}^{\epsilon_{max}} \sigma_{unload}(\epsilon) d\epsilon \quad (5)$$

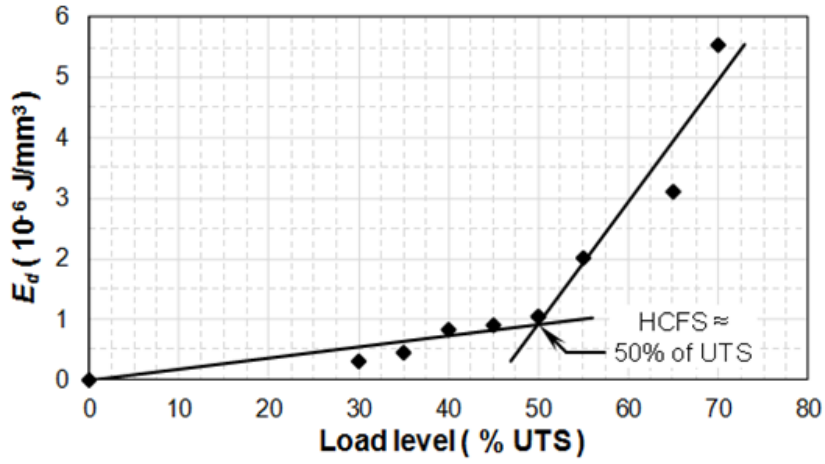
Figure 18. Bilinear approximation leading to the HCFS evaluation

Fig. 17 gives an illustration of  $E_d$  evaluation for different load levels, while Fig. 18 shows a plot of  $E_d$  versus load level for the cycle  $n = 6000$ . Hence quite similar
