Evaluation of PV Panel Power Loss Using Gabor Filter Bank

ABSTRACT

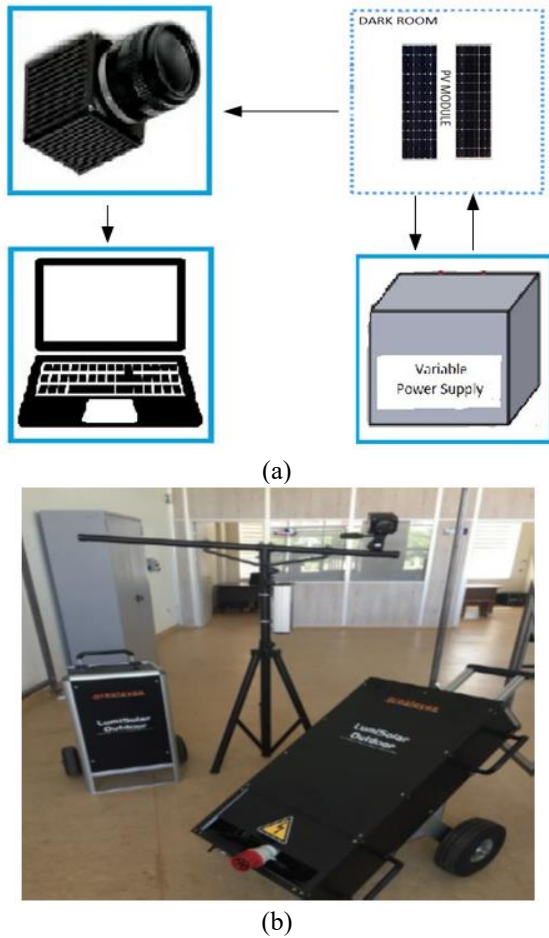
Figure 1. (a) EL imaging setup and dataset generation design (b) EL camera used in the study

In our study, images of 10 (10x6) PV panels brought from the field after being utilized for a long time were used. The images were recorded in the Photovoltaic and Power Electronics Laboratory within the GAPYENEV Center of Harran University, with a Greateyes Lumisolar Outdoor Line-Powered brand EL which can take pictures in 2048x2048 pixels in 2 seconds (Figure 1b). In Figure 1a, there is the connection diagram of the system used for EL image acquisition. The PV panel is energized with the Variable Power Supply in the dark room, and the image of the panel is taken with the Electroluminescence camera and recorded on the assigned computer. High temperature occurs in faulty areas on the panel that is energized by Variable Power Supply. This situation is visualized by the EL camera. With the EL camera, problems such as the structure of the panels, whether there exist any cracks in the panels, the effects of transportation during the EPC installation, or the strain of the panels can be detected. Since PV panels were evaluated separately as whole

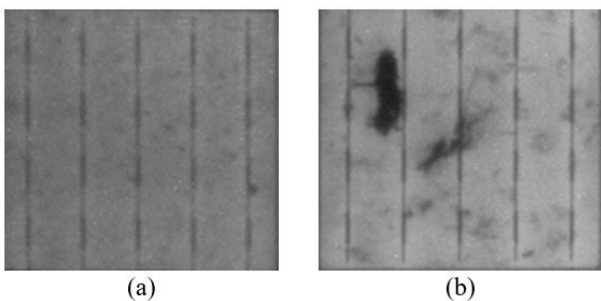
Figure 2. Examples of intact cells (a) and defected cells (b) used in the study

With the recorded image, the data set was created by taking into account the defects such as disproportionate panel efficiency losses, panel fractures, and micro-cracks, intercellular connection errors, and various damages in the PV panel, and it was estimated that the PV panel was intact, moderately defected or completely defected. The losses in the PV panels used in the study and examples of the intact cells are given in Figure 2.

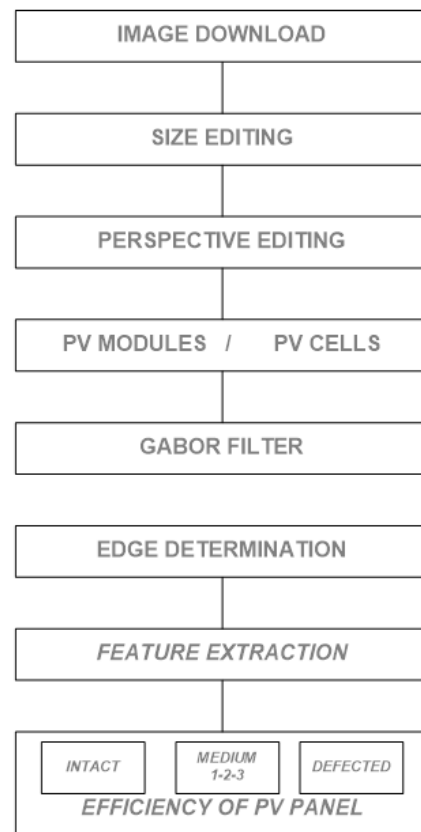
Figure 3. Flow chart of work

be processed on the computer. The flow chart of all these processes is presented in Figure 3.

Initially EL images of the PV panels captured were loaded into the MATLAB program. Then, noise and image adjustments of the captured images were made and greyscale images to be used in the study were obtained. After that, 60 cells were obtained by dividing each PV panel and the Gabor filtering method was applied to each cell separately and to all panels. With Gabor filtering, the cracks and distortions in the panel wafers will be emphasized and the parts that do not change will be suppressed. In this way, it will be possible to detect the errors in the image more accurately. The distortions caused by cracks or errors were obtained by applying OTSU algorithms to the images obtained as a result of Gabor. These distortions were evaluated as edge information. Finally, the edges were determined by the canny method, and an evaluation was made about whether the wafers and panels were intact or damaged.

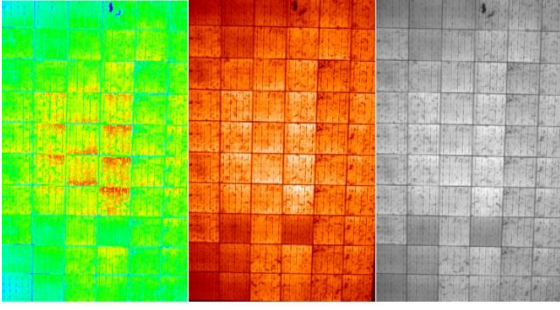
Figure 4. Original 3 color bands of EL images belonging PV panel

The determination of the intact or defects of PV panels from the data recorded in the Photovoltaic and Power Electronics laboratory within the GAPYENEV Center of Harran University was estimated using the image processing technique. One of the first and most important stages of image processing is noise removal and image editing. That's why, clipping and thresholding methods are applied in noise removal. 10 PV panels, each consisting of 60 cells, imaged with an EL camera, were handled in 2 original different color bands and evaluated grayscale image bands. The images of the records are presented in Figure 4.

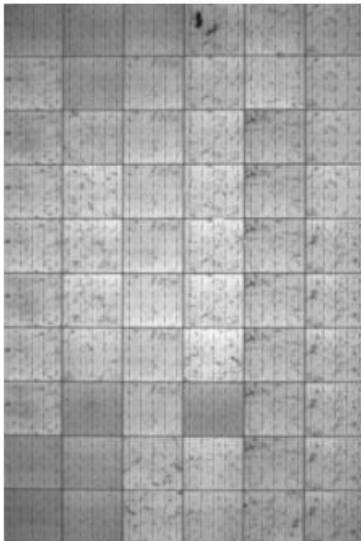
Figure 5. Perspective corrected PV panel

The threshold value of the EL camera images of the PV panel was determined by the OTSU threshold algorithm, and the panel part on the image was separated from the rest of the image. OTSU algorithm calculated an adaptive threshold value according to the brightness values in the image. Therefore, different threshold values are used for each image. Then, it was edited using perspective correction methods and processing was continued on grayscale images. The images of the corrected PV panels are given in Figure 5.

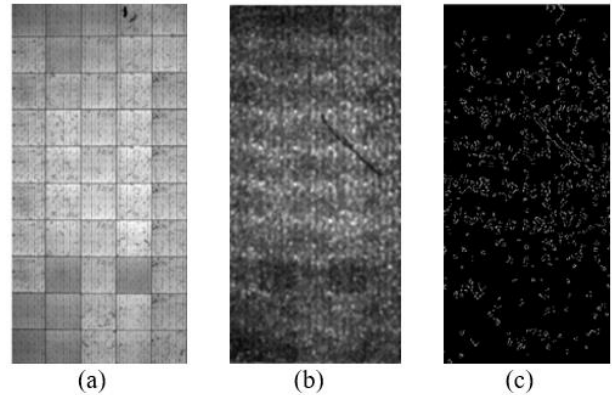
Figure 6. (a) Original image of the PV panel, (b) Gabor image of the PV panel and (c) edge image of the PV panel

In Figure 6, images of an example PV panel used in the study are given. The original image of the PV panel, an image created according to a different wavelength and orientation values with Gabor filter, and the images of the PV panel with edges subtracted are given in Figure 6a, 6b, and 6c, respectively.

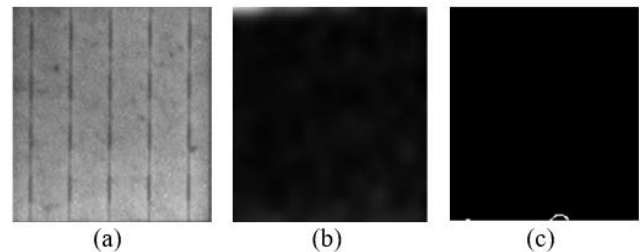
Figure 7. (a) Original image of a normal cell of the PV panel, (b) combined image of a normal cell of the PV panel with Gabor applied, (c) edge image of a normal cell of the PV panel

In addition, when each wafer is evaluated separately, the original image of an intact wafer, the combined image of the intact wafer with Gabor filter, and the images of the intact wafer with edges subtracted are given in Figure 7a, 7b, and 7c, respectively.

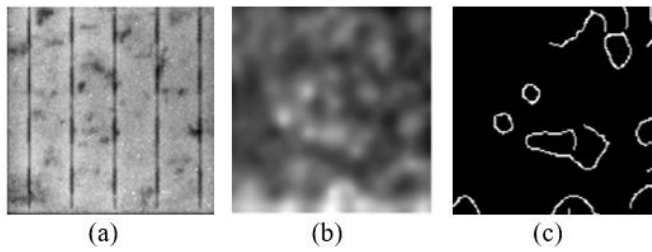
Figure 8. (a) Original image of a defected cell of the PV panel, (b) combined image of a defected cell of the PV panel with Gabor applied, (c) edge image of a defected cell of the PV panel

The same applications made for the intact wafer in Figure 7 are made for the defected wafers. The original image of a

defective wafer is given in Figure 8a. In Figure 8b, the combined image of the defected wafer with Gabor applied, and the images of the defected wafer with edges subtracted are given in Figure 8c.

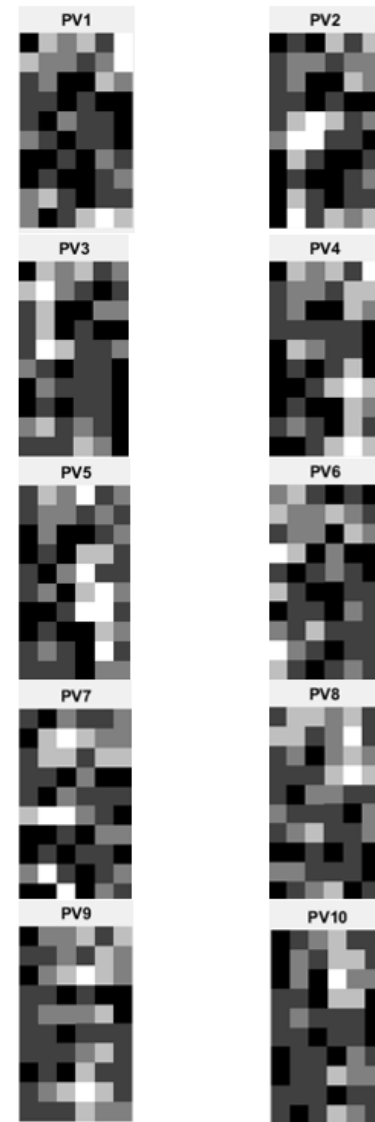
Figure 9. Intact cell and defected cell results of PV panels

After the edge detection of the images, 1.5 was chosen as the most appropriate parameter value because when a value smaller than this value was selected, very thin lines to be neglected would appear, or when a higher value was given, some lines that might be meaningful for the evaluation would be missed. This value was determined based on the control groups (laboratory measurement results are known). When the separated cells were evaluated, a threshold value was determined for the normal cell, moderately defected cells were grouped at certain intervals, and above a certain value, it was considered as completely defected. The cells were evaluated in 5 categories normal, medium 1, medium 2, medium 3 and defected. Since 10 defective PV panels were used in the study, a total of 600 cells were studied and 180 of them were determined as normal, 200 as medium 1, 120 as medium 2, 70 as medium 3 and 30 as defected. The calculated number of fractures in the image was used to determine the state of the wafers of PV panels. The wafers are marked as intact and 4 different degrees of damage. While doing this grouping, if the threshold values obtained were below the value of 0.01, it was accepted as normal; and by adding 0.005 above this value, damage grouping was made. This value was determined based on the control groups and expert comments. Since conductivity is one of the factors that are effective in deciding whether the PV panels are normal or defective, an evaluation was made of the PV panel based on the condition of the cells. As mentioned above, since 10 PV panels used in the study were defective, the failure conditions were determined by various methods used and also compared in terms of efficiency. Since the cells on the 10x6 PV panel are connected in series with long sides attached, the failure of one of the cells affects the conductivity between the series of connected cells, thus making all the cells in that row ineffective. Thus, it is possible to comment on the efficiency of the PV panel depending on the defective cell in the serial connection on the panel. The results of normal and defected cells of 10 PV panels formed according to the determined threshold value are presented in Figure 9.
