Development of energy efficient, cost-optimized transformer with low partial discharges

Dhruvesh Mehta^{*}, Prasanta Kundu, Anandita Chowdhury

Deptartment of Electrical Engineering, SVNIT, Surat, Gujarat, India

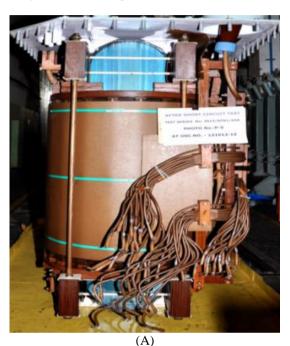
Figure 11. Photographs of the transformer active part after full scale dynamic short circuit test

A developed transformer is successfully tested for all routine tests as mentioned at factory end. After that developed transformer is subjected to dynamic short circuit withstand test at NABL accredited testing laboratory in accordance with IS 2026: Part 5 [10]. Applied short circuit current is also calculated as per the standard [10]. Prior to short circuit test, Transformer is ready with all protection devices e.g., gas-and-oil actuated relays, pressure release device. Reactance measurement is performed on the perphase basis and recorded to compare with post short circuit test reactance data. During each test applied voltages and currents oscillography recording are also taken to check any abnormality during the test. According to the standard, if measured reactance after short circuit test is within a maximum deviation of the order of 2% from the before test measured reactance, transformer declared as passed the short circuit test [10]. Also, along with reactance, the physical external appearance of the transformer is also verified to check the possibility of any anomalies and/or operation of any protection system during or after the test as this may indicate an incipient fault inside the transformer. Also, the out-of-tank inspection of the transformer active part is carried out to reveal any defects such as displacement, the shift of laminations, and deformation of windings, connections or supporting structures. No significant changes should appear which might endanger the safe operation of the transformer [10]. Also, no traces of internal arc electric discharges are found. Figure 11 (A) and (B) shows the photographs of the transformer active part taken after a full scale dynamic short circuit test and no abnormalities are found during internal as well as external inspections. Also post short circuit measured reactance is well within 2% of the measured reactance before short circuit test. Therefore, the transformer is declared as successfully pass the dynamic short circuit test.
